NATIONAL TRANSPORTATION SAFETY BOARD

Airworthiness Group Chairman's Factual Report

NTSB ID No.: DCA17FA021

NTSB Accident Number: DCA17FA021
Location: Chicago, Illinois
Date: October 28, 2016
Time of Accident: About 1432 Central Daylight Time
Aircraft: Boeing 767-323(ER)
Registration Number: N345AN

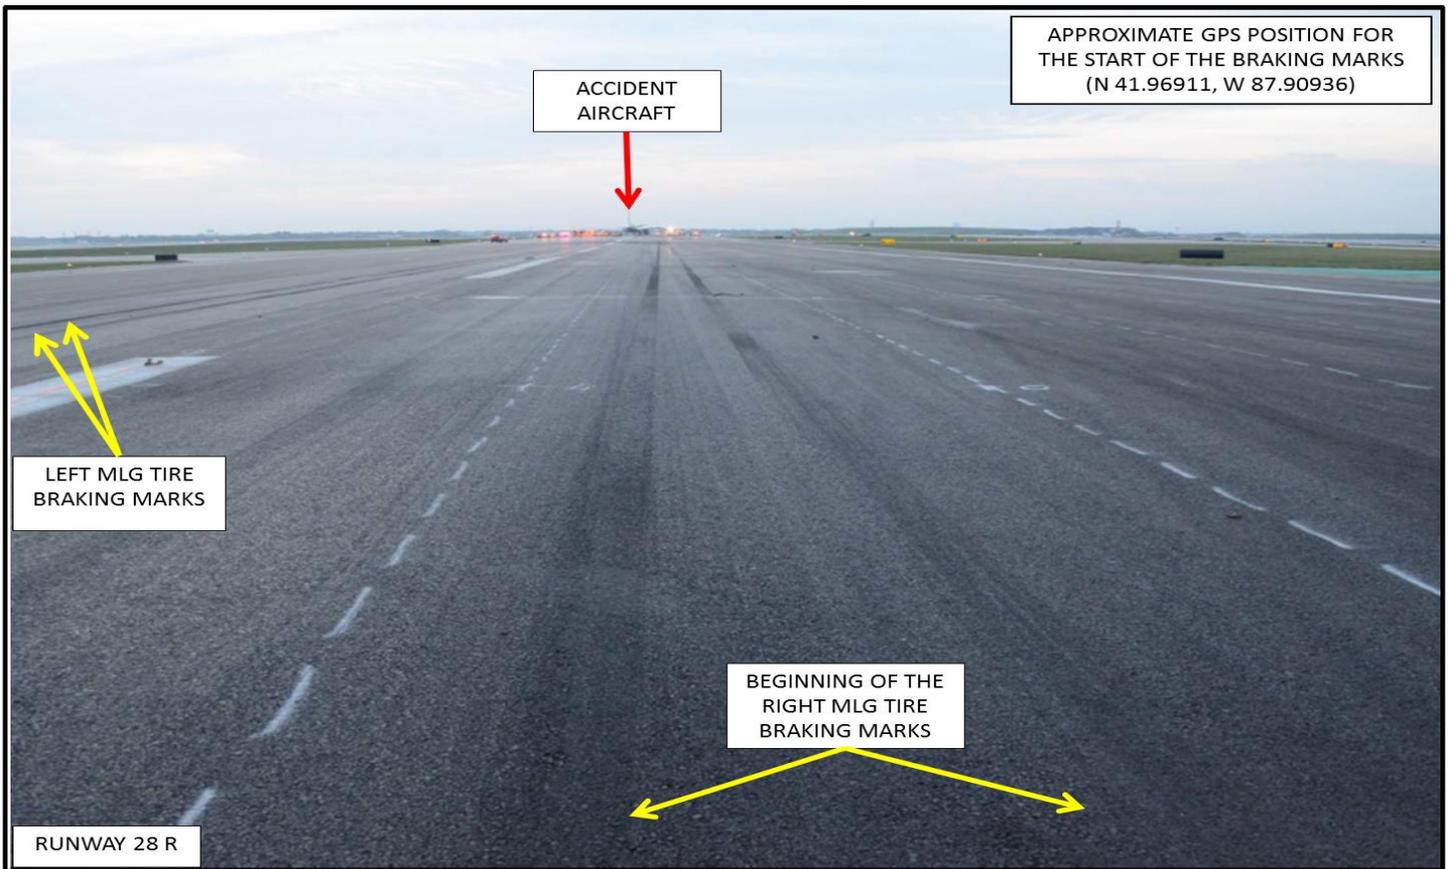
On Saturday, October 29, 2016, the Airworthiness group noted that the accident airplane was positioned approximately 9,225 feet from the threshold of 28R with approximately 3,775 feet of runway remaining. The length of runway 28R is 13,000 feet. The Airworthiness group walked runway 28R and noted that tire braking marks from the accident aircraft's left and right main landing gear tires were noticeable on the runway surface starting at approximately 6,941 feet from the threshold of 28R (or about 4,020 feet from taxiway N5¹). The braking marks continued approximately 2,284 feet to the airplane's final position.

Figure 2 View showing the beginning of the braking marks on runway 28R

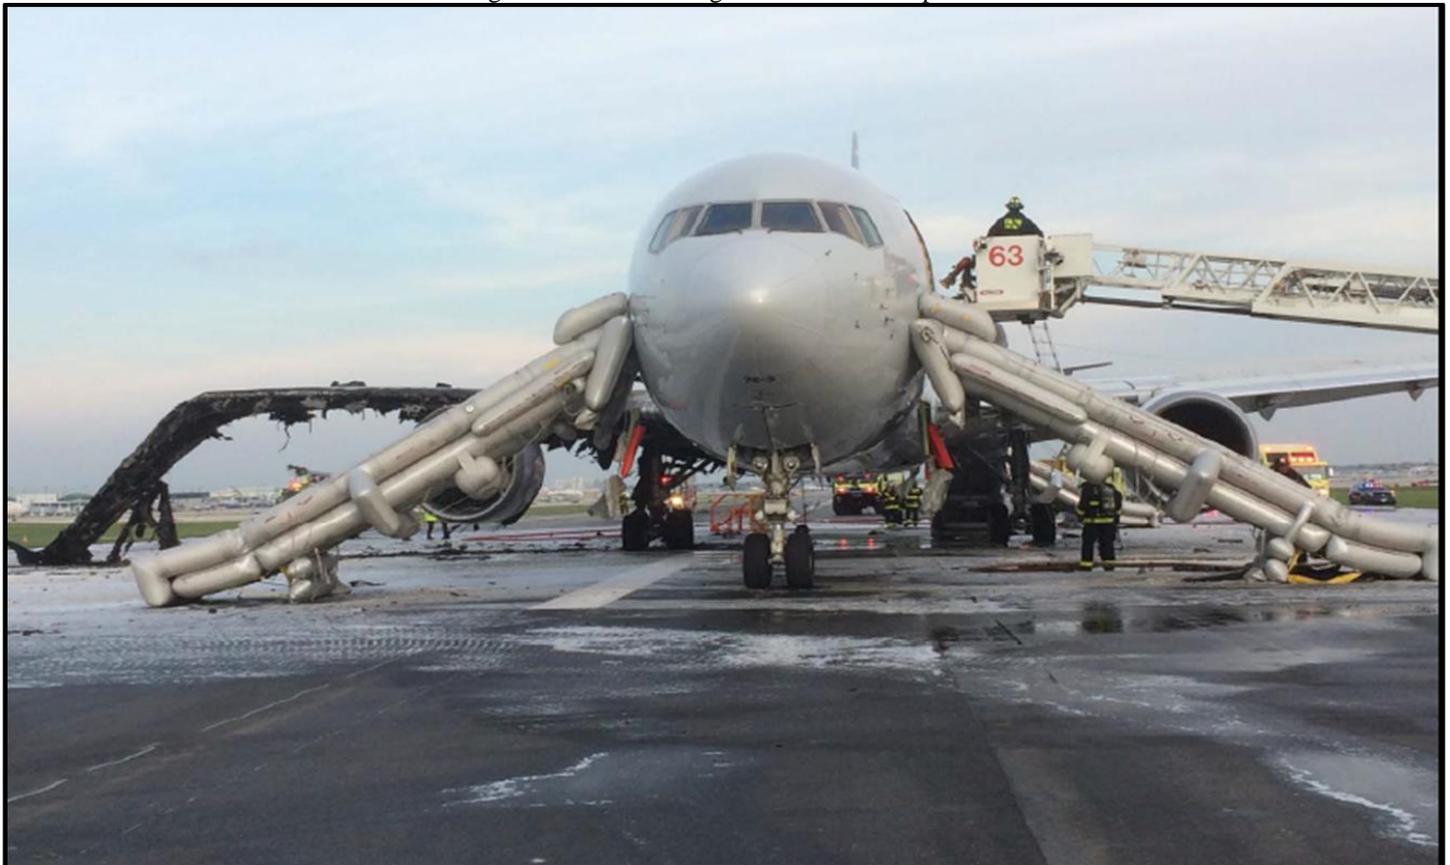
Figure 3 View showing the front of the airplane

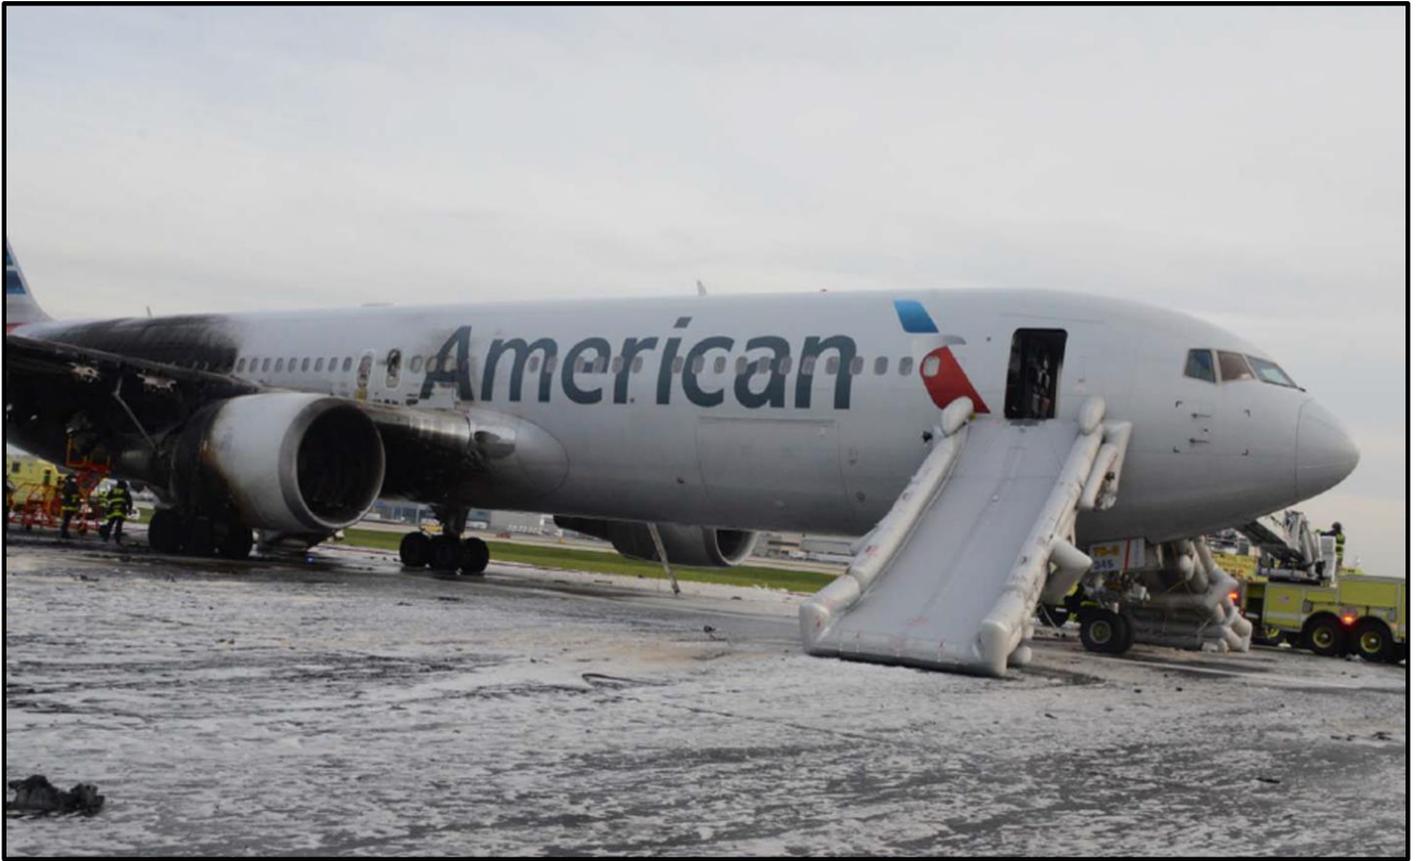
Figure 4 View showing the forward right side of the airplane

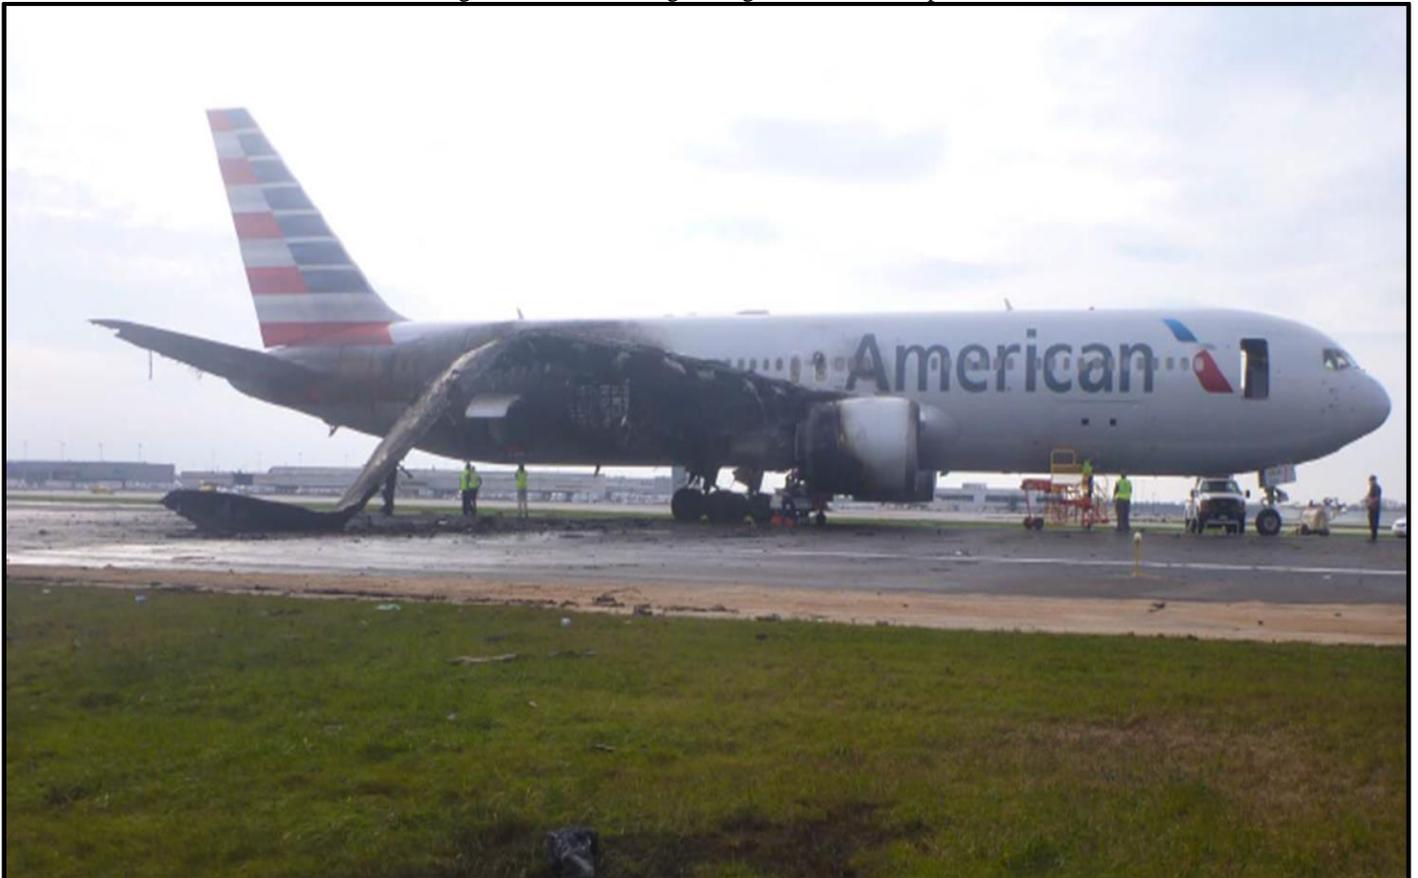
Figure 5 view showing the right side of the airplane

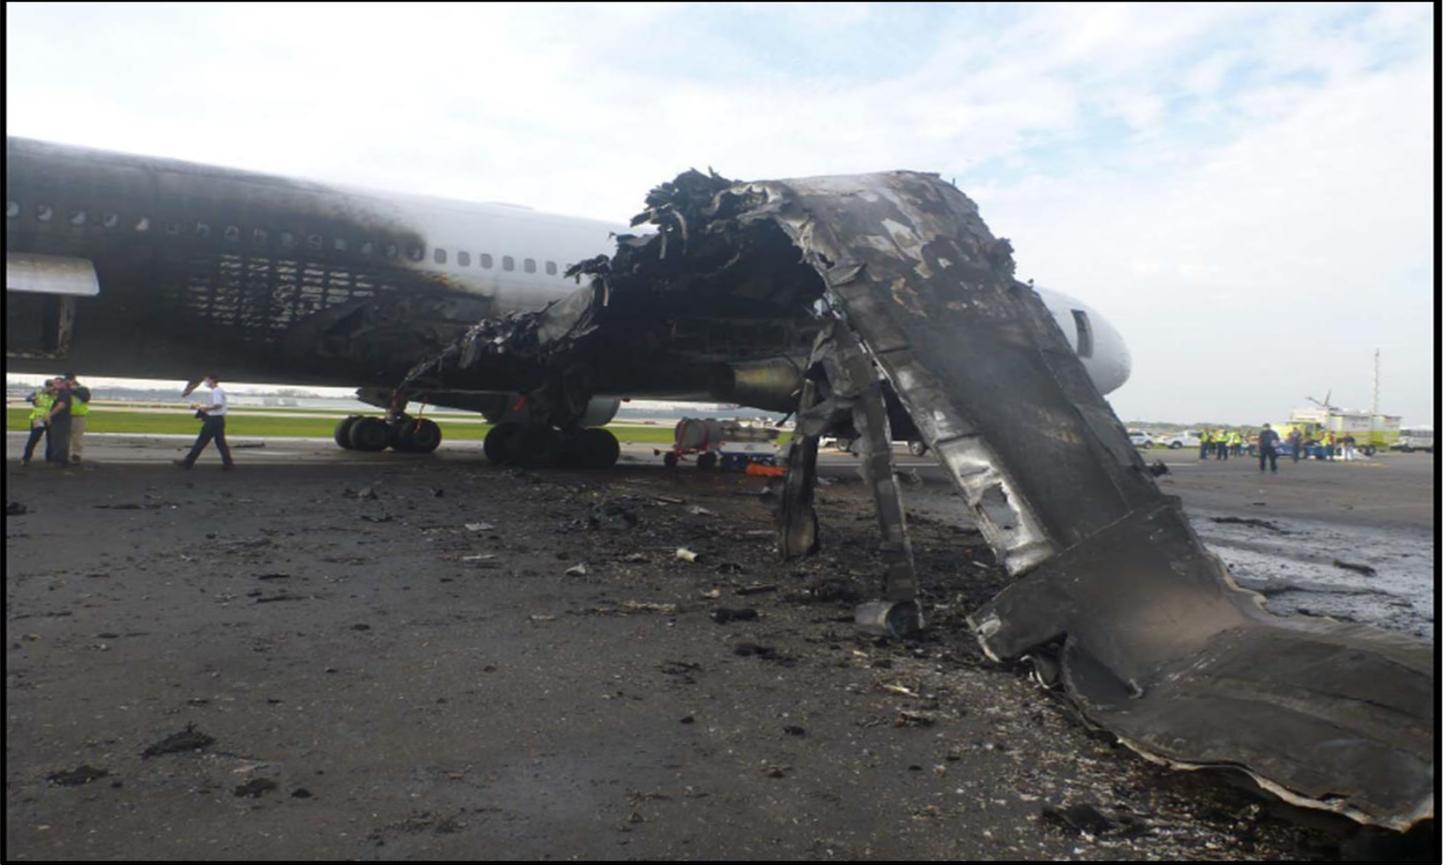
Figure 6 View showing the outboard end of the right wing

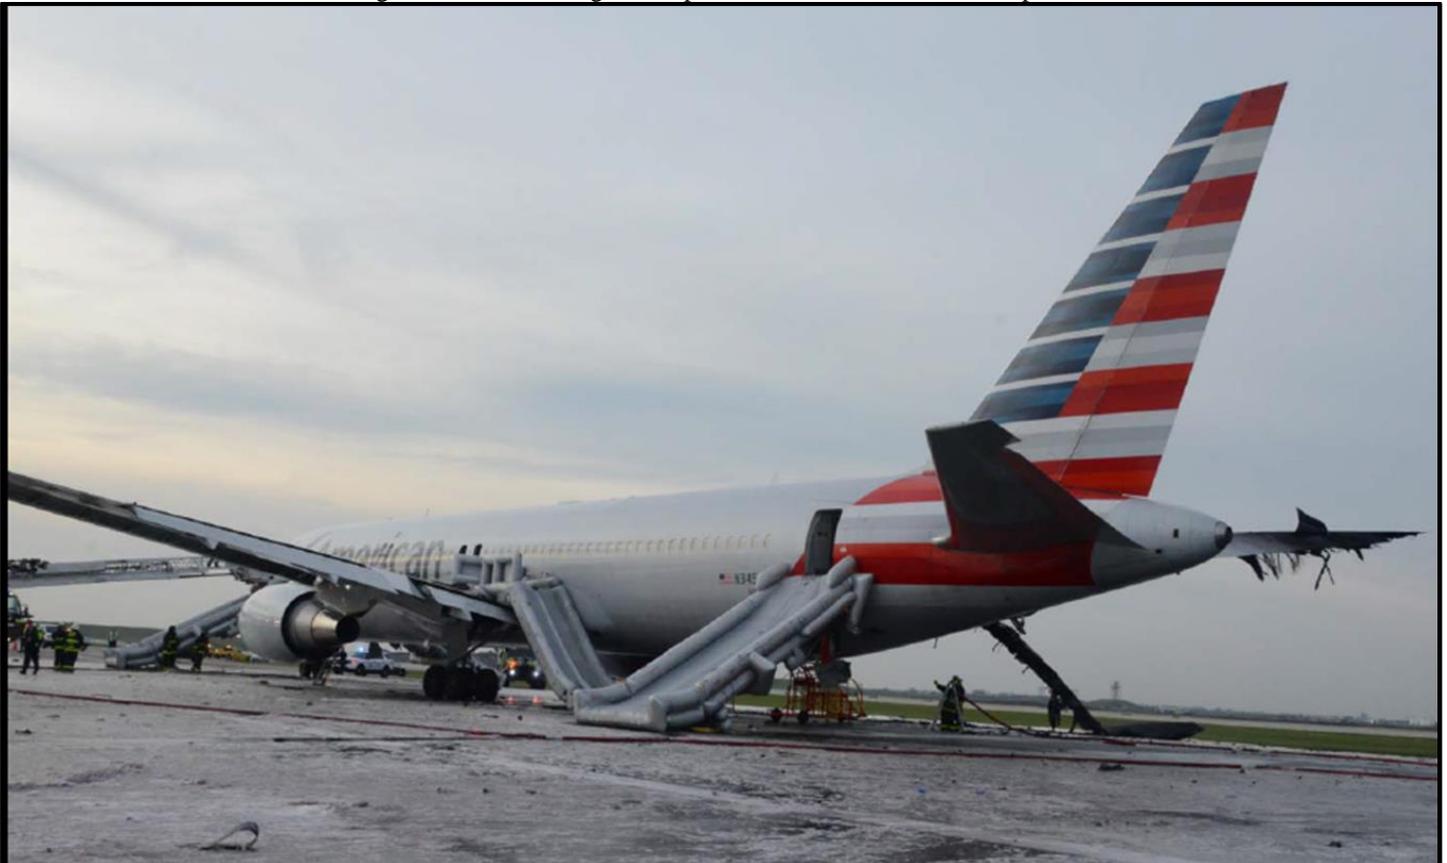
Figure 7 View showing the aft portion of the left side of the airplane

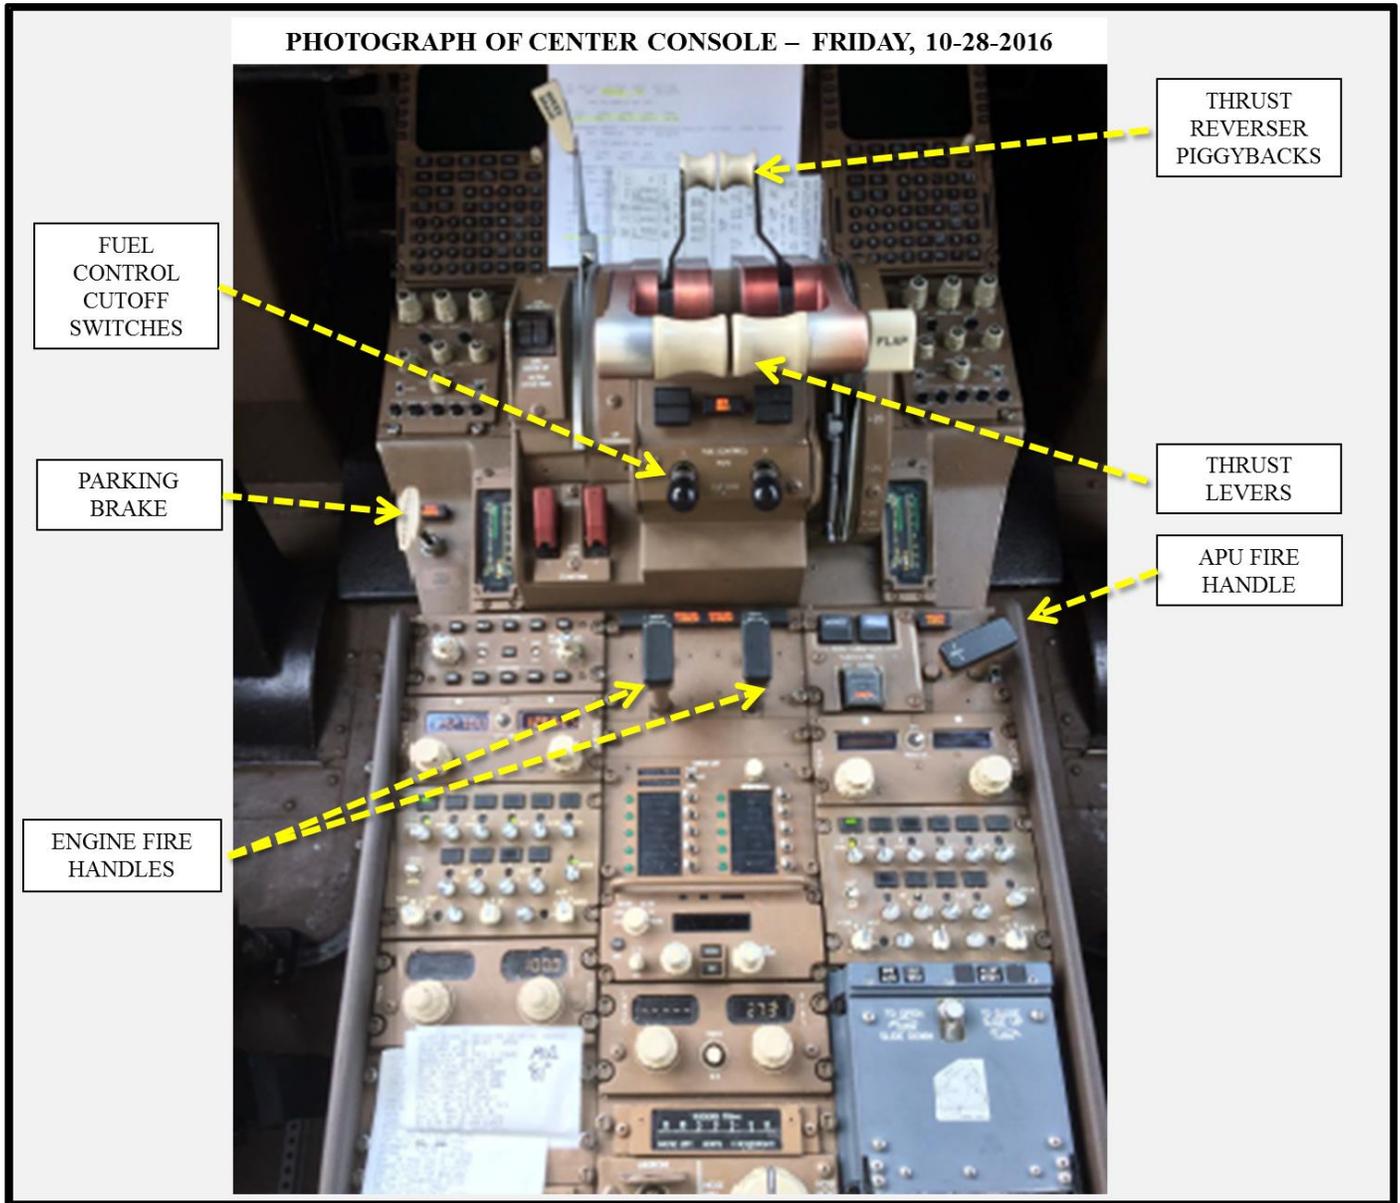
Figure 10 Center Console

Control	Position
Thrust levers	Both thrust levers (throttles) were against their aft stops.
Thrust reverse levers “Piggybacks”	Stowed.
L ENG FIRE handle	Fully extended and centered.
R ENG FIRE handle	Fully extended and centered.
APU FIRE handle	Fully extended and rotated counter clockwise.
EVAC Command Switch	The guard on the evacuation command switch was found raised and the toggle switch was found in the on position.
Fuel pumps (left main and right main)	ON
Cross feed and the center pump	OFF
Cargo fire (forward and aft)	Armed
Auto Brakes	OFF
Fuel Control Cutoff Switches	Both switches were found in the down and CUTOFF position.
Flap Handle and position indicator	Positioned to 15
Parking brake	Set
Oxygen Masks	All of the oxygen masks were found stowed.
Handheld Fire Extinguisher & Protective Breathing Equipment (PBE)	Stowed

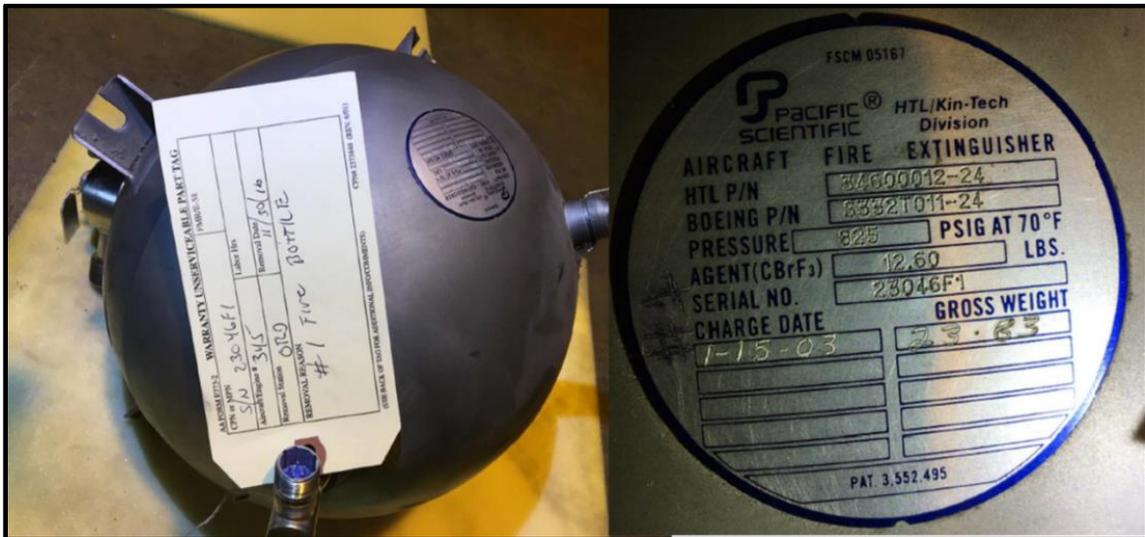
As shown in Figure 13, the data label on the number 1 fire extinguisher bottle, recorded a pressure of 825 PSIG (at 70 Degrees) and a weight of 23.83 pounds. As shown in Figure 14, the data label on the number 2 bottle recorded a pressure of 825 PSIG (at 70 Degrees) and a weight of 23.92 pounds. After removal from the airplane, the weight of both bottles was measured and both were found to weigh about 10.5 pounds.

Figure 13 Number 1 fire extinguisher bottles after removal from the forward cargo compartment

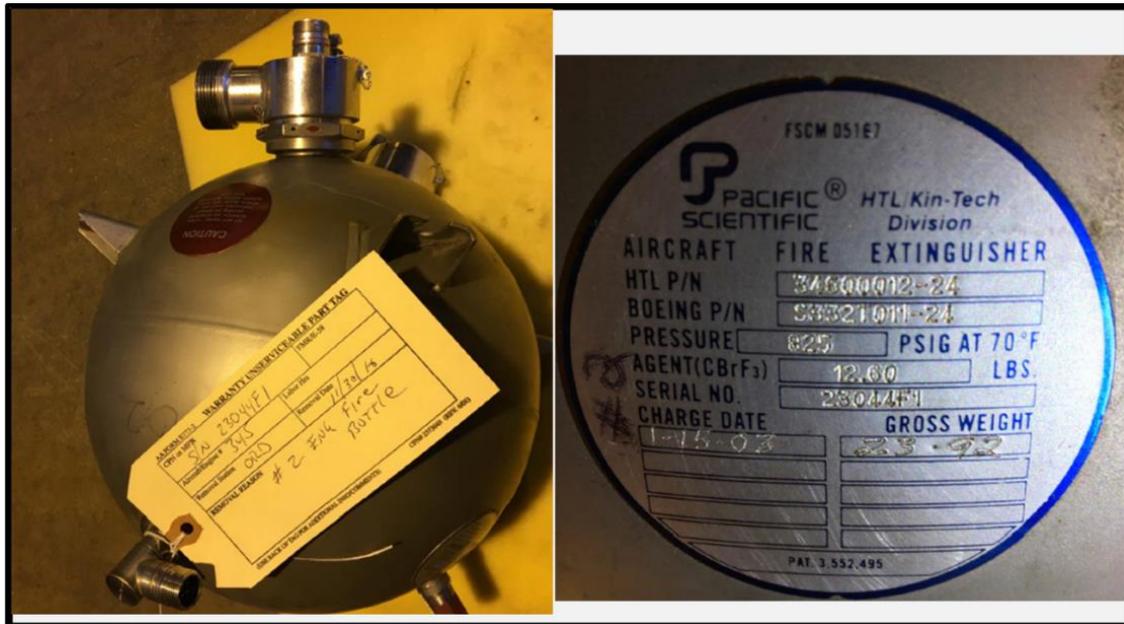
Figure 14 Number 2 fire extinguisher bottles after removal from the forward cargo compartment

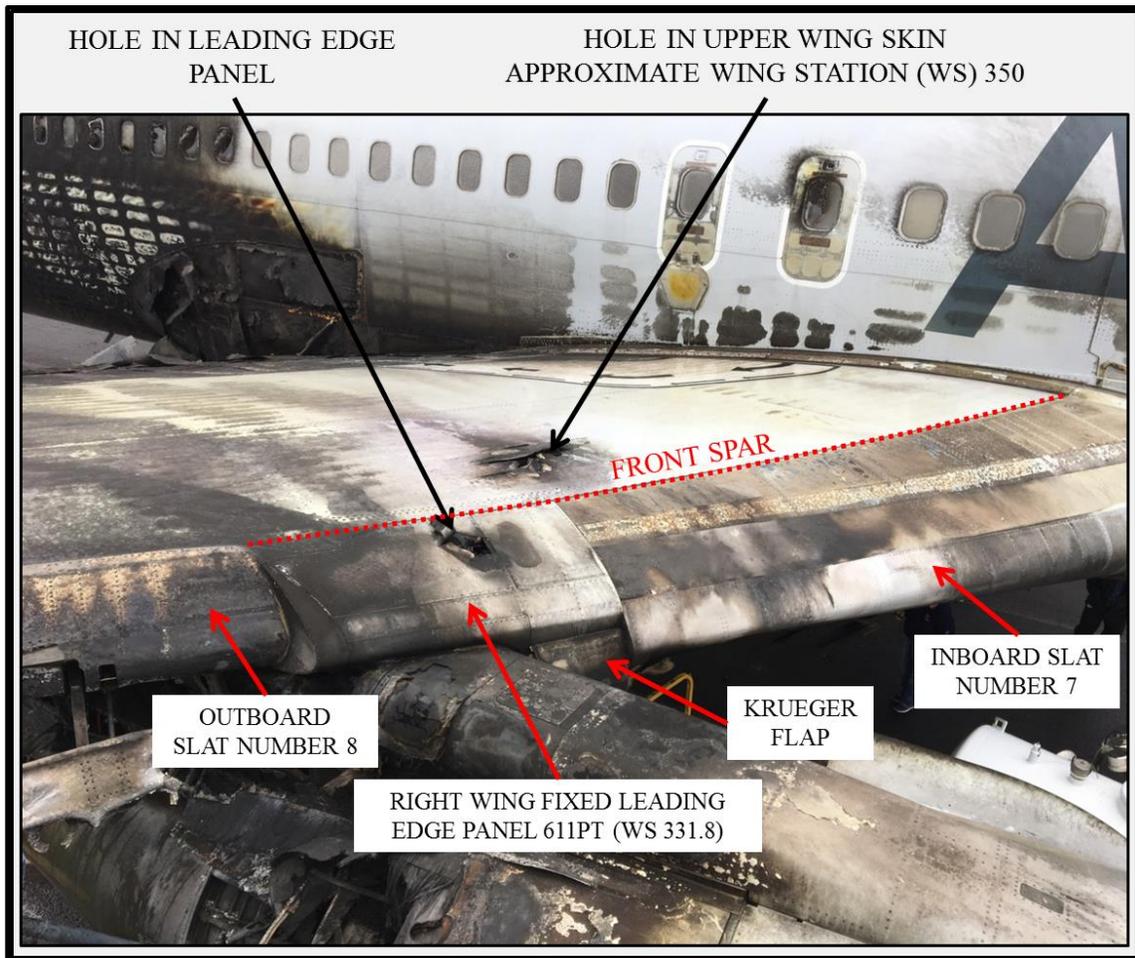
Visual inspection of the accident airplane's right wing revealed that all of the impact damage to the wing was located inboard of the pylon; no impact damage was observed outboard of the right engine pylon from exiting HPT stage 2 disk or engine debris. Inspection of the upper surfaces of the right wing revealed two through-hole penetrations; one hole was located forward of the front spar in the fixed-wing leading edge panel and the other was located aft of the wing front spar between wing rib 6 and 7 in the area of the dry bay. (Reference Figure 15) Inspection of the lower surfaces of the right wing revealed one hole aft of the wing front spar between wing rib 6 and 9 in the area of the dry bay, several small holes in the dry bay access door, and a few small holes inboard of rib 6. (Reference Figure 16)

Figure 15 Damage to the right wing upper skin and leading edge

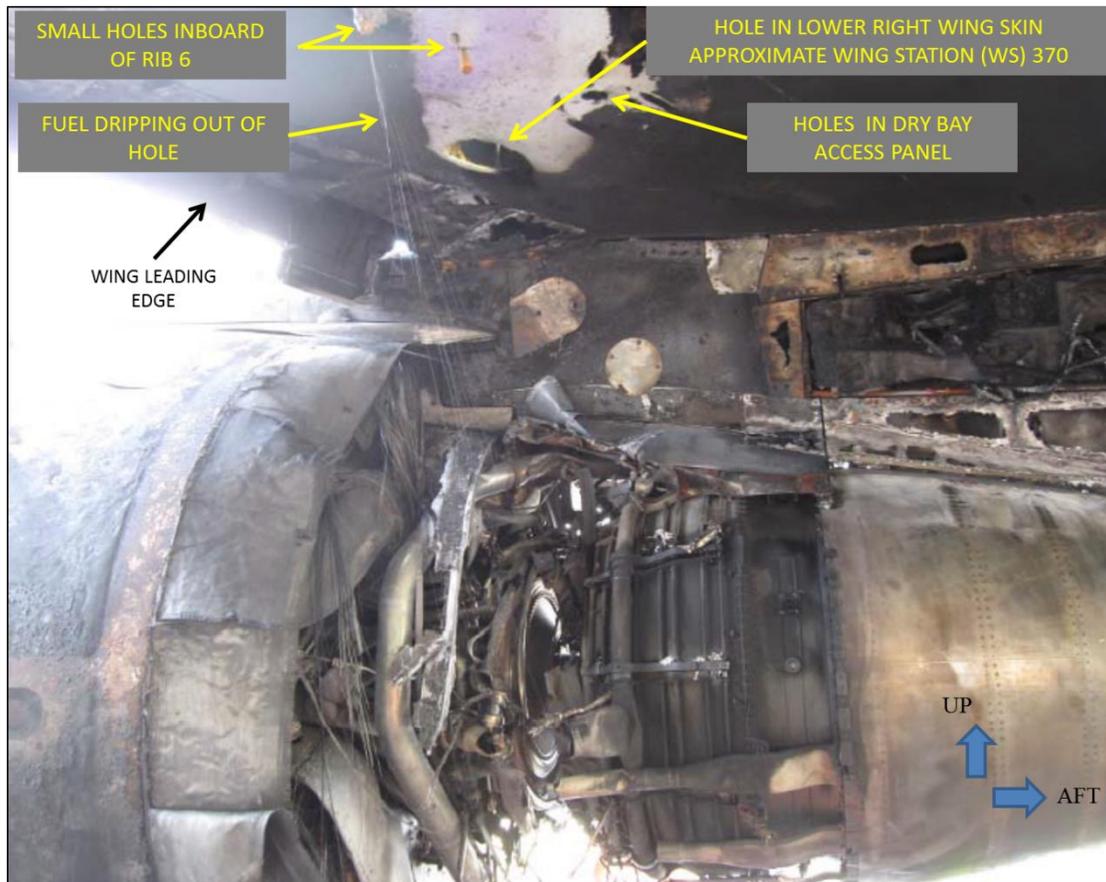
Figure 16 Damage to the right wing lower skin

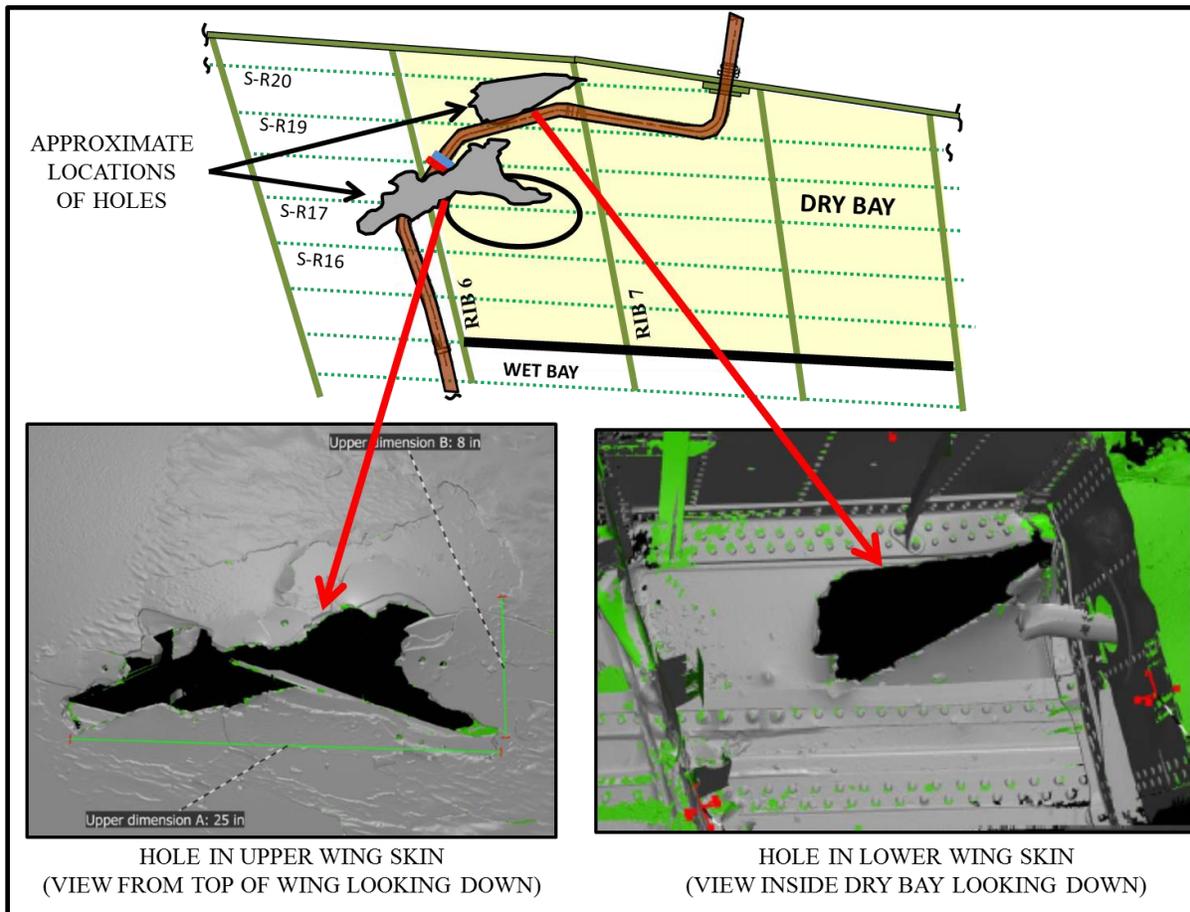
Figure 18 Location of the holes in the upper and lower wing skin in the area of the dry bay

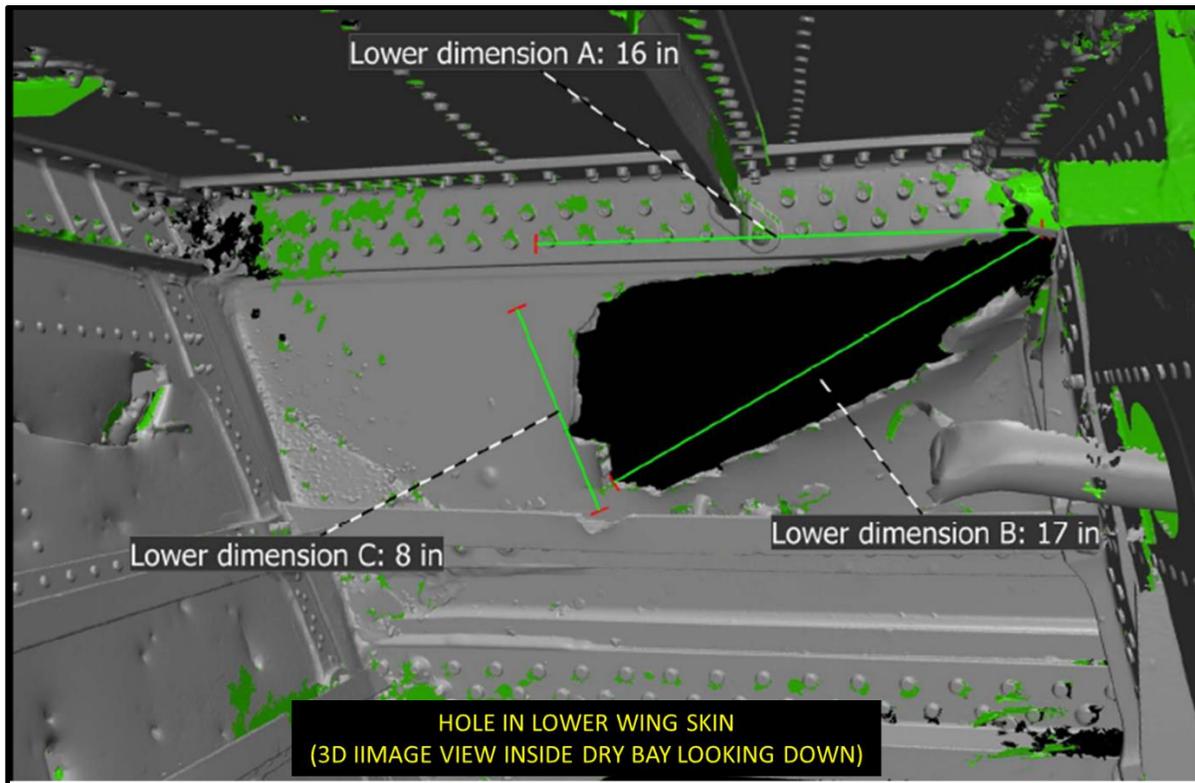
Figure 19 Close-up view of lower hole showing dimensions

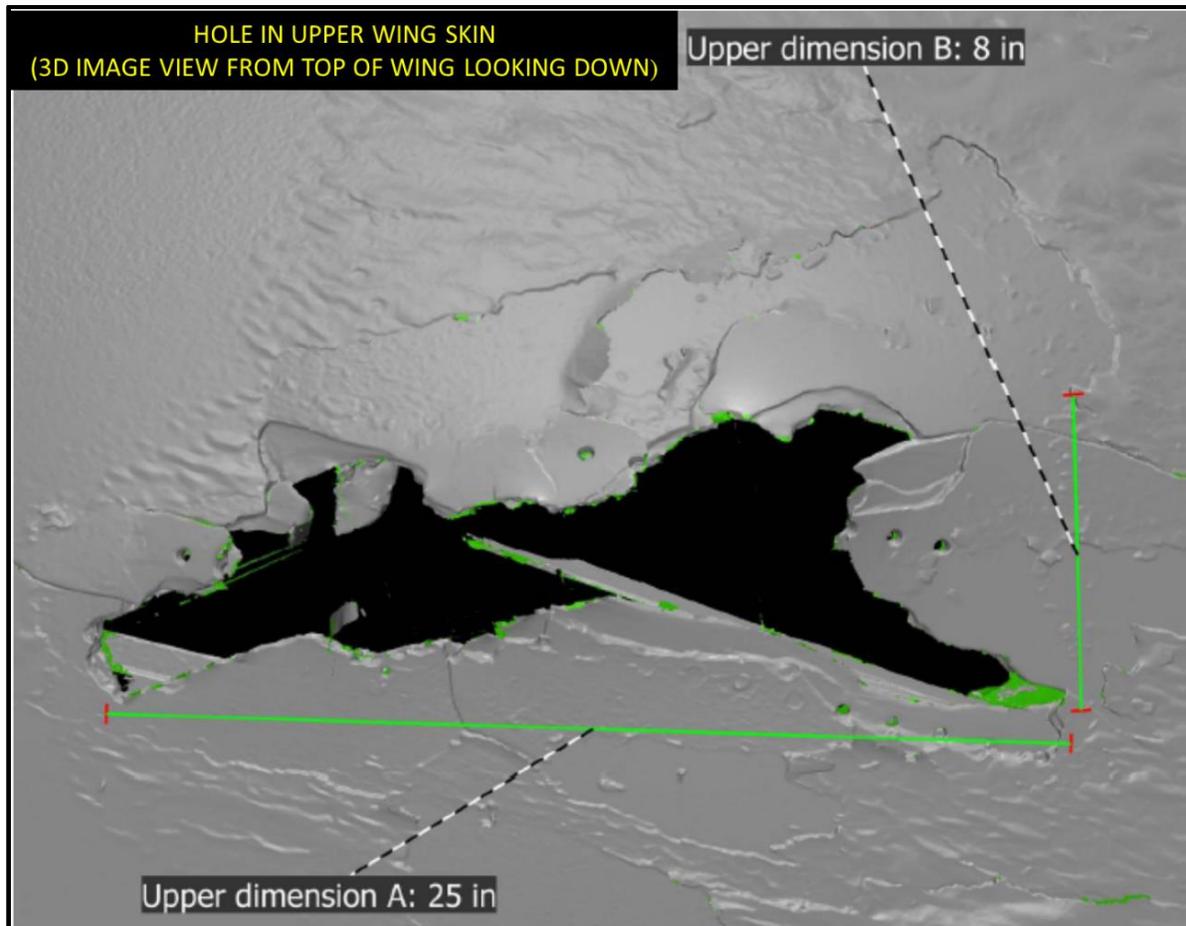
Figure 20 Close-up view of upper hole showing dimensions

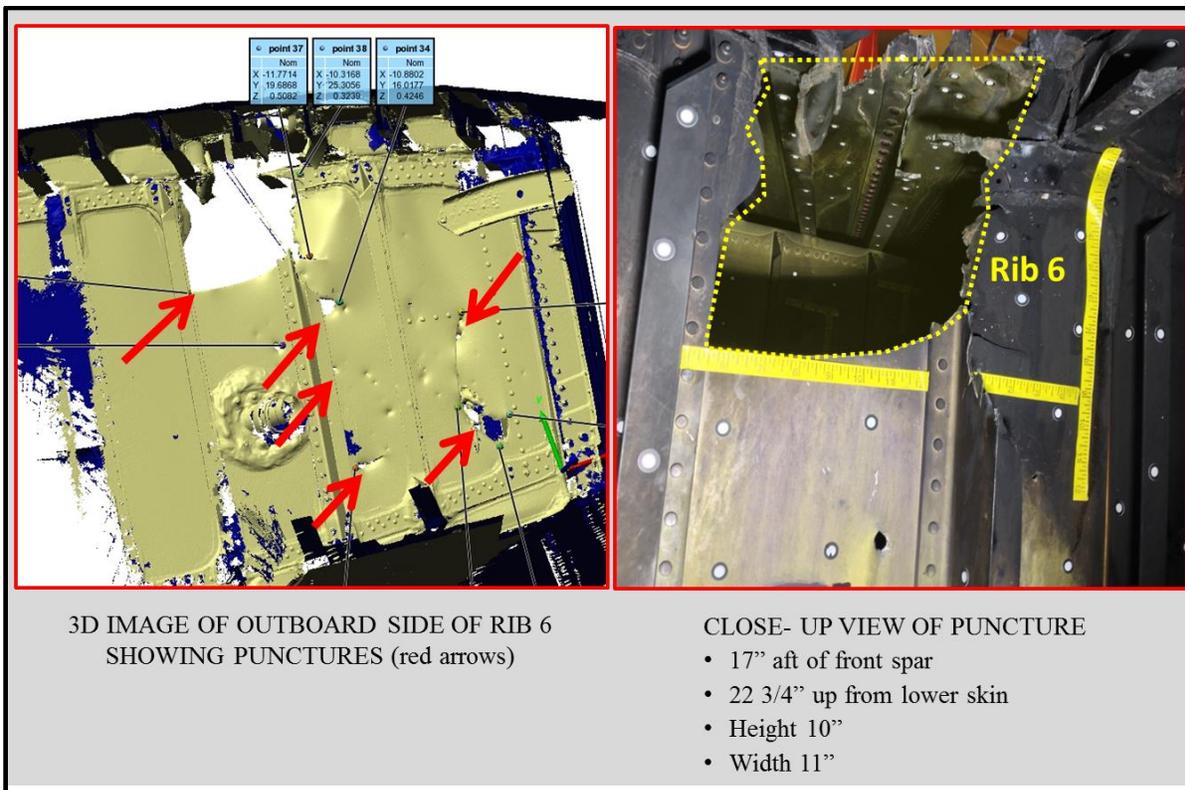
Figure 21 View showing the damage to rib number 6.

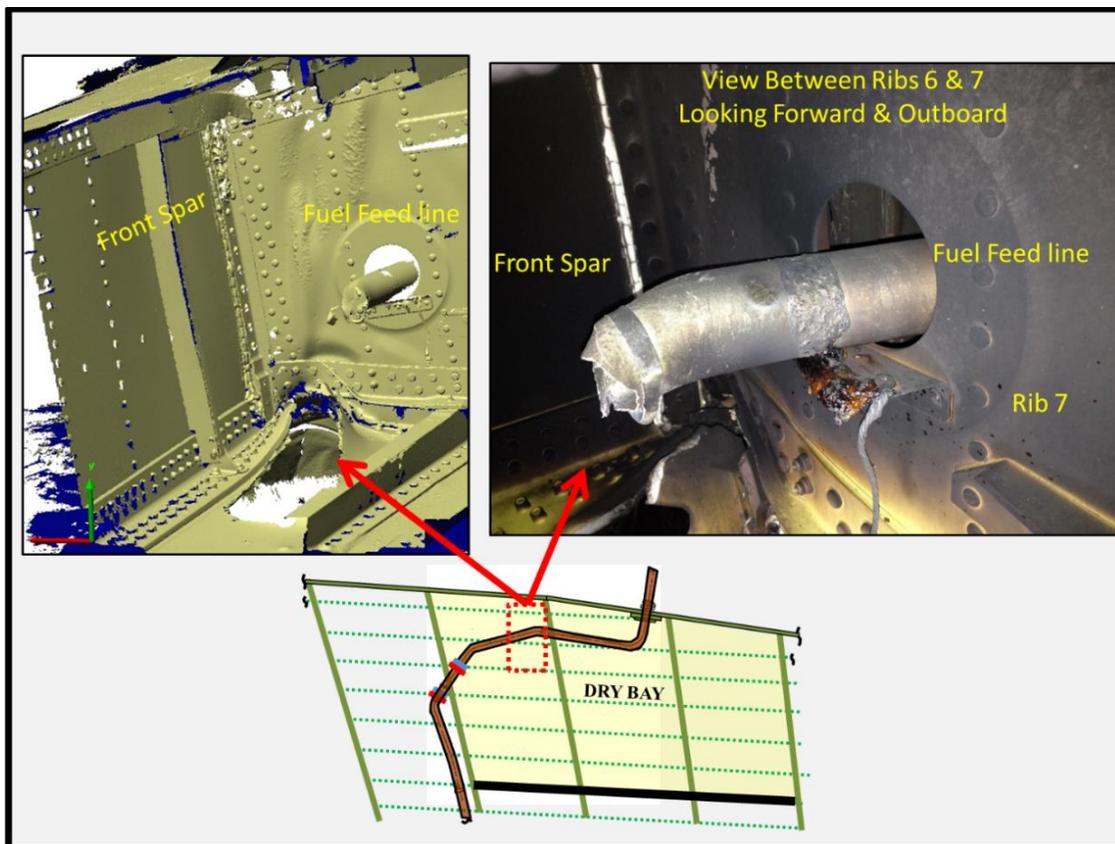
The main engine fuel feed line located between ribs 6 and 7 was found completely severed and open to the dry bay. Reference Figures 22 – 23. The fuel line has an approximate diameter of two inches and is made of 0.028” wall thickness aluminum tubing.

Figure 22 View of hole in lower wing skin and damaged main fuel feed line

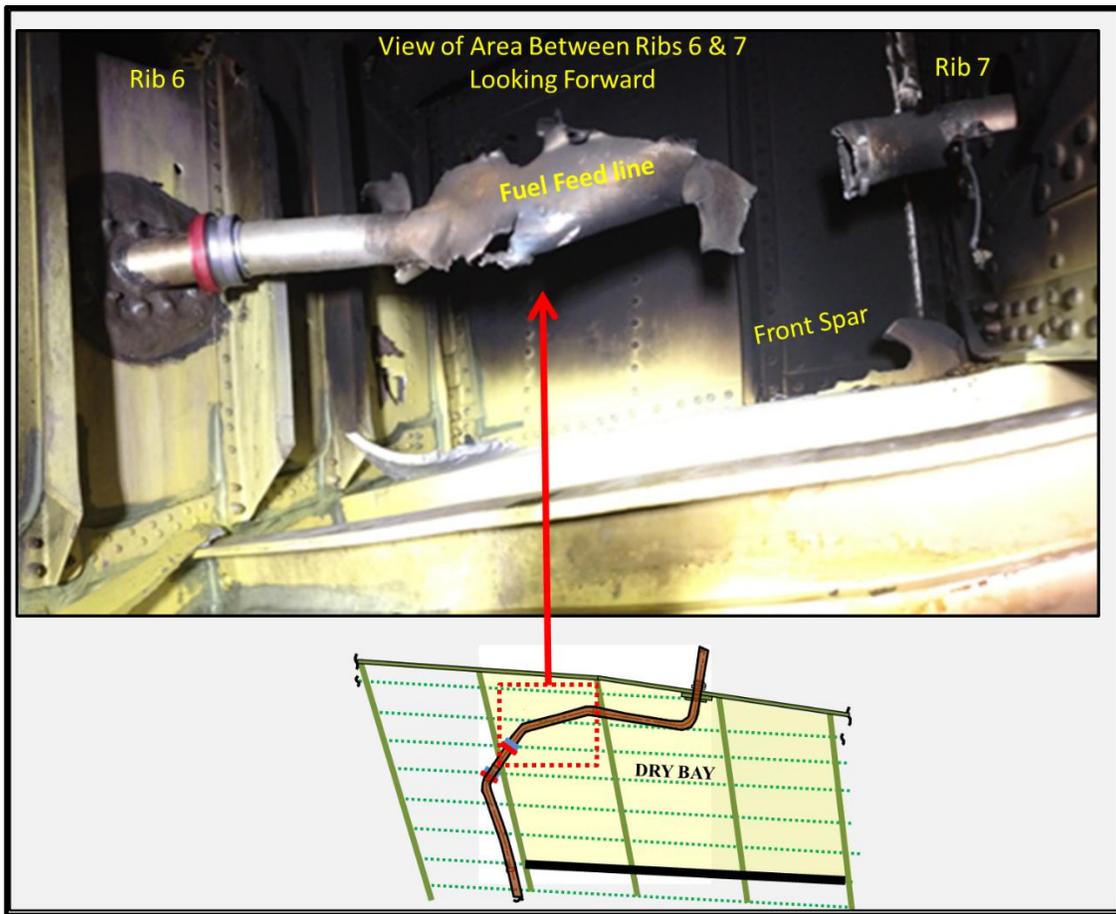
Figure 23 View of the damaged main fuel feed line

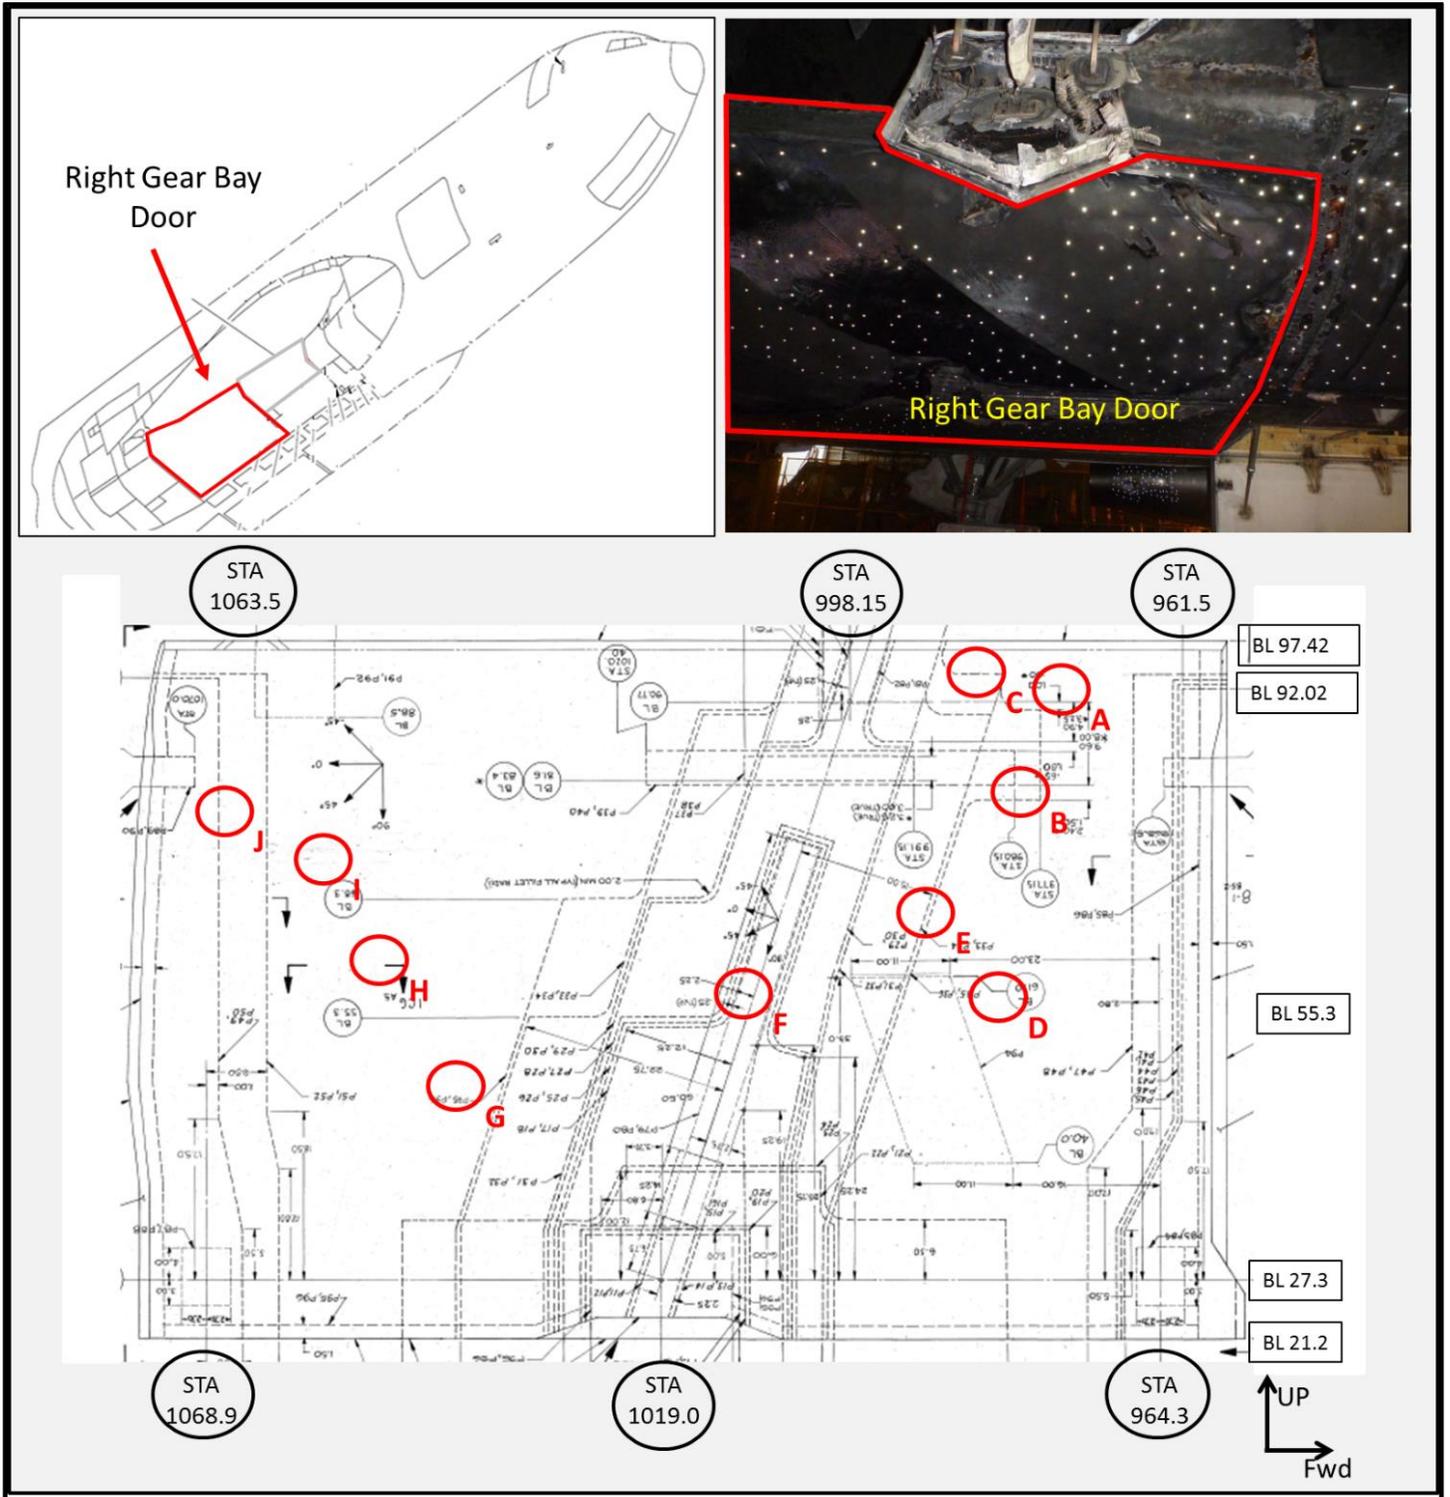
Examination of the right MLG door revealed multiple areas where the door had been impacted by debris. Figure 24 provides a schematic of the landing gear door with the main impact areas highlighted by red circles and identified by letters ranging from A to J. Table 2 provides the details (location, length, width, and condition) of each of the identified impact areas. For the impact area identified as “A”, the examination revealed that a fragment from the right engine (a piece of the aft flange of the HPT inner shaft) remained embedded within the top edge of the forward portion of the gear door. (Figure 25).

Figure 24 Drawing of right main landing gear door showing impact mark locations

A	B	C	D	E	F	G	H
Length	1.2"	1.5"	4"	0.9"	0.6"	1.2"	1.0"	0.8"
Width	0.85"	0.7"	2.2"	0.6"	0.5"	0.1"	0.25"	0.6"
Condition	Outer Skin Hole & Core Crushed	Outer Skin Hole & Core Crushed	Complete Hole	Outer Skin Hole & Core Crushed

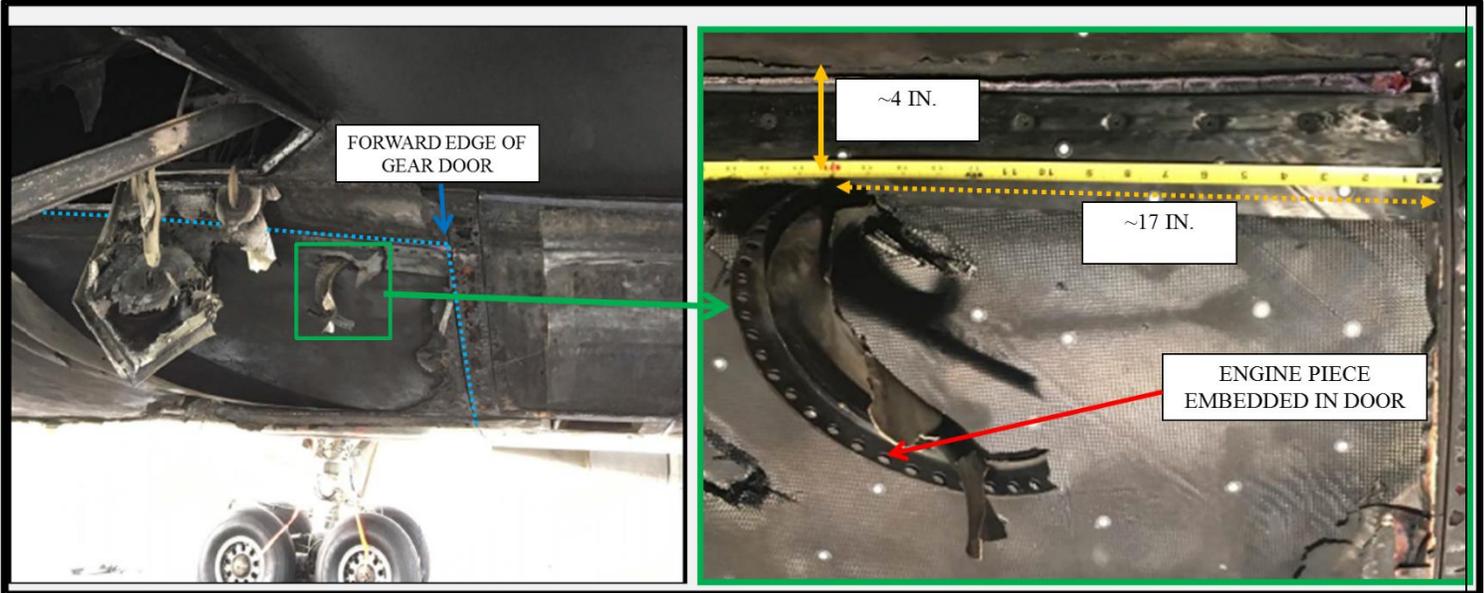
Figure 25 Photograph showing the piece of engine FOD embedded in right gear bay door
