NATIONAL TRANSPORTATION SAFETY BOARD

Airworthiness Group Chairman's Factual Report

NTSB ID No.: DCA17FA021

NTSB Accident Number: DCA17FA021
Location: Chicago, Illinois
Date: October 28, 2016
Time of Accident: About 1432 Central Daylight Time
Aircraft: Boeing 767-323(ER)
Registration Number: N345AN

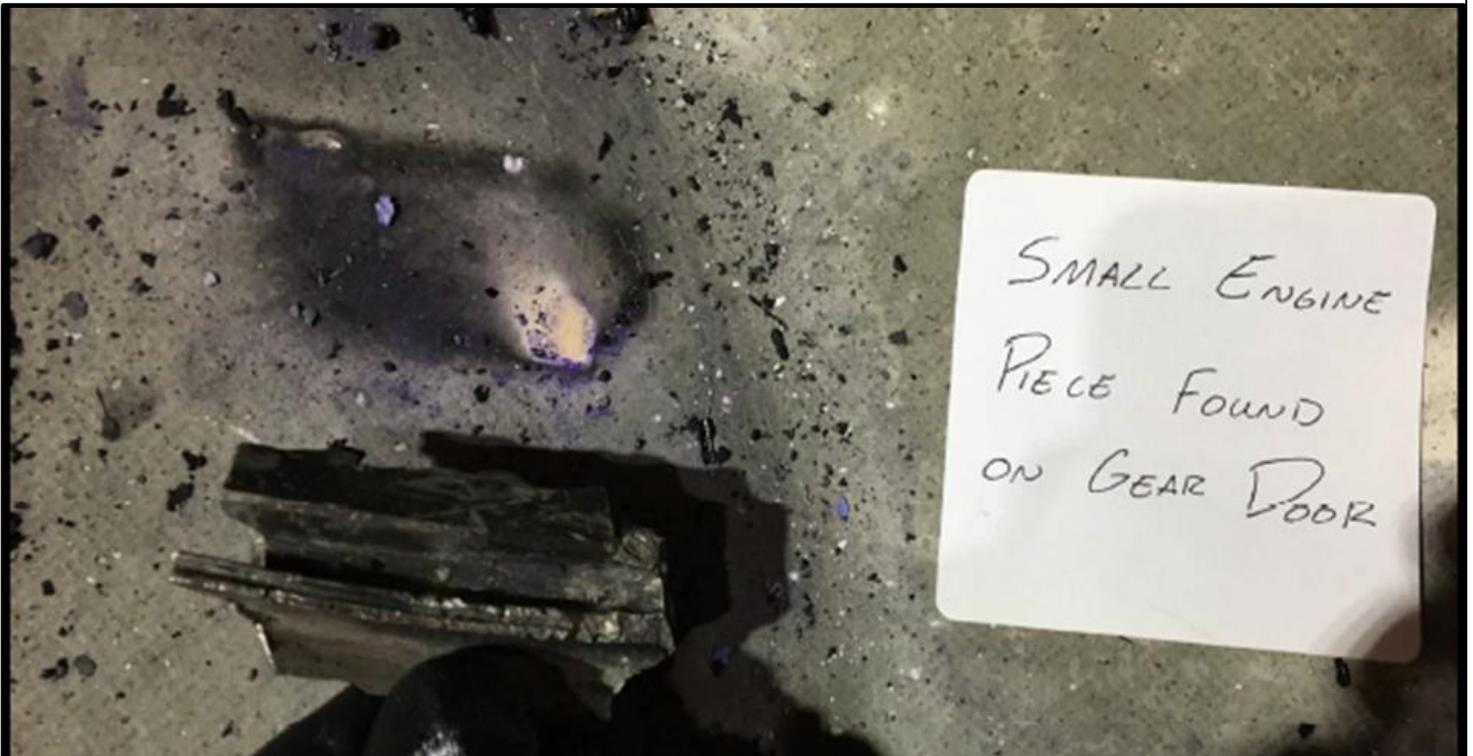
Figure 26 Small Engine piece found in right main gear bay when door opened

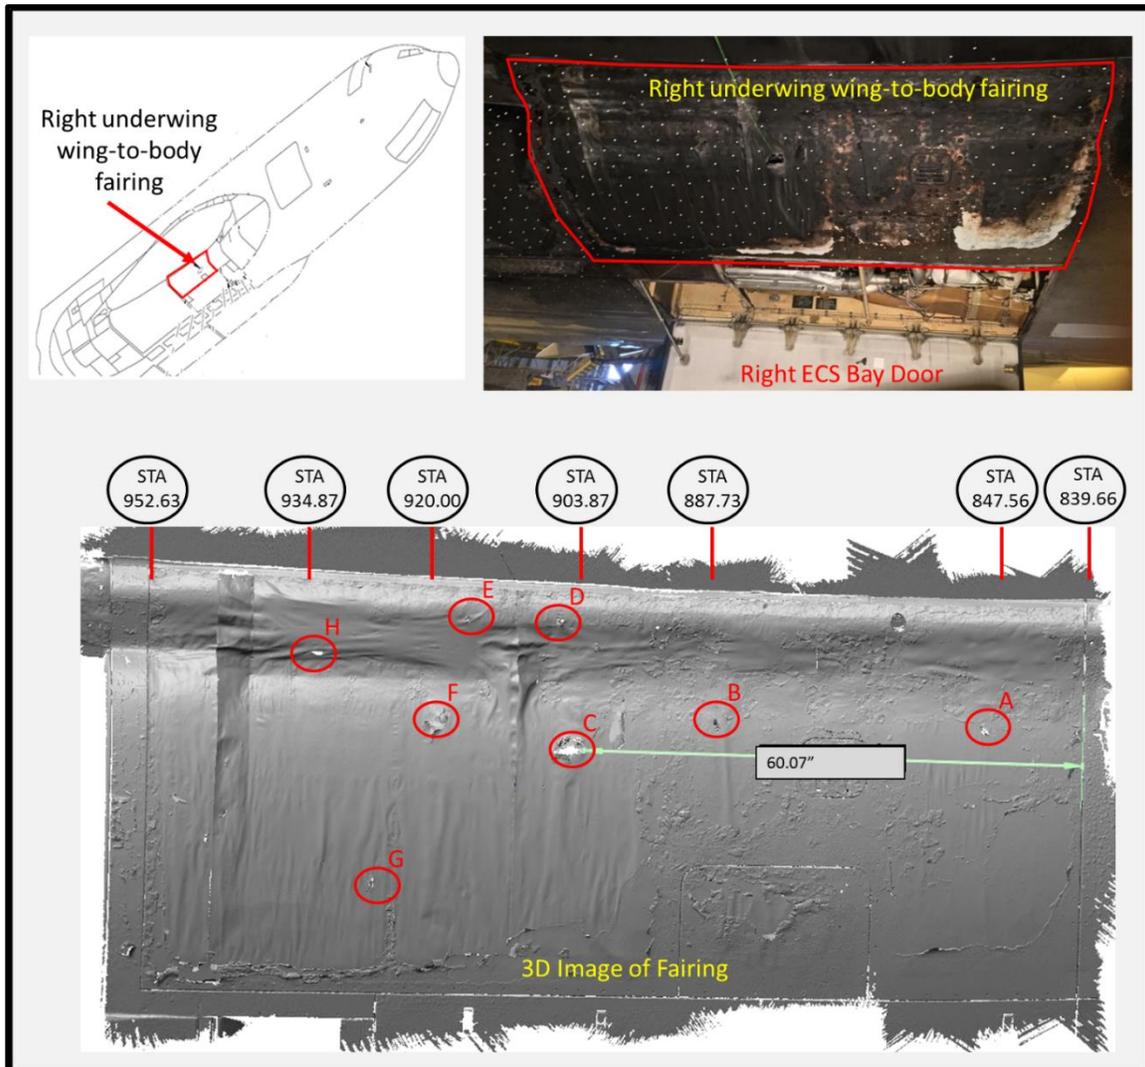
Examination of the underwing wing-to-body fairing revealed multiple areas where the door had been impacted by FOD. Figure 27 provides a photograph and a 3D image of the fairing with the main impact areas highlighted by red circles and identified by letters ranging from A to H. Table 3 provides the details (length, width, and condition) of each of the identified impact areas. Because the impact area identified as "C", penetrated completely through the fairing, the Airworthiness Group visually inspected and documented the area within the right ECS bay compartment for FOD and impact related damage. When the ECS bay door was opened, a small section of the stage 2 (HPT blade) from the No. 2 engine was observed resting on the lower section of the door. Additionally, a small piece of the No. 2 engine's aft heat shield was found near the third (from the aft) door hinge. (Figures 28 - 29) From the ECS bay, looking outboard toward the hole in the wing-to-body fairing, a hole was observed in the body crossover air supply duct. An impact mark (no puncture) was also observed on the primary heat exchanger duct. (Figure 30 - 31).

Figure 27 Picture of damaged underwing wing to body fairing panel (looking toward airplane centerline from right side)

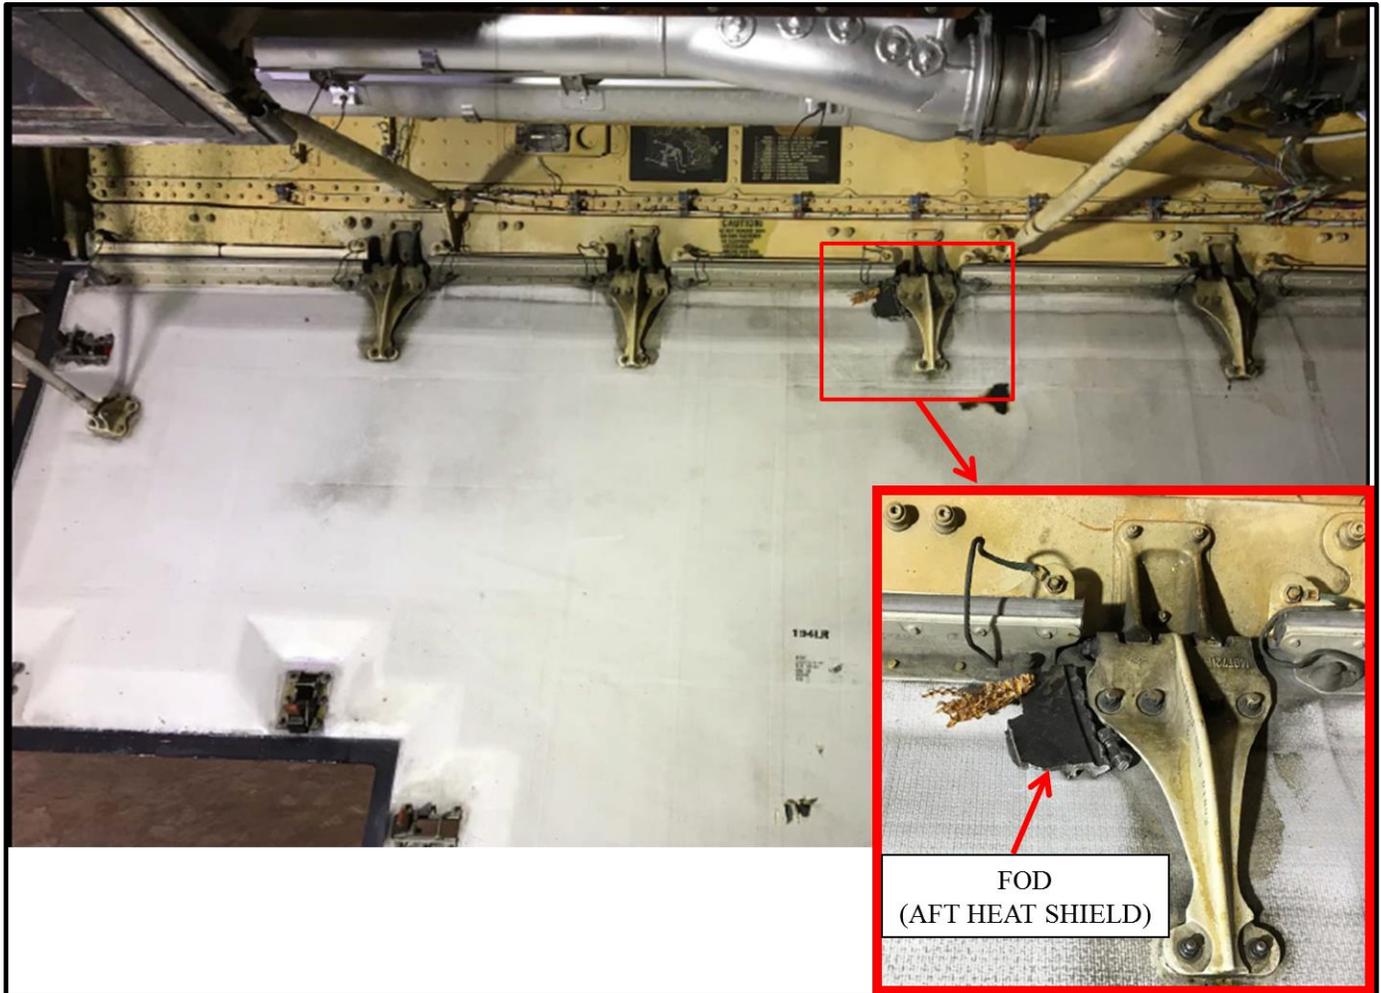
Figure 28 View showing 2nd piece of FOD in ECS bay

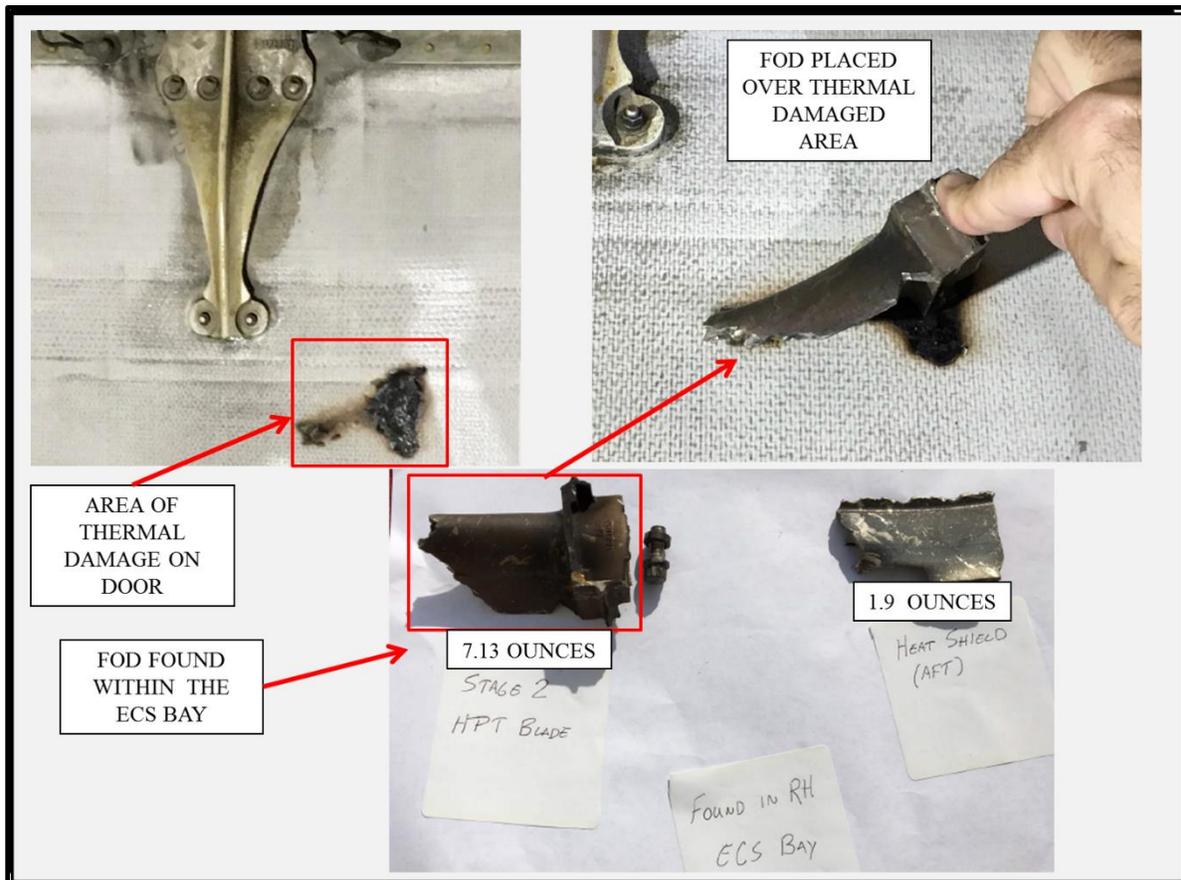
Figure 29 View of damage to right ECS bay door

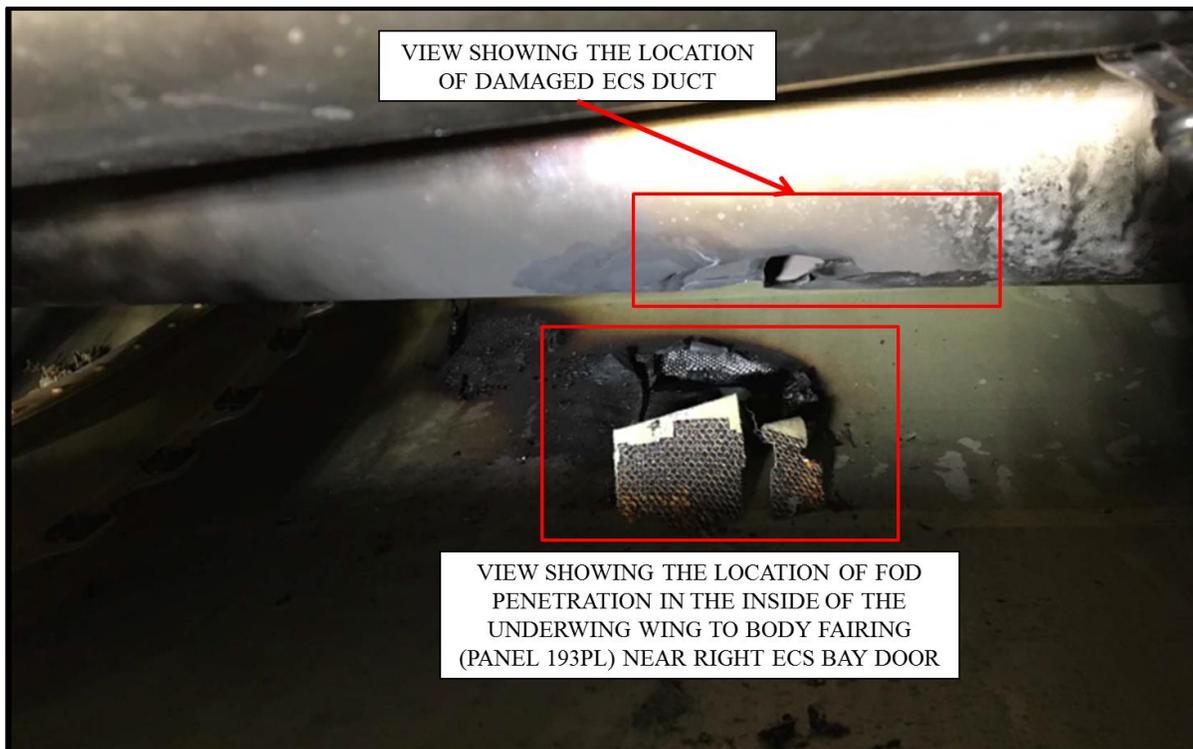
Figure 30 View of inside of ECS bay looking outboard

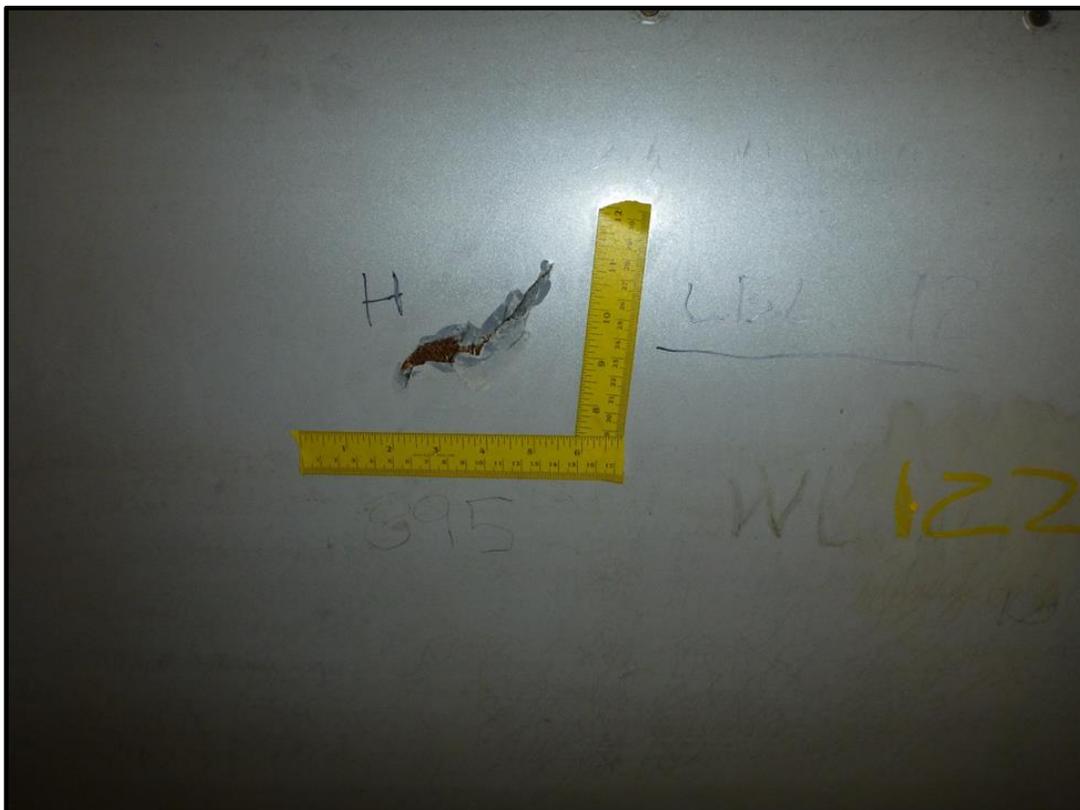
Figure 33 Impact H, ECS pack bay left side

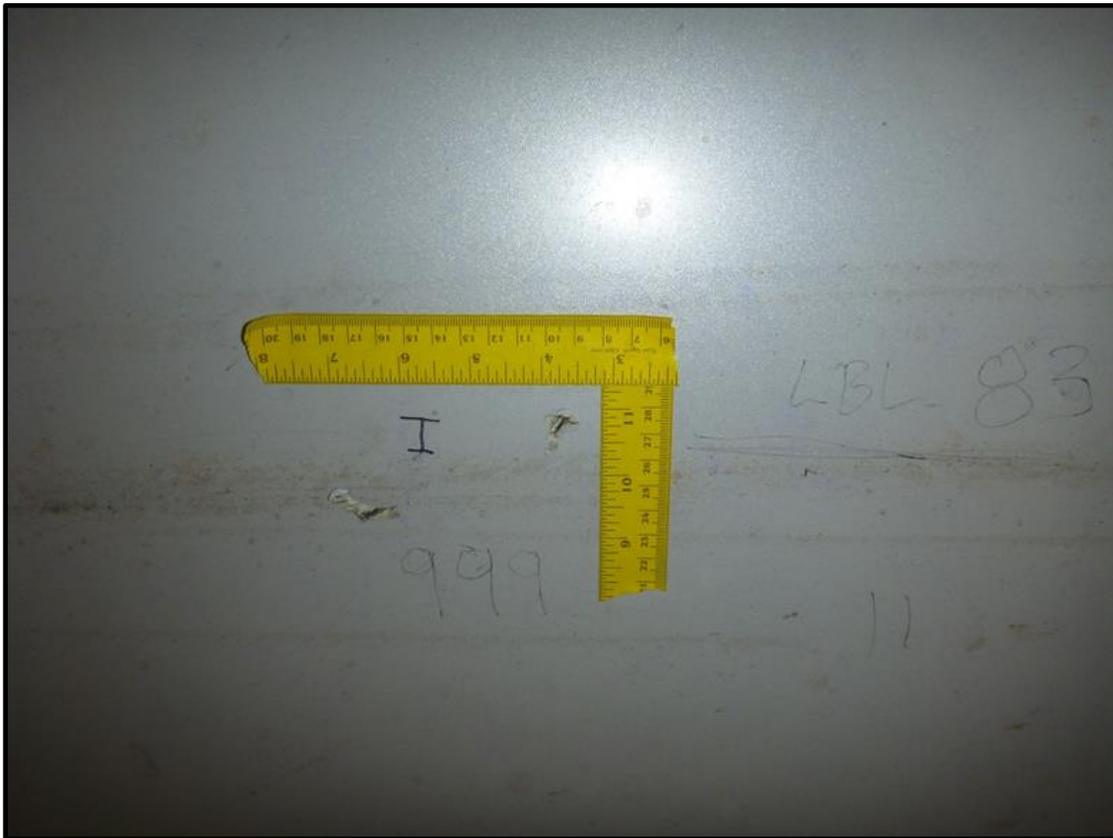
Figure 34 Impact I, Main gear door left side

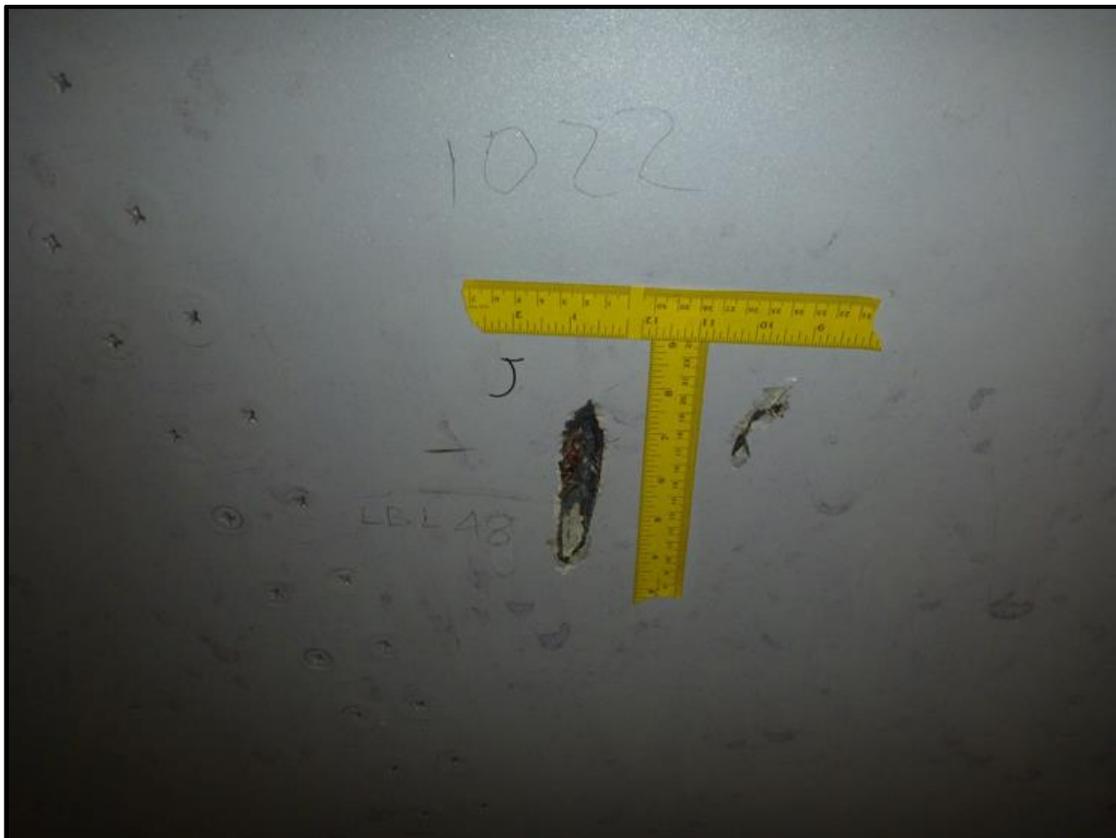
Figure 35 Impact J, Main gear door left side

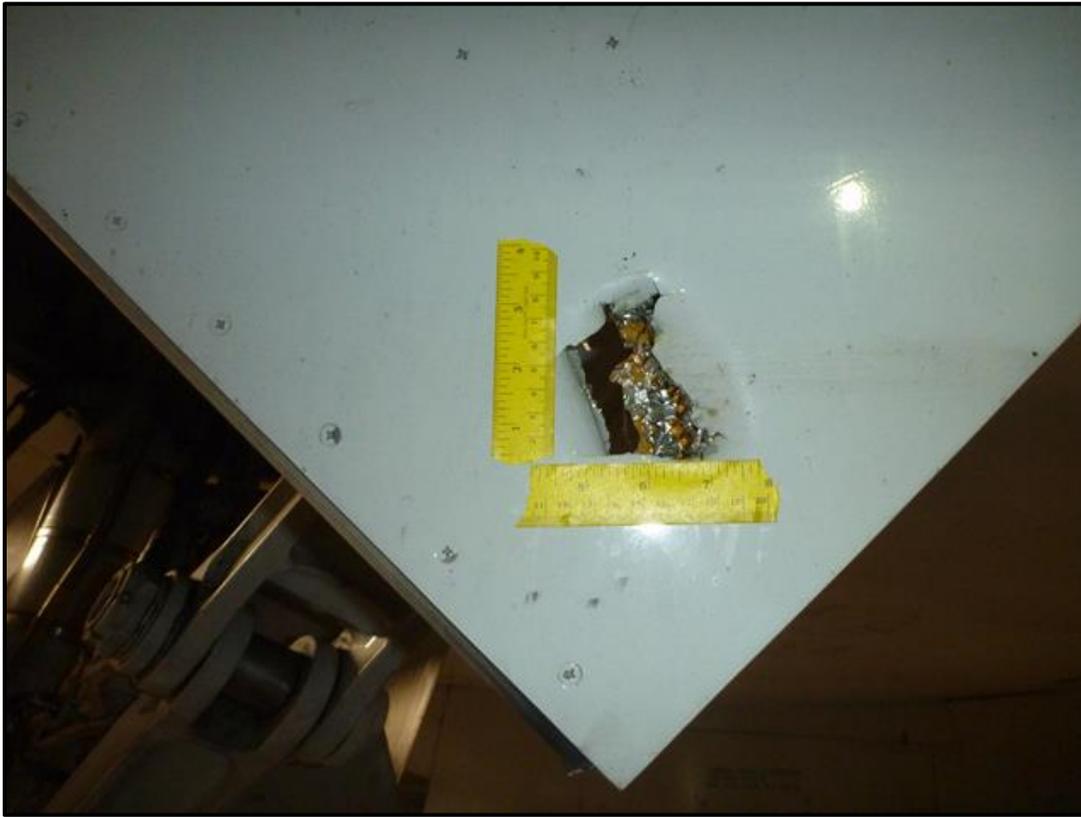
Figure 38 Impact L, left main gear drag strut door

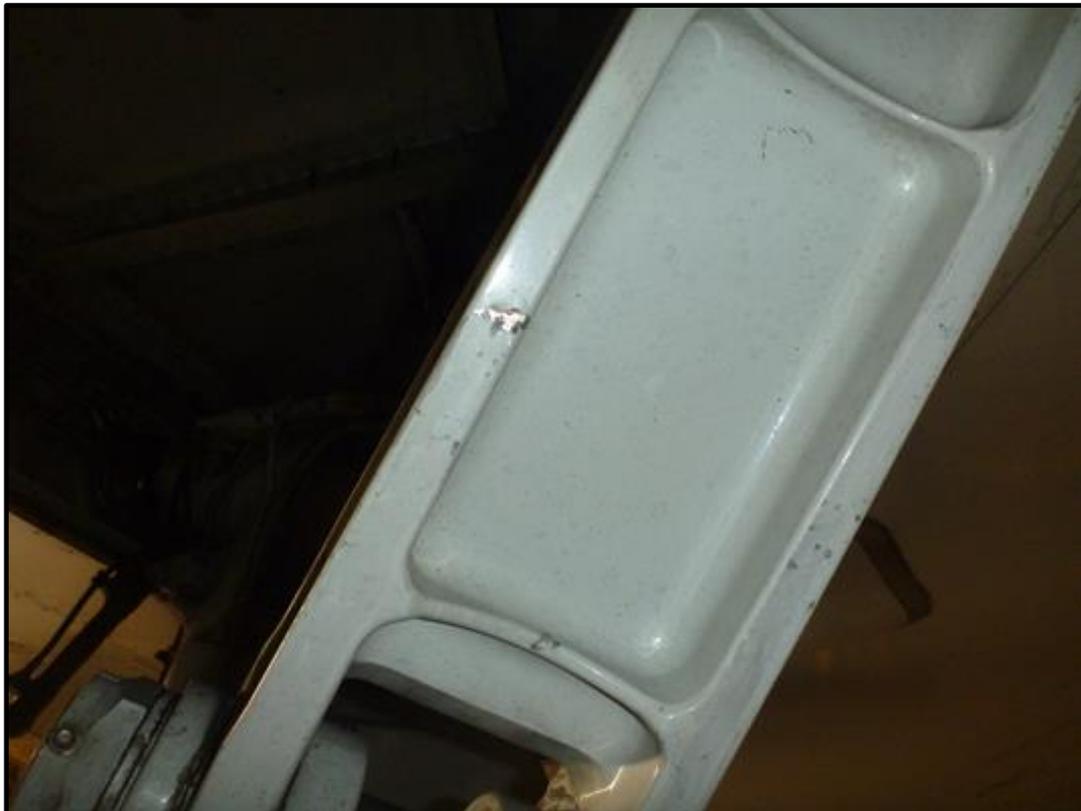
Figure 39 Impact M, left main gear drag strut link

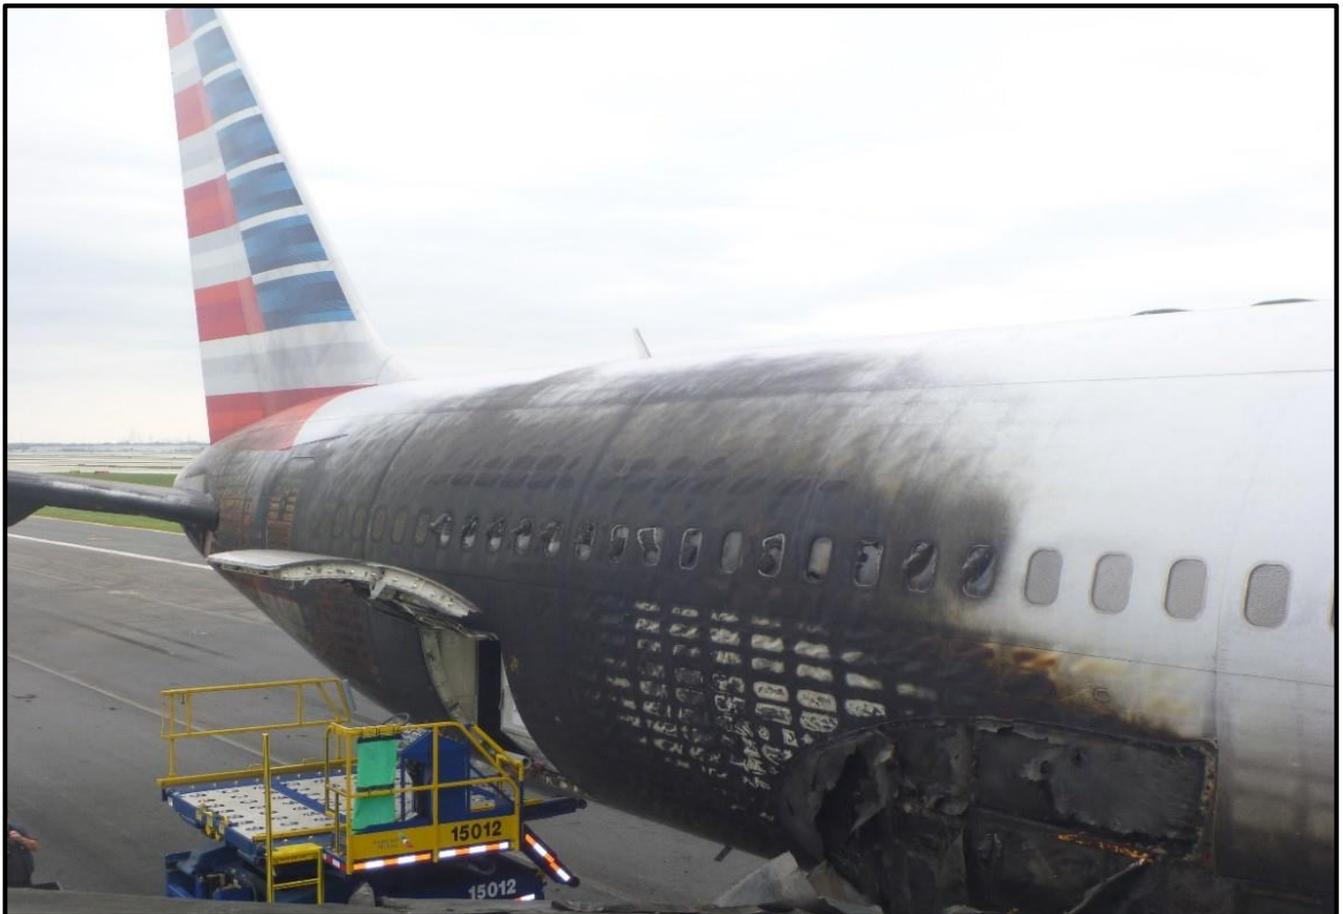
Figure 43 Thermal damage to the right side of the fuselage

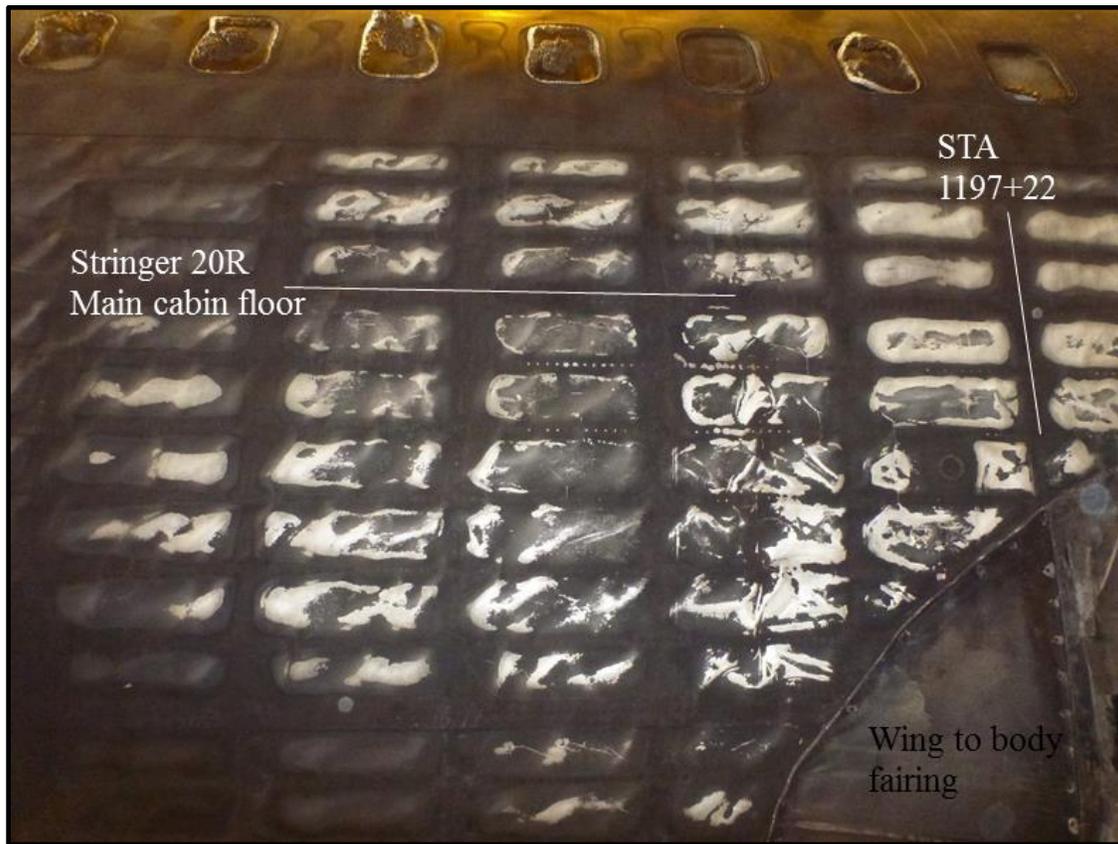
Figure 44 Thermal damage on the right side fuselage skin

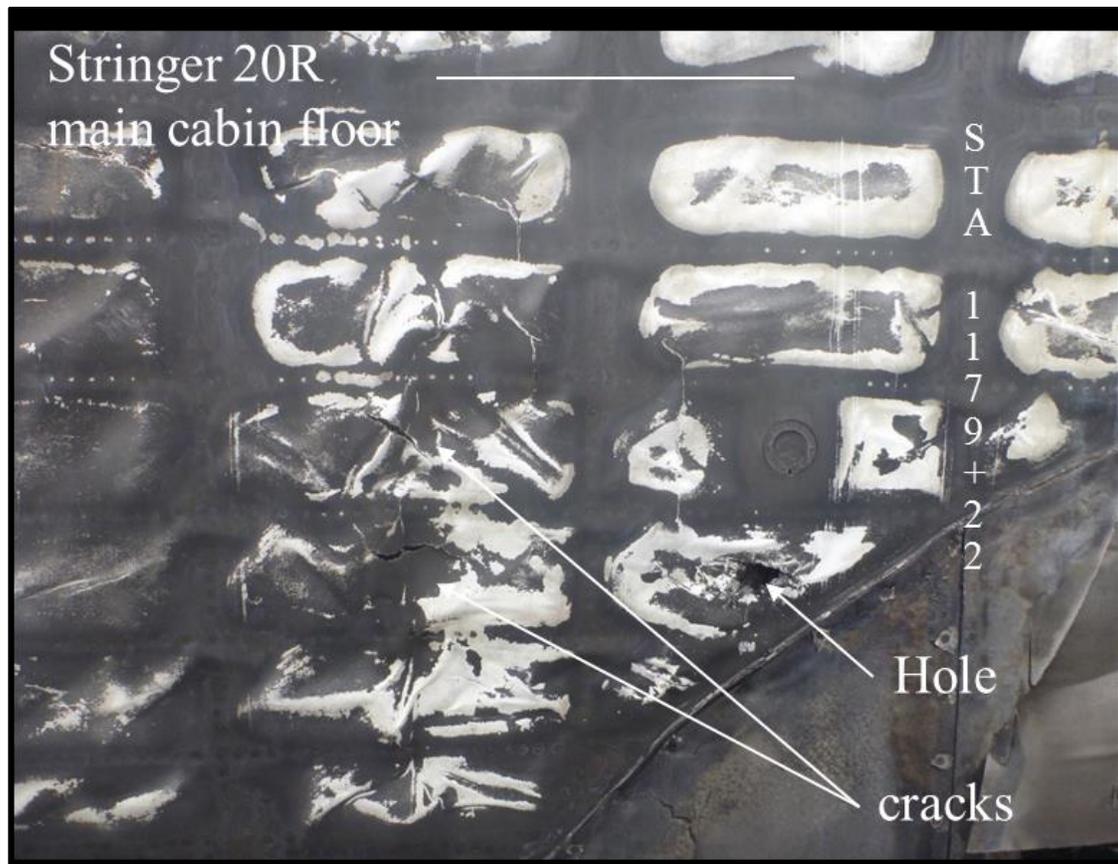
Figure 45 Multiple thermal cracks and hole in fuselage skin

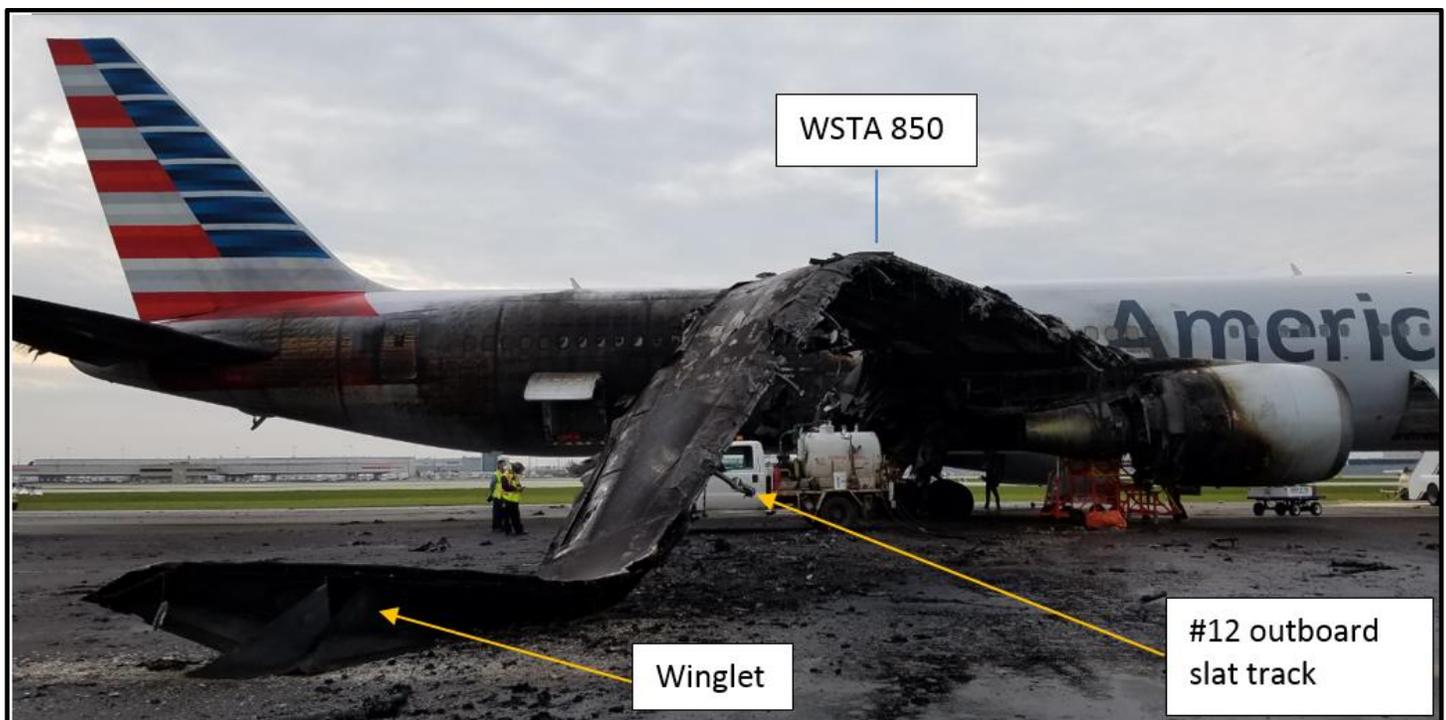
The majority of the lower wing in-spar skin and ribs outboard of wing station 800 were found consumed. The outboard end of the right wing was found sagging and touching the ground at the wing to winglet interface. Reference Figure 46 – 50.

Figure 46 View looking inboard at right wing bent down and contacting the tarmac

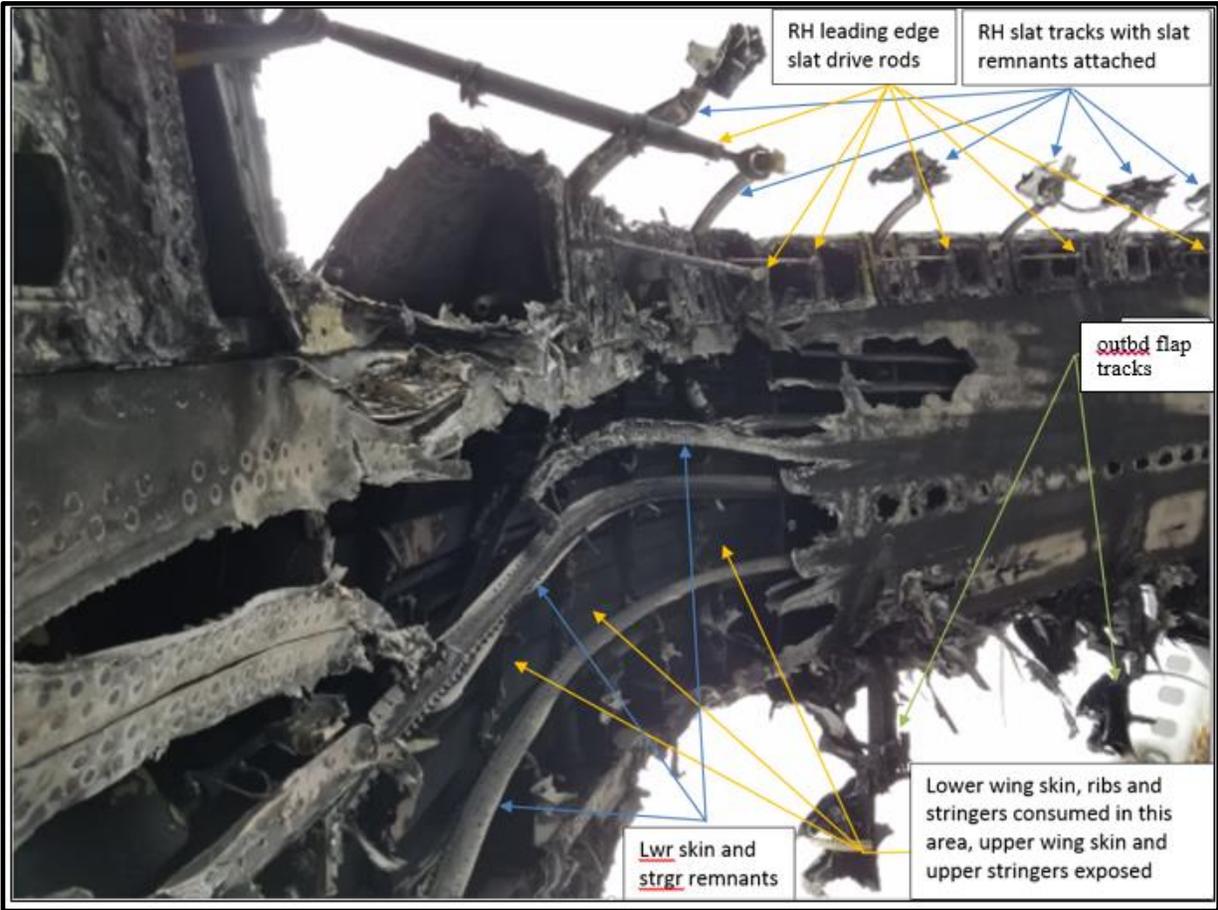
Figure 47 View looking up and inboard at right wing underside in area of bend in wing.

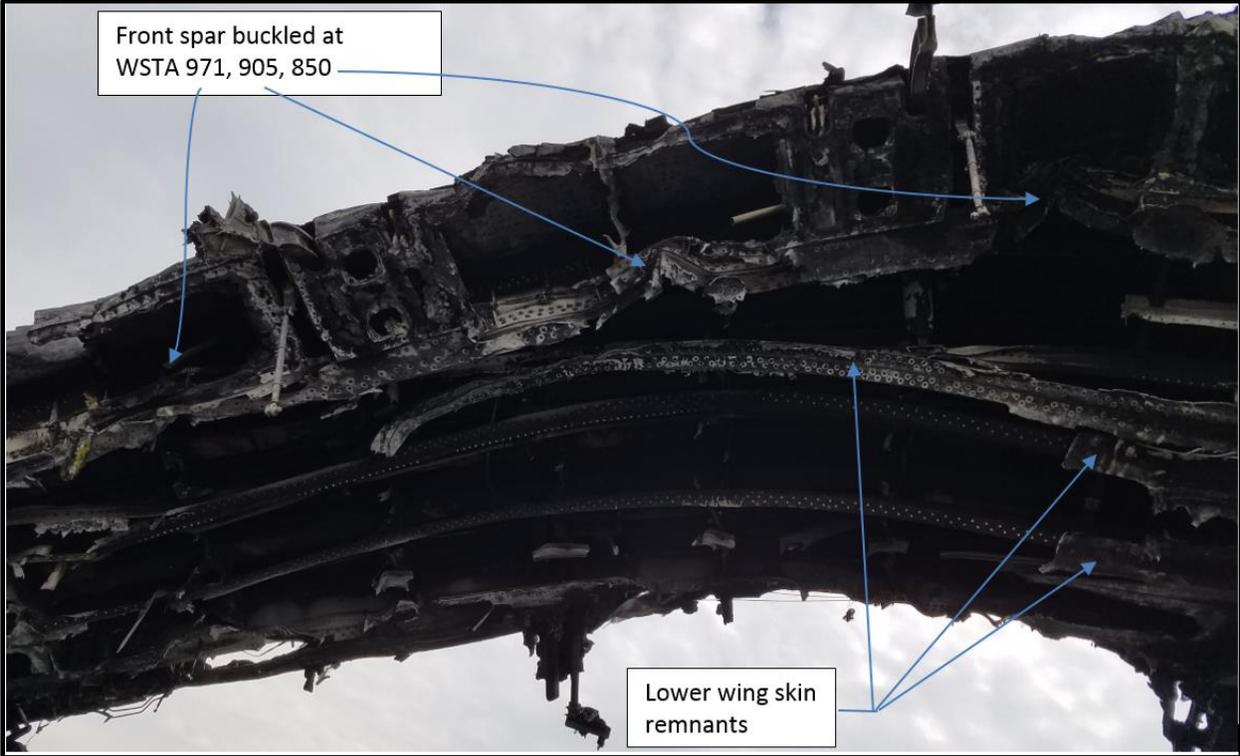
Figure 48 View looking aft and up at wing from WSTA 825-960 showing front spar buckles

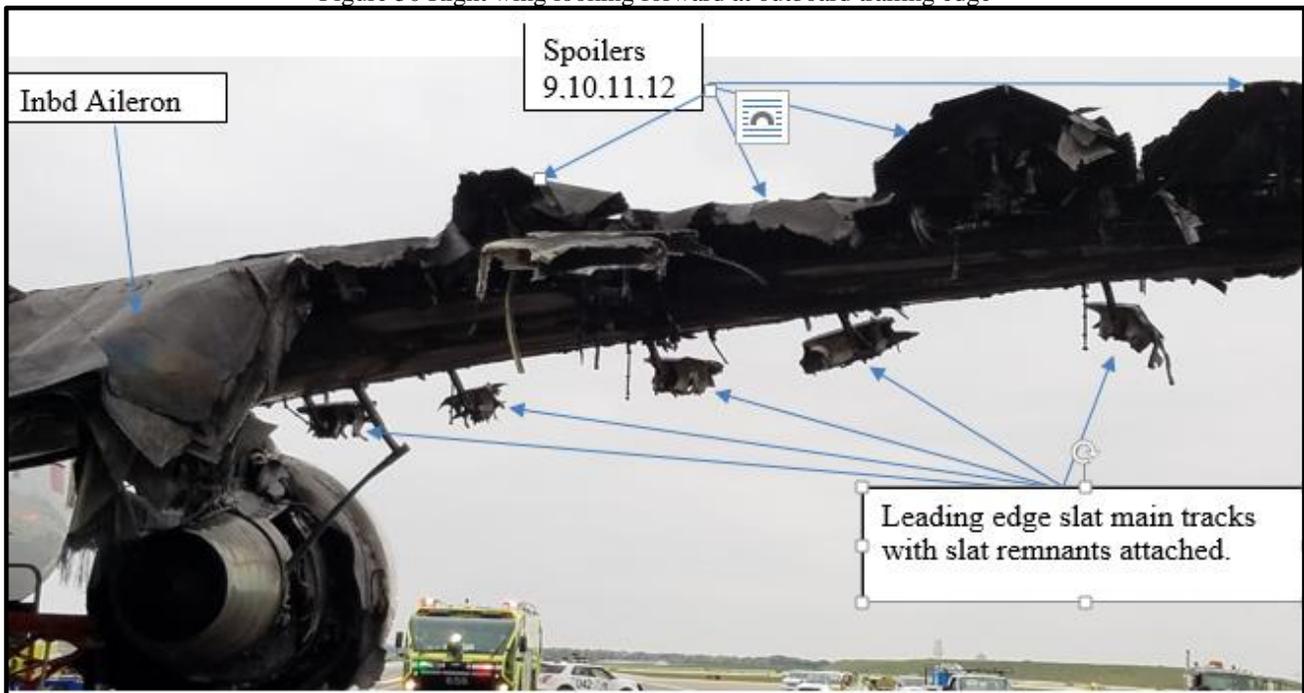
Figure 50 Right wing looking forward at outboard trailing edge

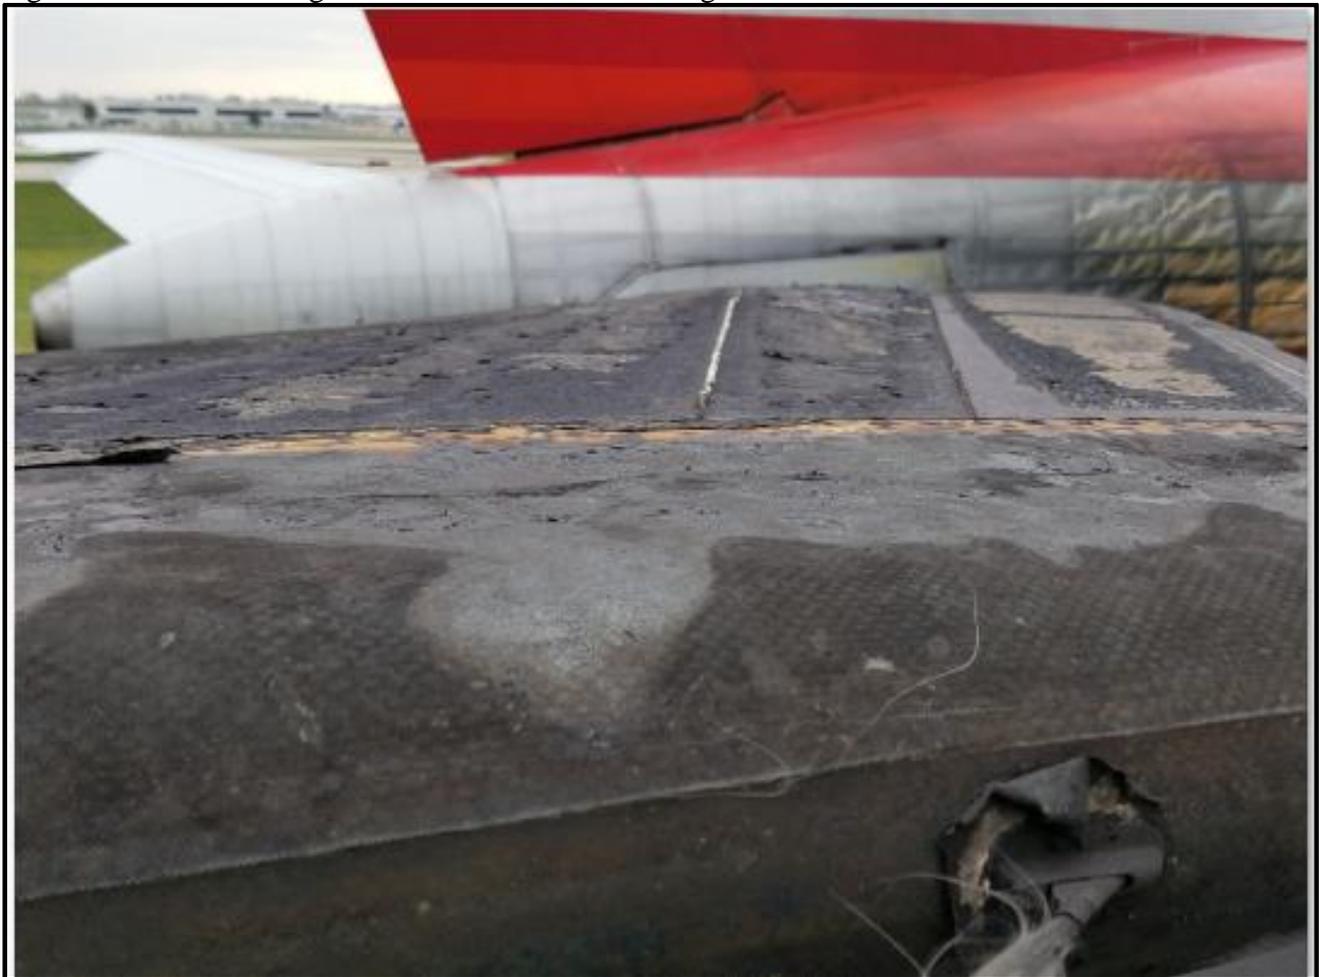
Visual examination revealed that the right horizontal stabilizer had impact damage on its leading edge surface; the stabilizer also appeared to be slightly sagging. Reference Figure 51. The stabilizer lower in-spar skin had been consumed outboard of stabilizer auxiliary spar station number 290 and the upper in-spar skin was found warped and upper stringers were found cracked and split in some areas, the ribs were found intact.

Figure 52 View of the right horizontal stabilizer looking inboard from the outboard end of the stabilizer

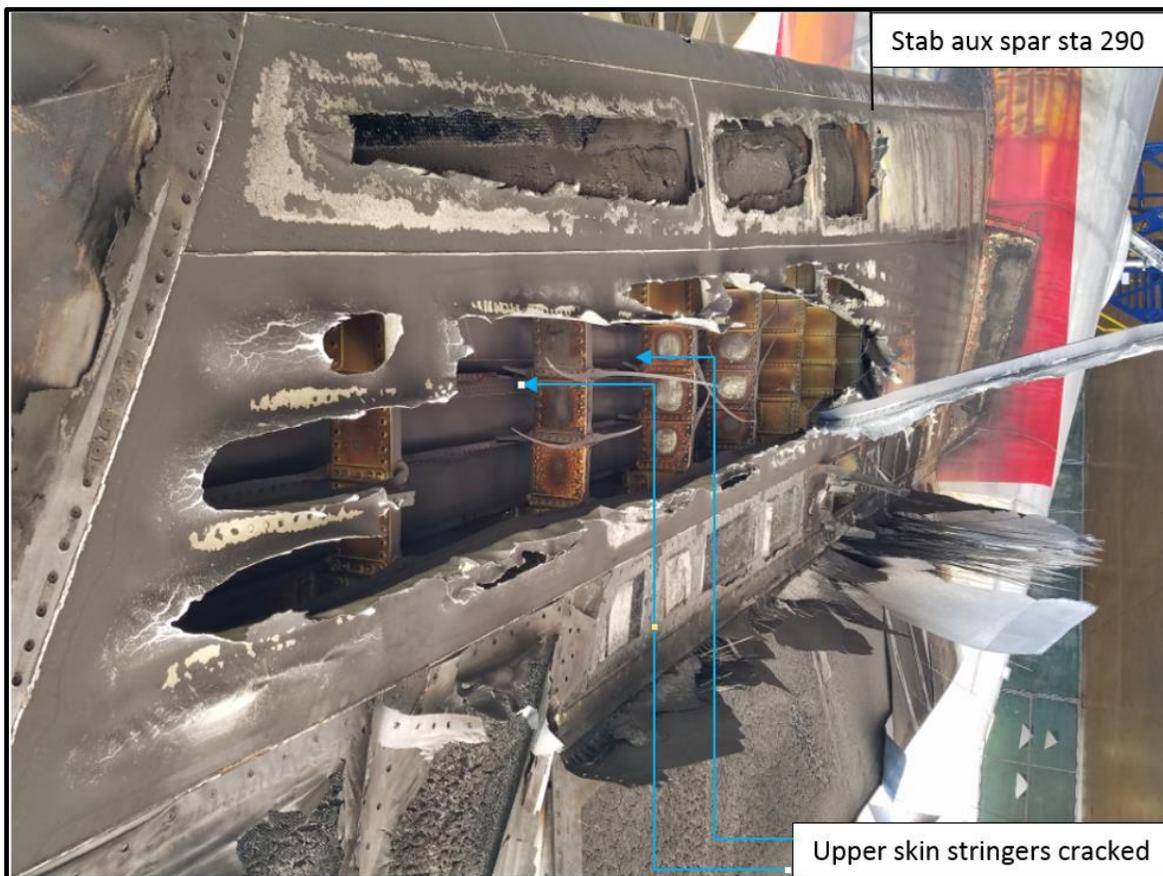
Figure 53 View of the underside of the horizontal stabilizer looking up and inboard from below its outboard tip

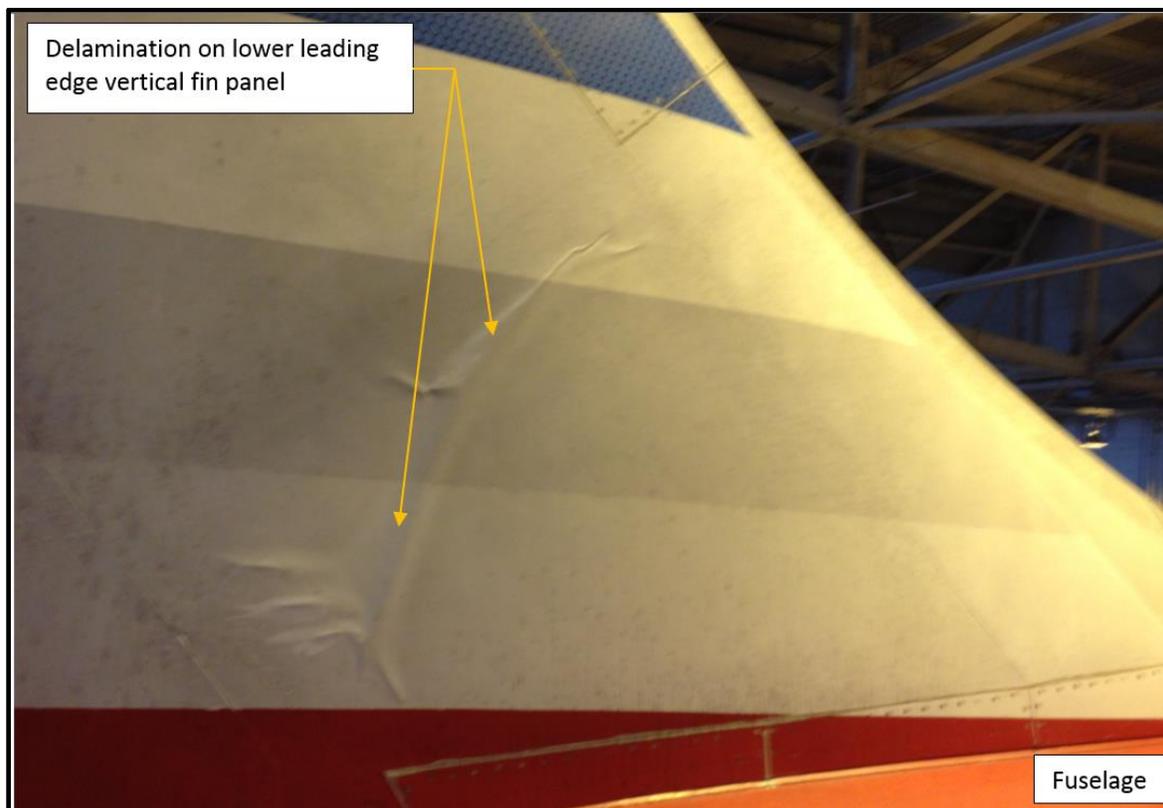
Figure 54 Vertical Stabilizer showing delamination

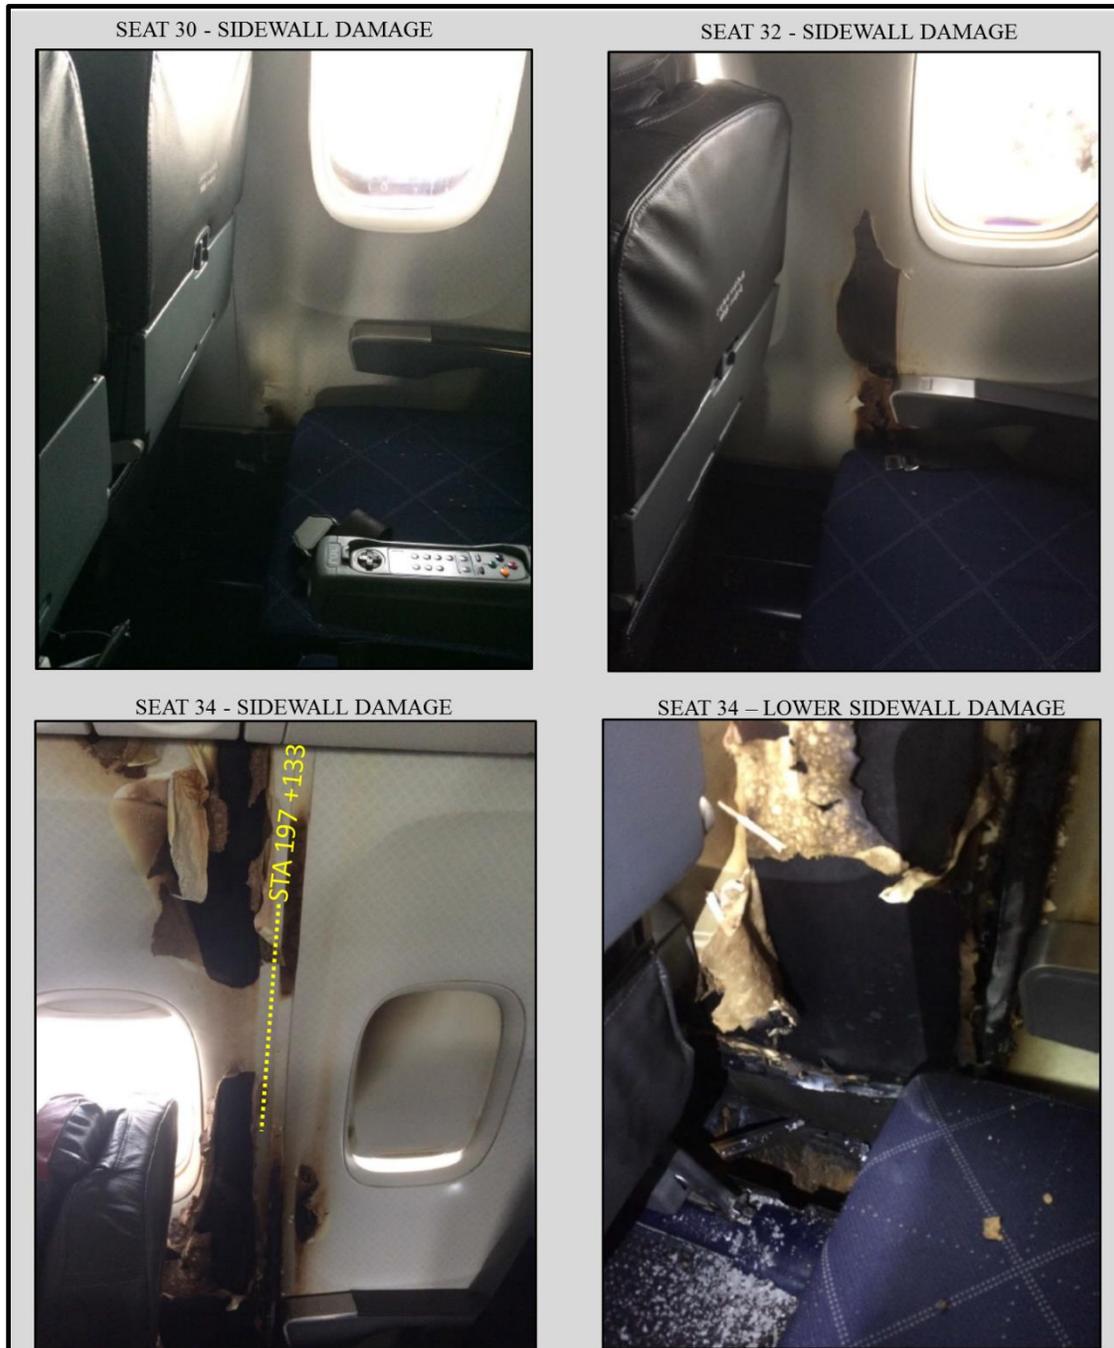
Figure 55 Sidewall Damage at seat locations 30 to 34
