NATIONAL TRANSPORTATION SAFETY BOARD

Airworthiness Group Chairman's Factual Report

NTSB ID No.: DCA17FA021

NTSB Accident Number: DCA17FA021
Location: Chicago, Illinois
Date: October 28, 2016
Time of Accident: About 1432 Central Daylight Time
Aircraft: Boeing 767-323(ER)
Registration Number: N345AN

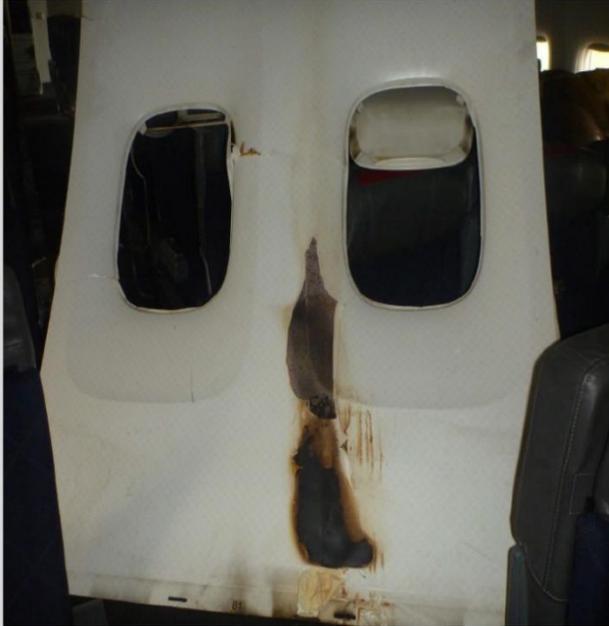
SEAT 32 - SIDEWALL PANEL

The visible damage (other than crazed windows) was limited to the interior sidewall panels at seats 30, 32, 34, and 35. The damage to the panels consisted of melting and charring of the decorative laminate, and charring to their inboard and outboard sides. (Reference Figure 56).

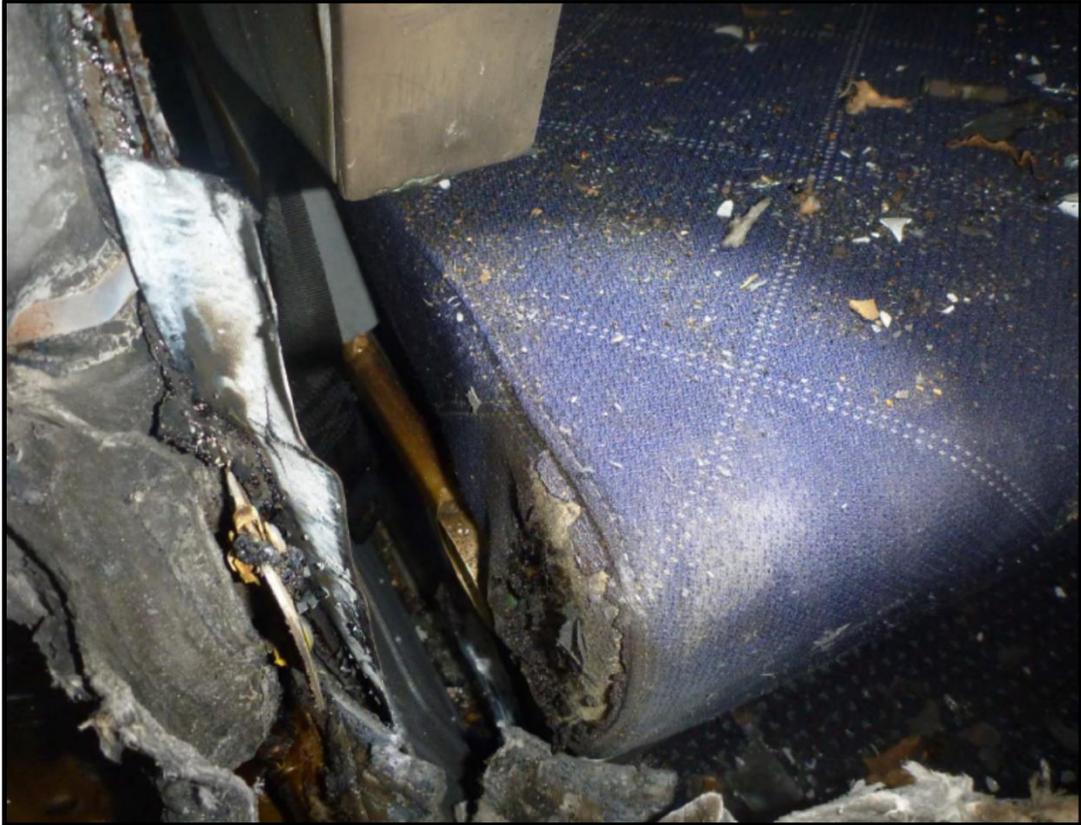
Figure 57 Seat 34 charred seat cushion

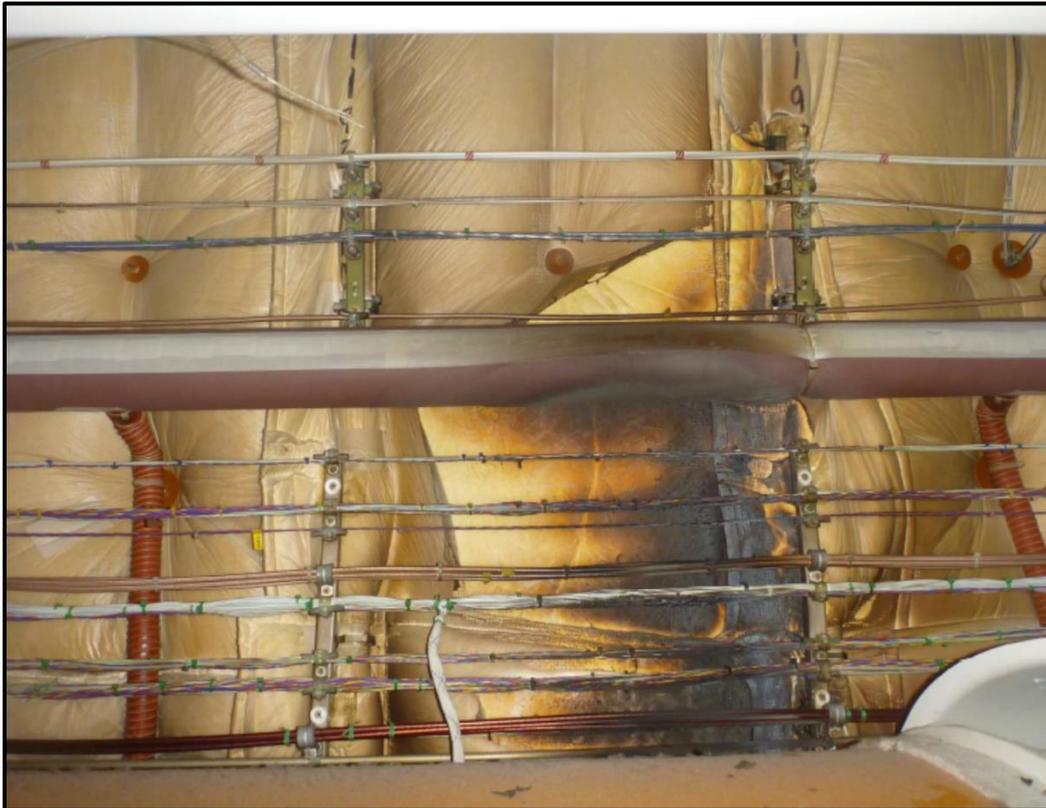
Figure 58 Charred insulation and wiring in crown above seat 34

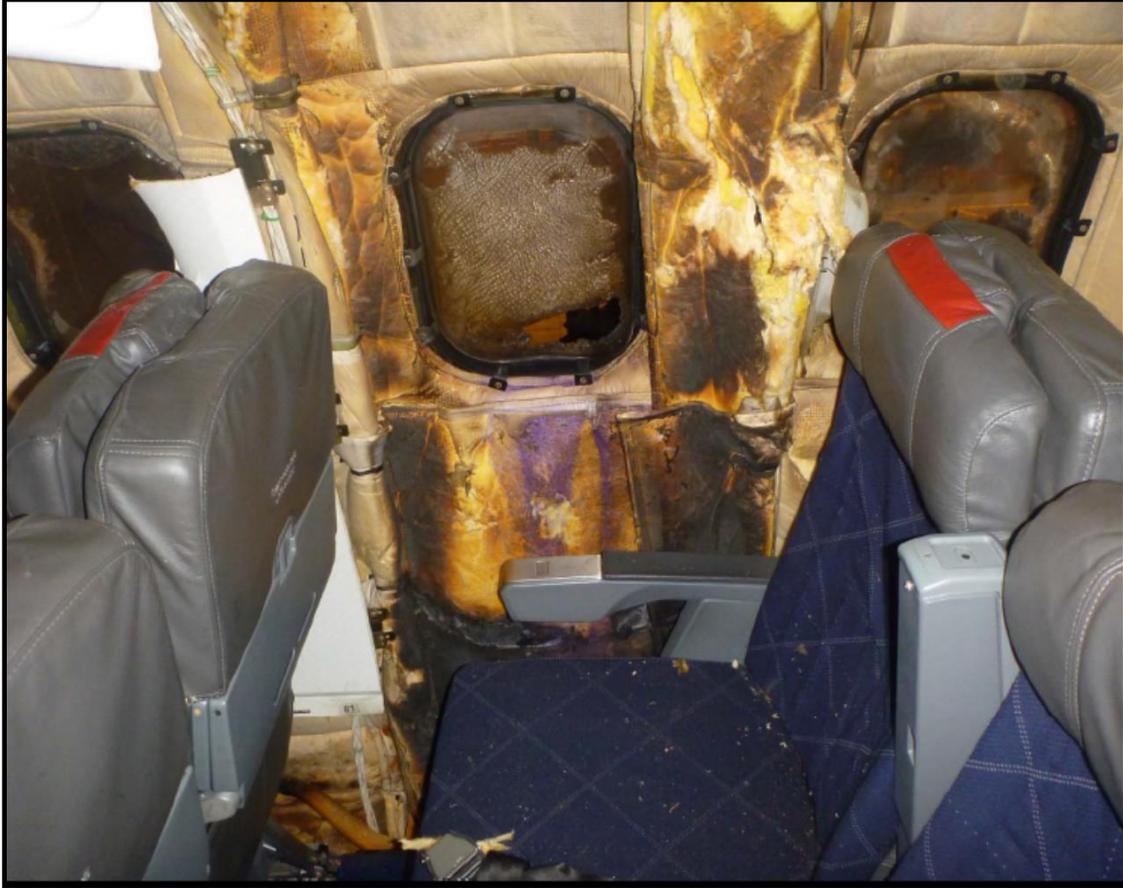
Figure 59 Charred insulation blankets and melted window at seat 30

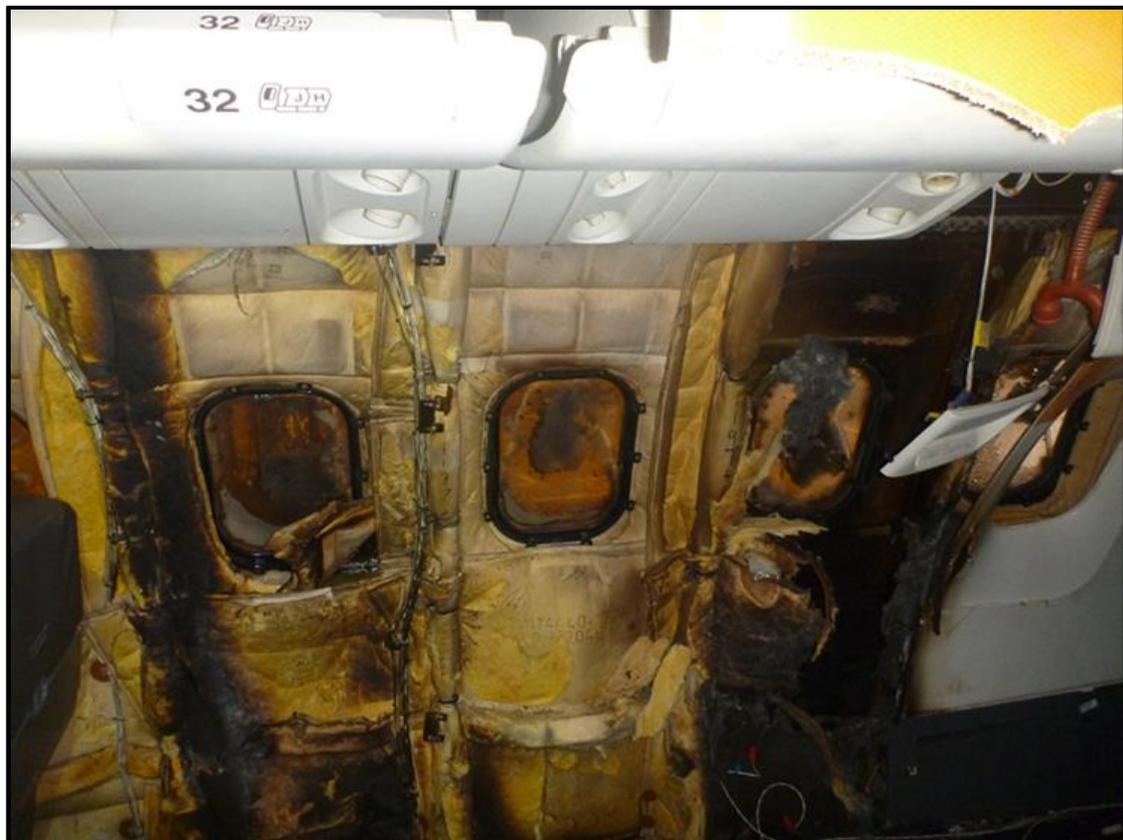
Figure 60 Charred insulation at seats 33 through 34

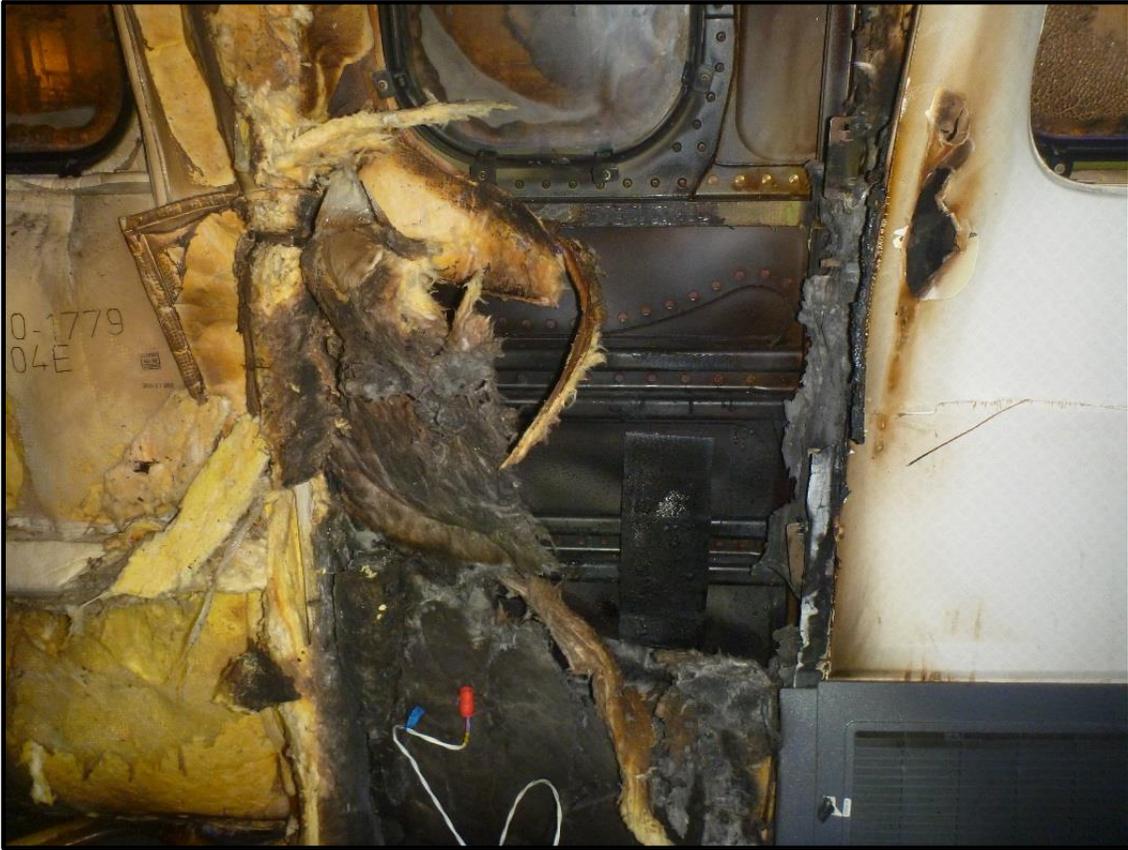
Figure 61 Charred insulation and CIC on skin at seat 34

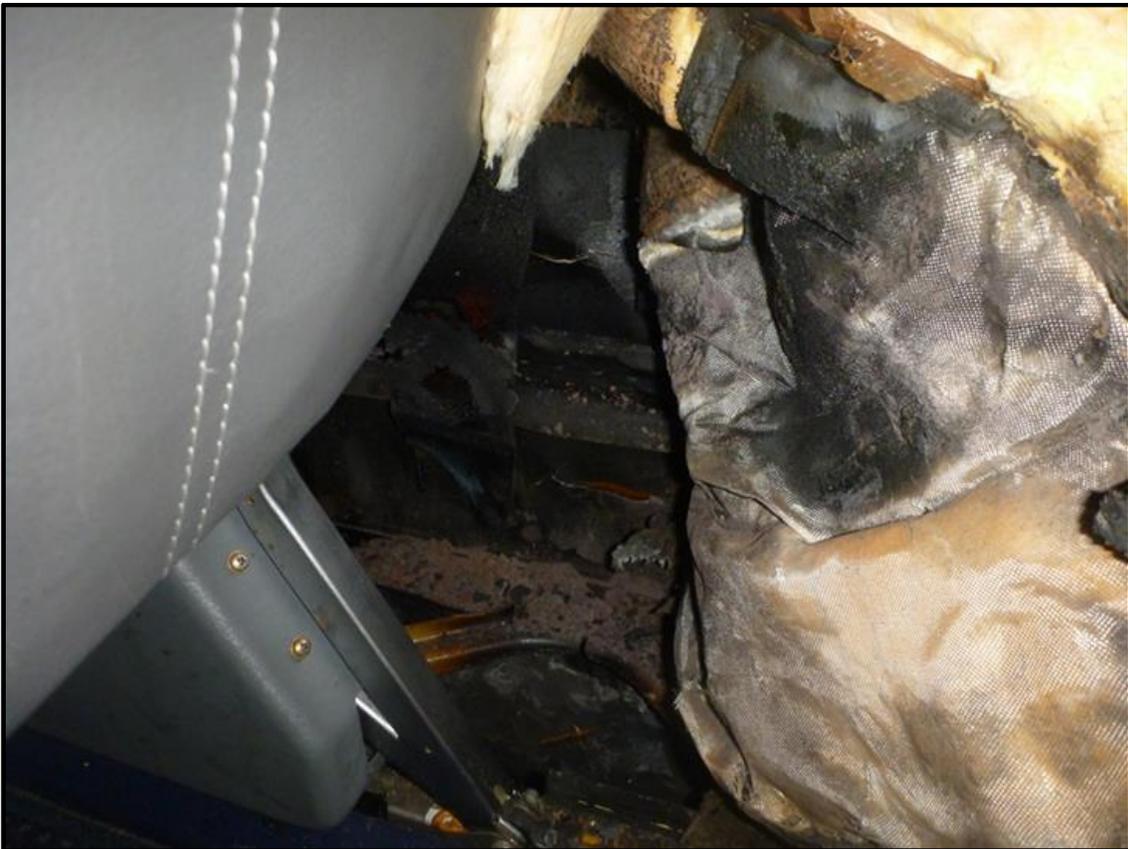
Figure 62 Charred insulation and crack in skin at seat 31

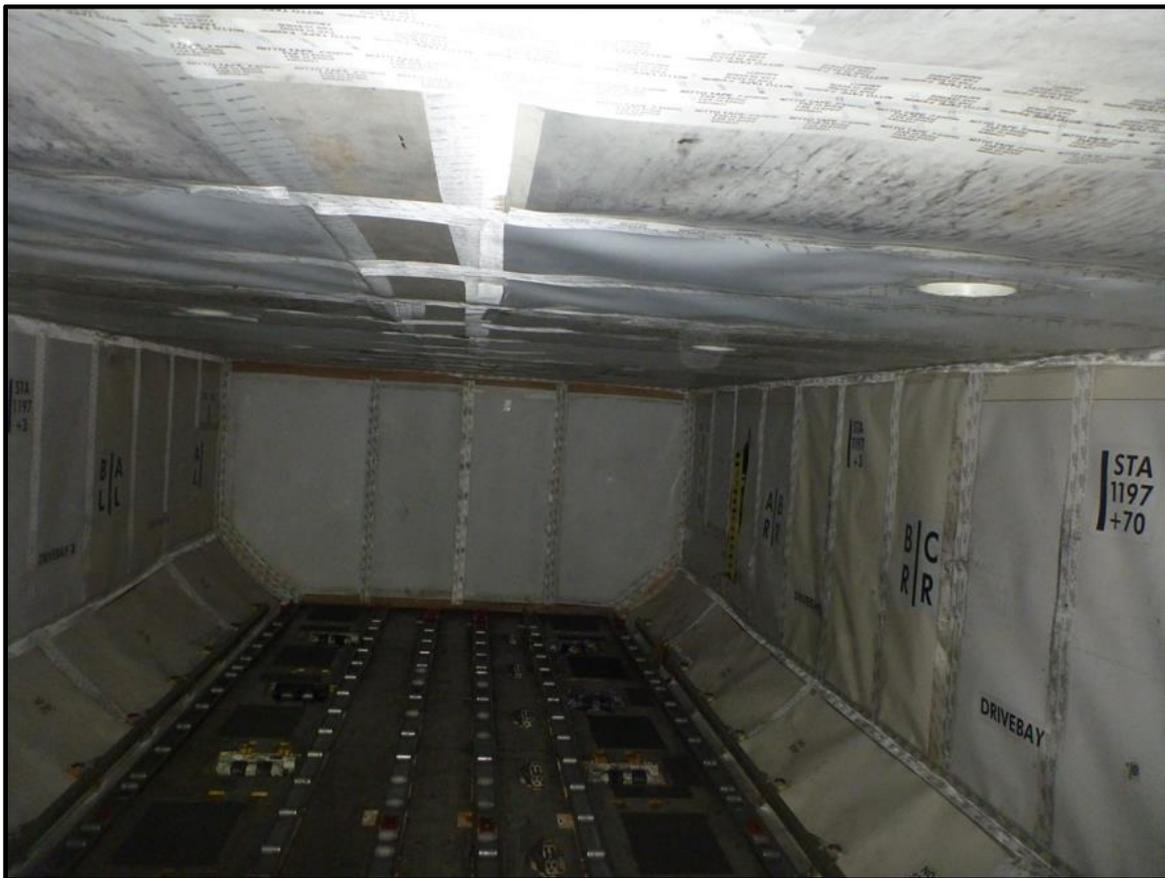
As shown in Figure 63, the aft cargo compartment looked normal, all the liners were in good condition and the joints taped. There were no signs of any heat damage or soot.

Figure 63 Aft cargo compartment (looking forward)

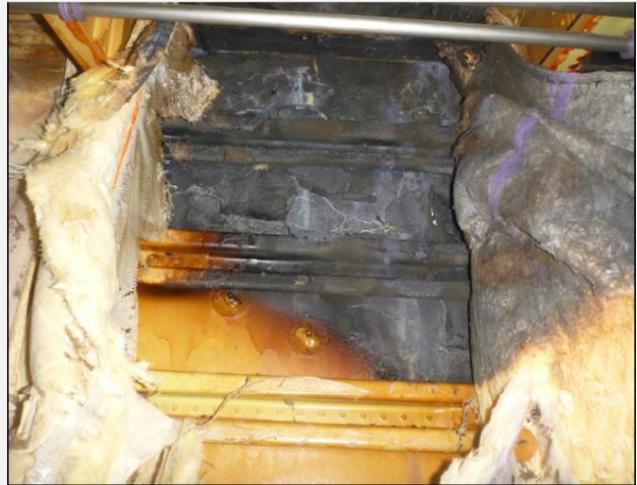
STA 1197 to 1197+22 (note the cracks)

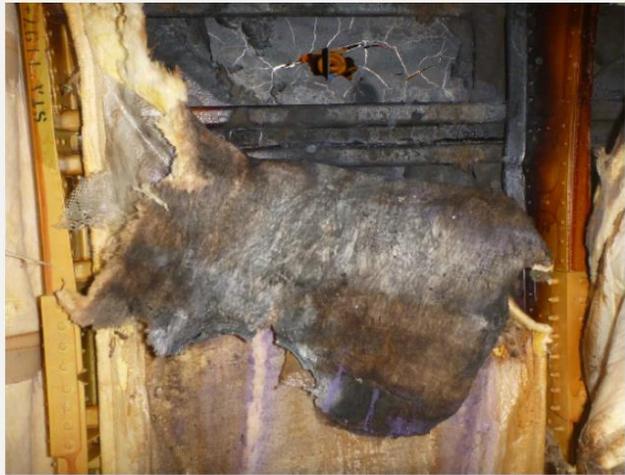
STA 1197+22 to 1197+44 (note hole/cracks)

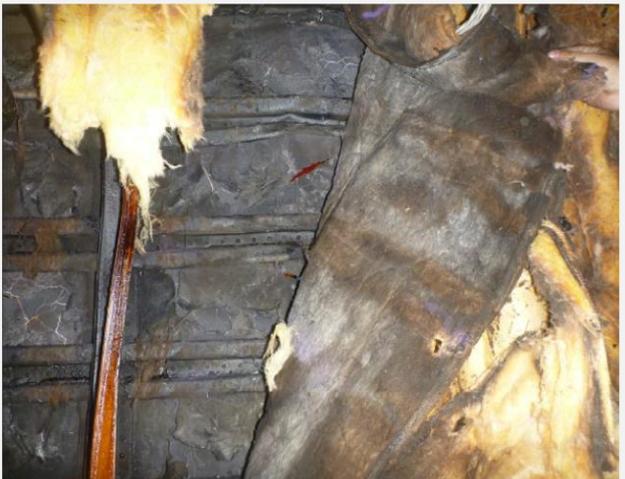
STA 1197+44 to 1197+66 (note the cracks)

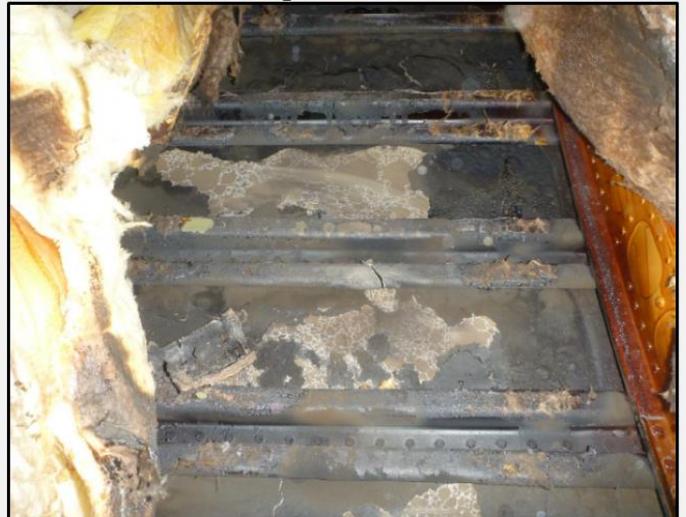
Cracked stringer 25R at STA 1197+120

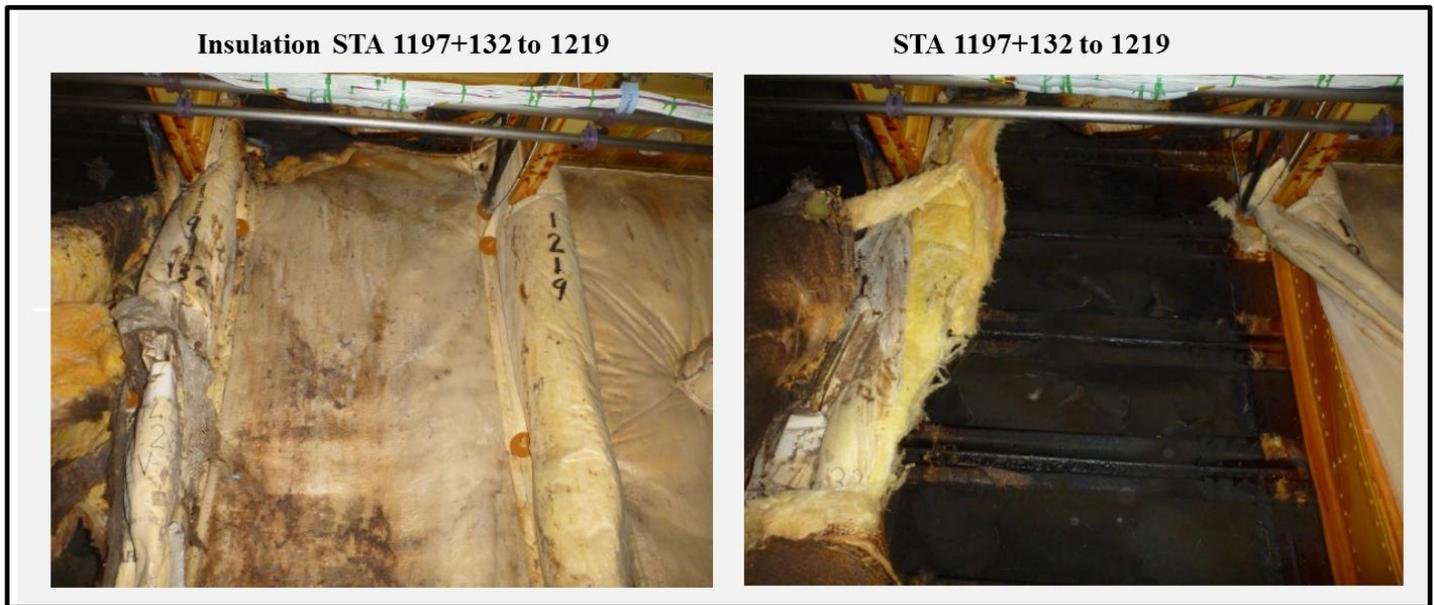
Figure 66 Insulation blanket damage

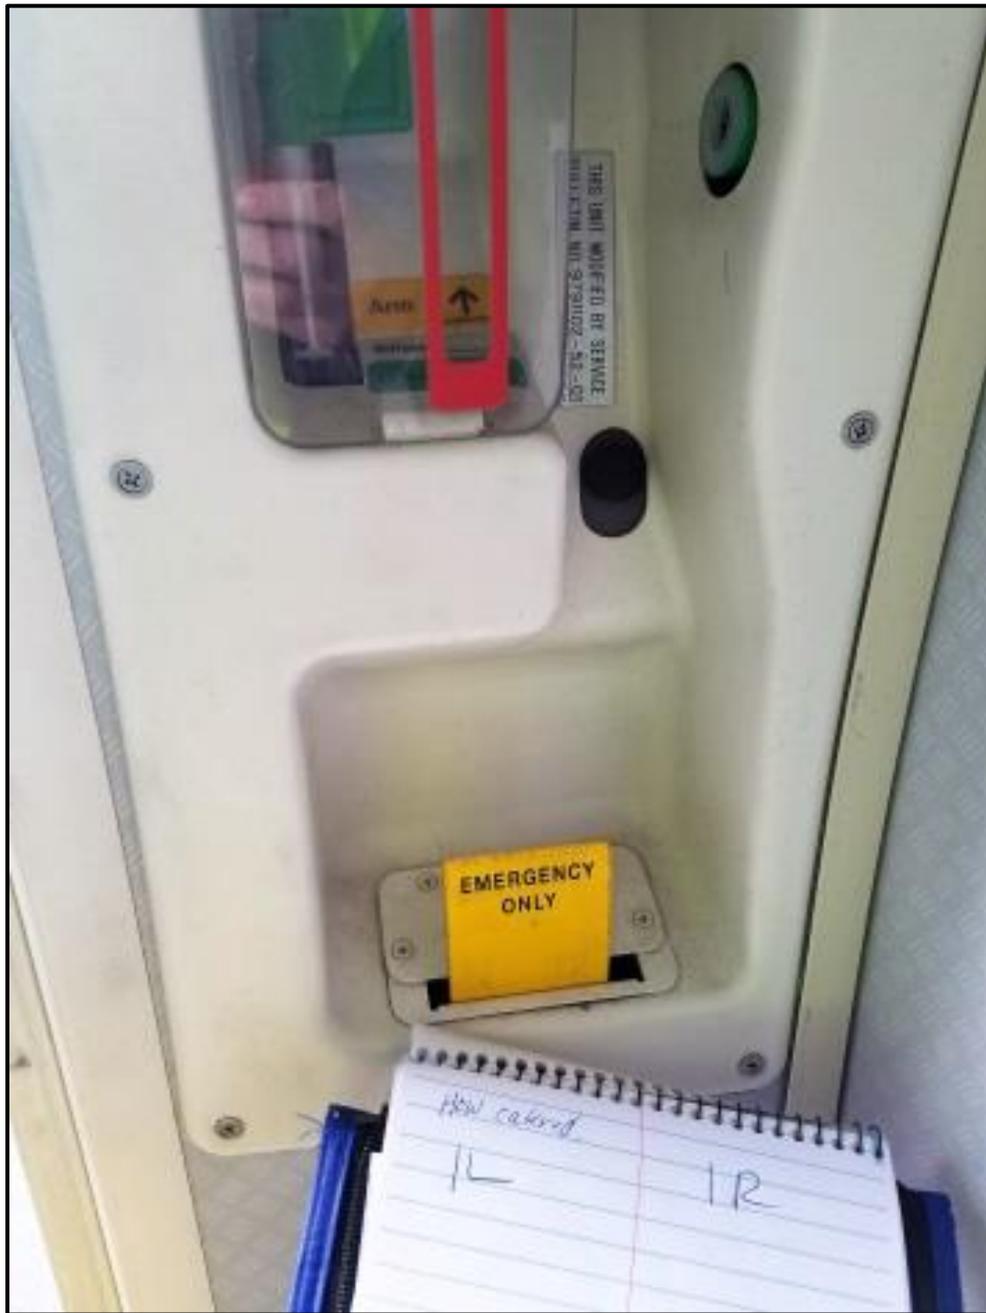
Figure 67 Door 1L was armed and open with ramp stand in place

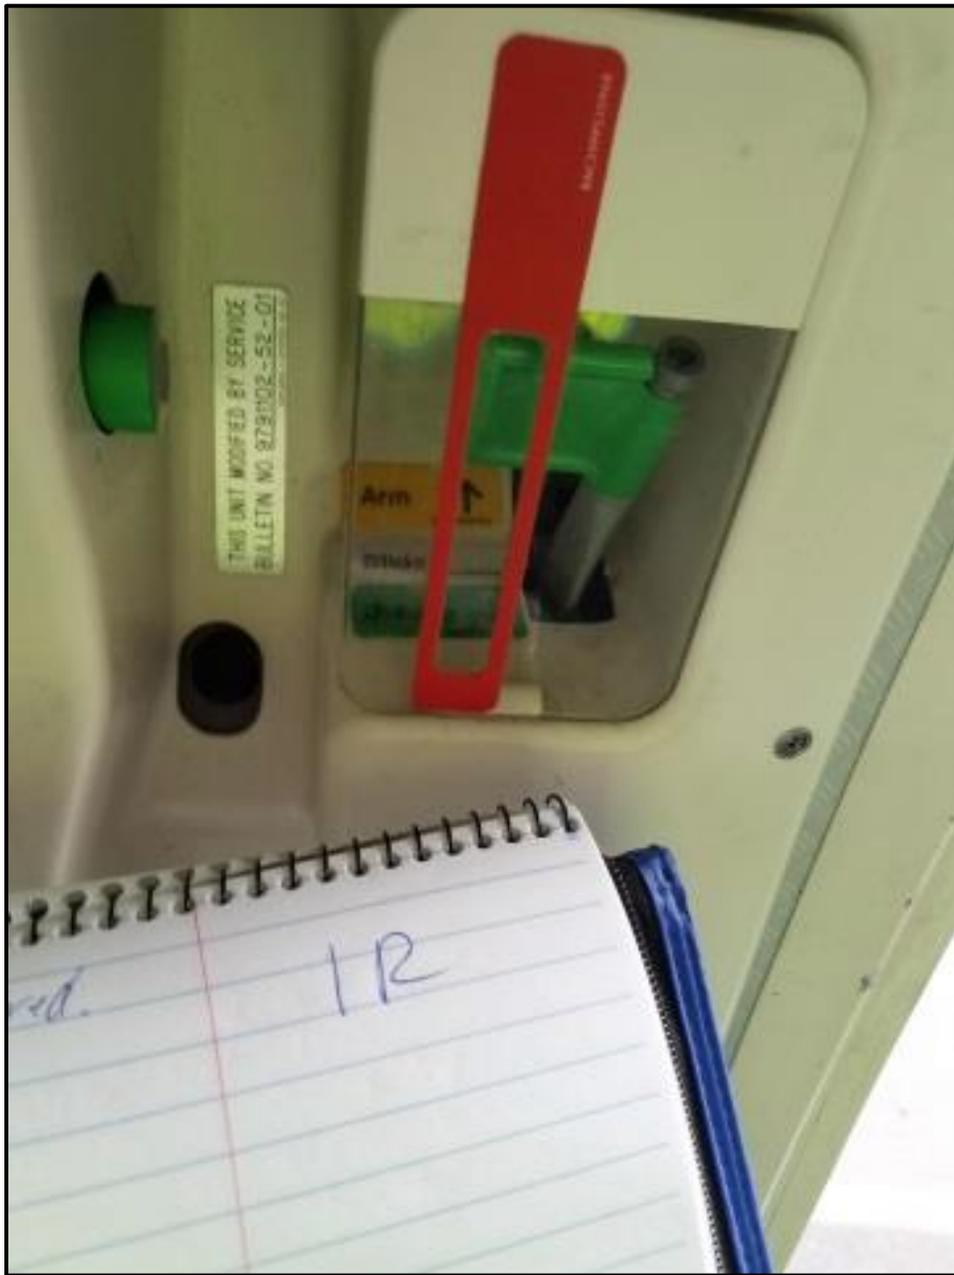
Figure 68 Door 1R was found open and in a disarmed position
