NATIONAL TRANSPORTATION SAFETY BOARD

Airworthiness Group Chairman's Factual Report

NTSB ID No.: DCA17FA021

NTSB Accident Number: DCA17FA021
Location: Chicago, Illinois
Date: October 28, 2016
Time of Accident: About 1432 Central Daylight Time
Aircraft: Boeing 767-323(ER)
Registration Number: N345AN

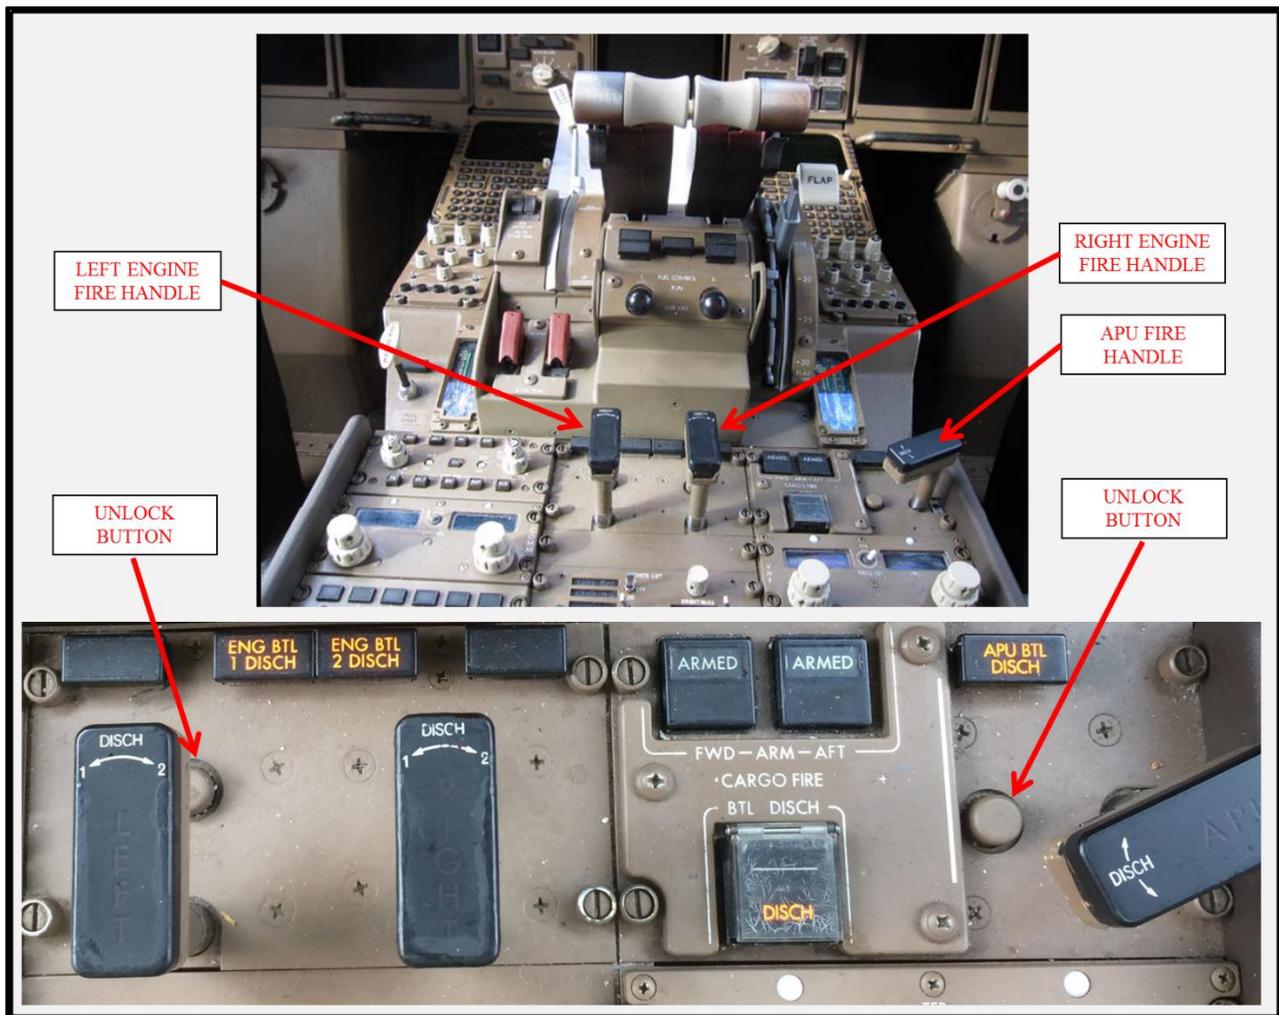
Figure 11 Photograph showing the engine fire control panel.

This system comprises, in part, two fire extinguisher bottles and an engine fire control panel located on the center console in the flight deck. As shown in Figure 11, there are two engine fire switch handles (one for the left engine and one for the right engine) and an APU fire switch handle located on the engine fire control panel.

Visual inspection showed that the left and right engine handles were found extended and centered; neither was found rotated towards their number 1 or the number 2 fire bottle position.

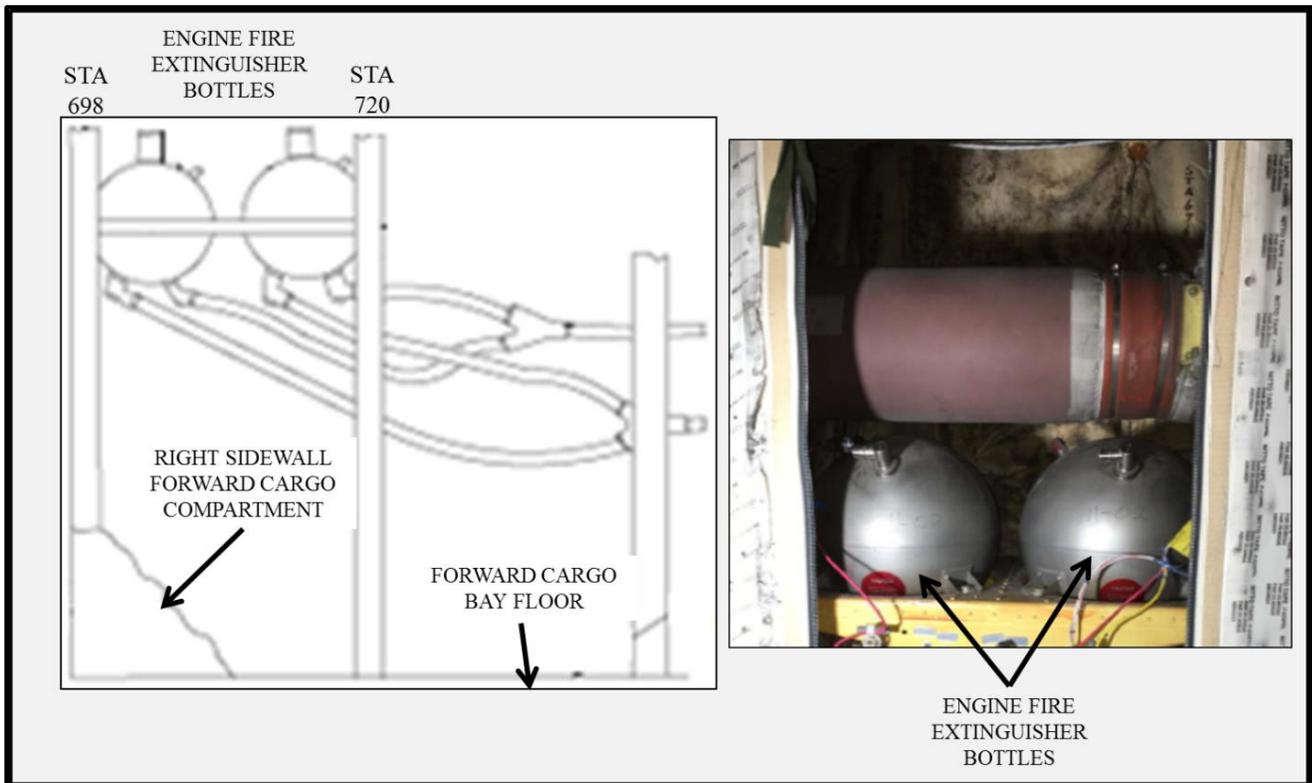
Figure 12 Fire extinguisher bottles

As shown in Figure 12, the airplane was equipped with two, Pacific Scientific, engine fire extinguisher bottles located in the forward cargo compartment in the aft right cheek. Each extinguisher bottle included two squib cartridges (one per discharge port), a pressure switch, and a combined safety relief and filter port. When detonated, the squib cartridge ruptures a retaining disk in the discharge port releasing the extinguishing agent.

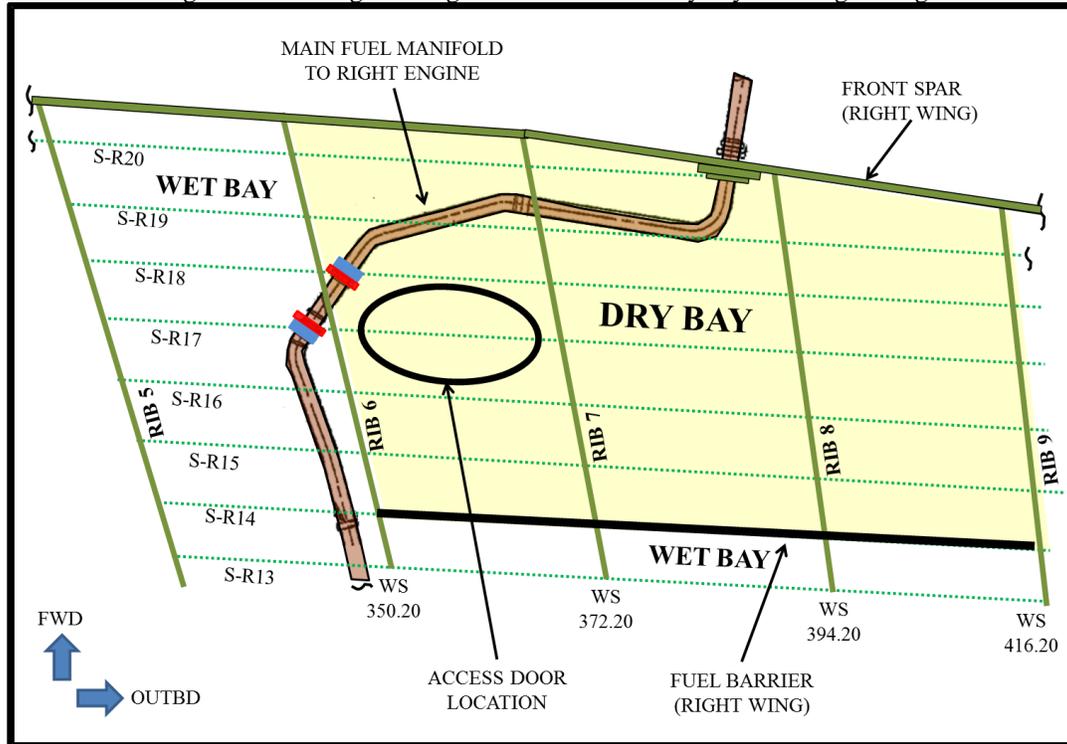
Figure 17 Drawing showing the location of the dry bay in the right wing

Each main fuel tank contained a fuel-free compartment, identified as a “dry bay”, that was located directly above the engine in the forward part of the fuel tank (Reference Figure 17). The incorporation of the dry bay was one of the major precautions taken on the fuel system to minimize the hazard to the airplane in the event of an engine non-contained failure.

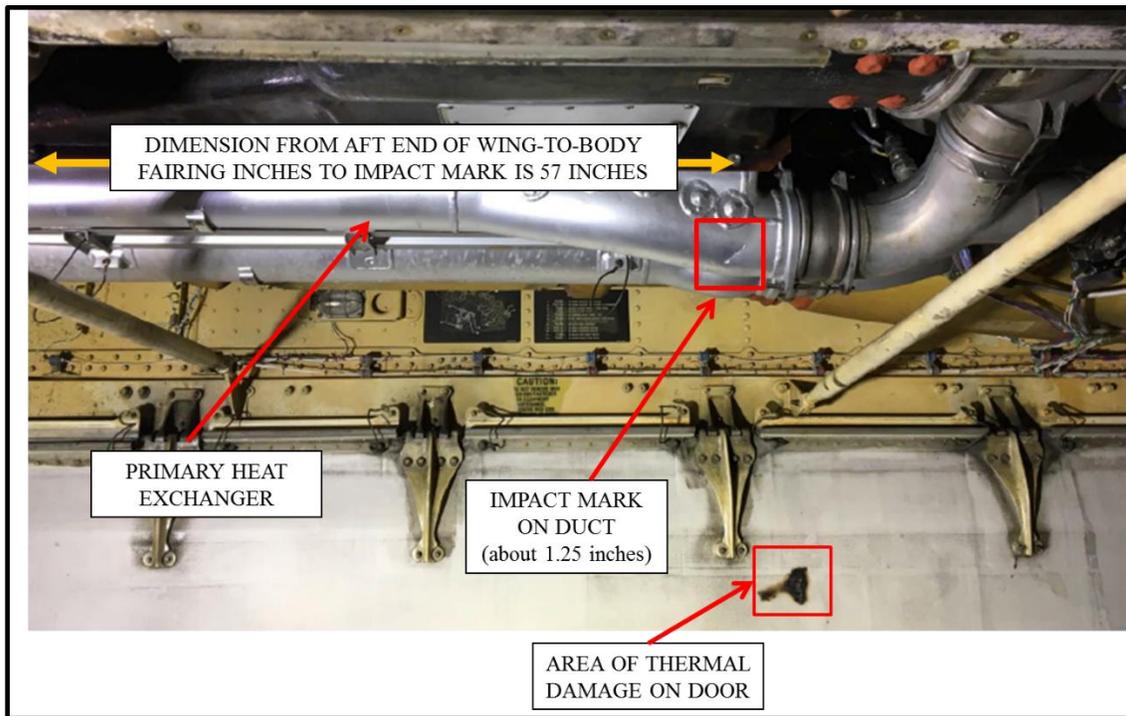
Figure 31 View of inside of right ECS bay showing impact mark on duct

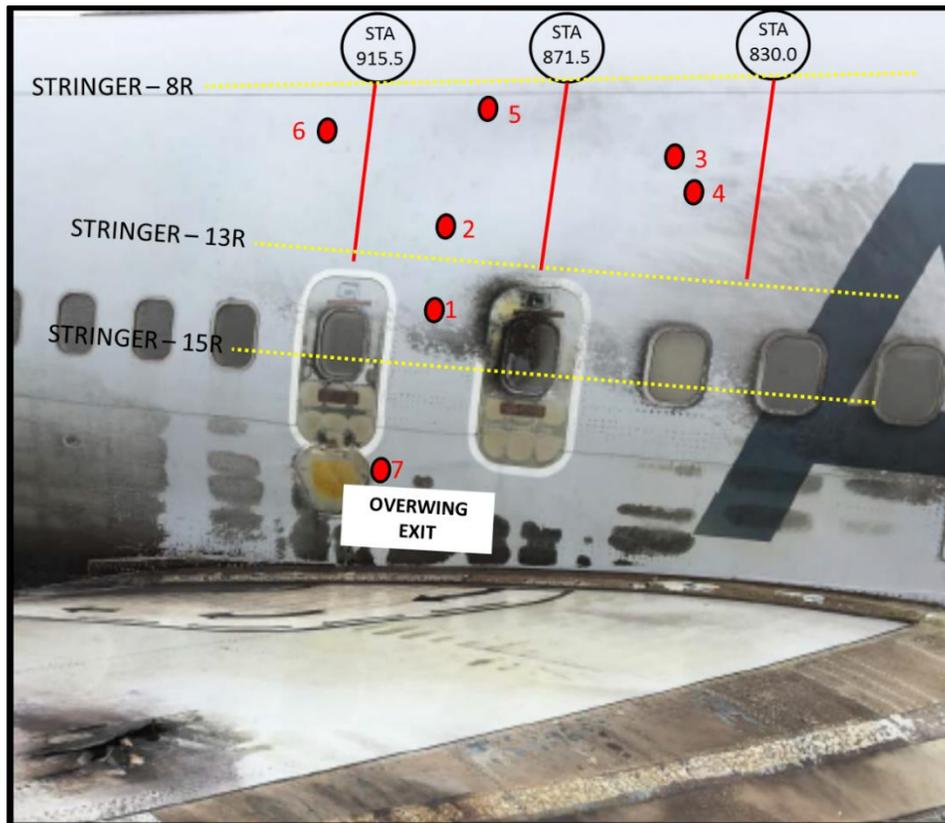
Visual examination revealed small, non-penetrating, impact marks on the fuselage in several locations above the right wing and near the over-wing emergency exit. Reference Figure 33 and Table 4.

Figure 32 Drawing showing the location of impact marks above emergency exits

Impact #	Station	Stringer	Depth (+ paint)
1	895	14.5R	.0139
2	895	12R	.0114
3	848	10R	.0119
4	842	10.5R	.0118
5	895	8.4R	.0328
6	928	9R	Only paint
7	905	21R	.05

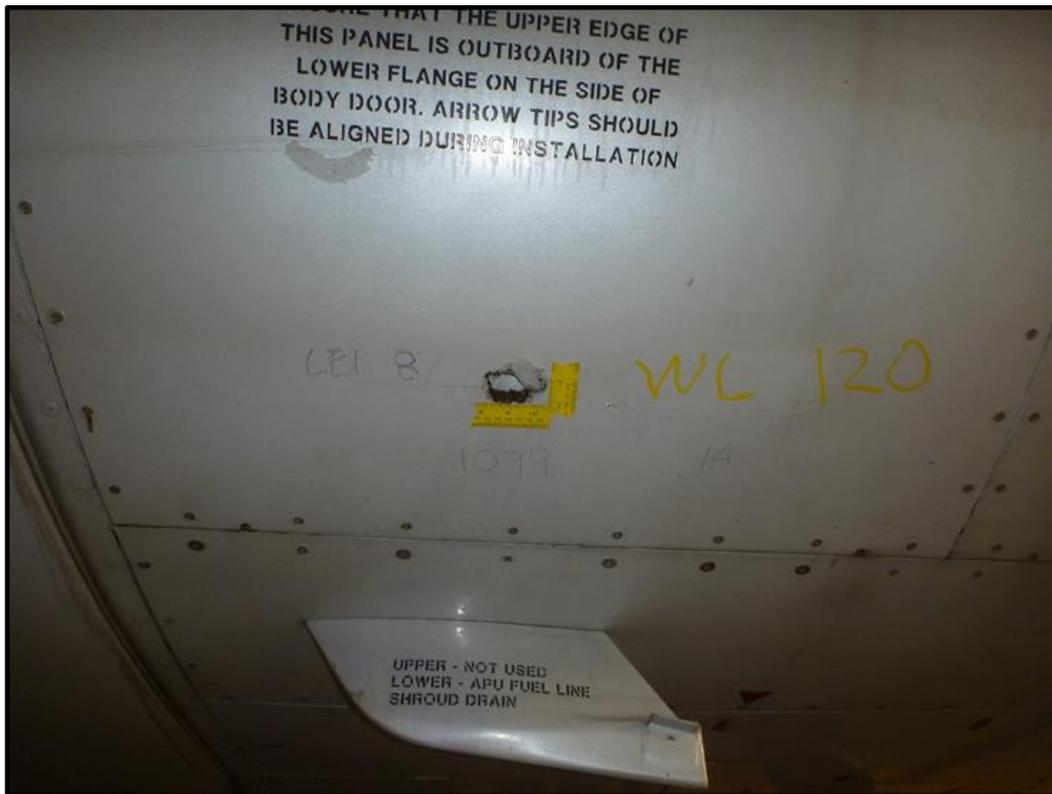
Visual examination revealed impact marks on the left side of the fuselage in several locations near the ECS pack bay and the landing gear. Reference Table 5 and Figures 33 through 39.

Figure 36 Impact K, Left side of body door

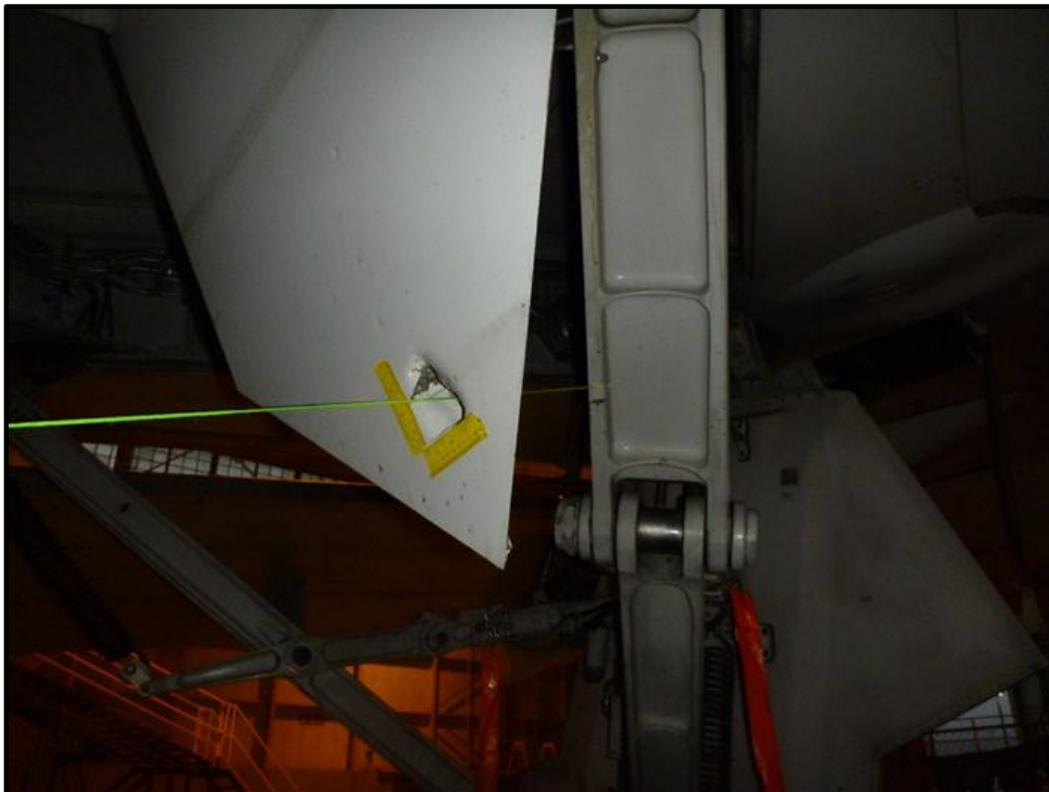
Figure 37 Impact L, Left main gear drag strut door

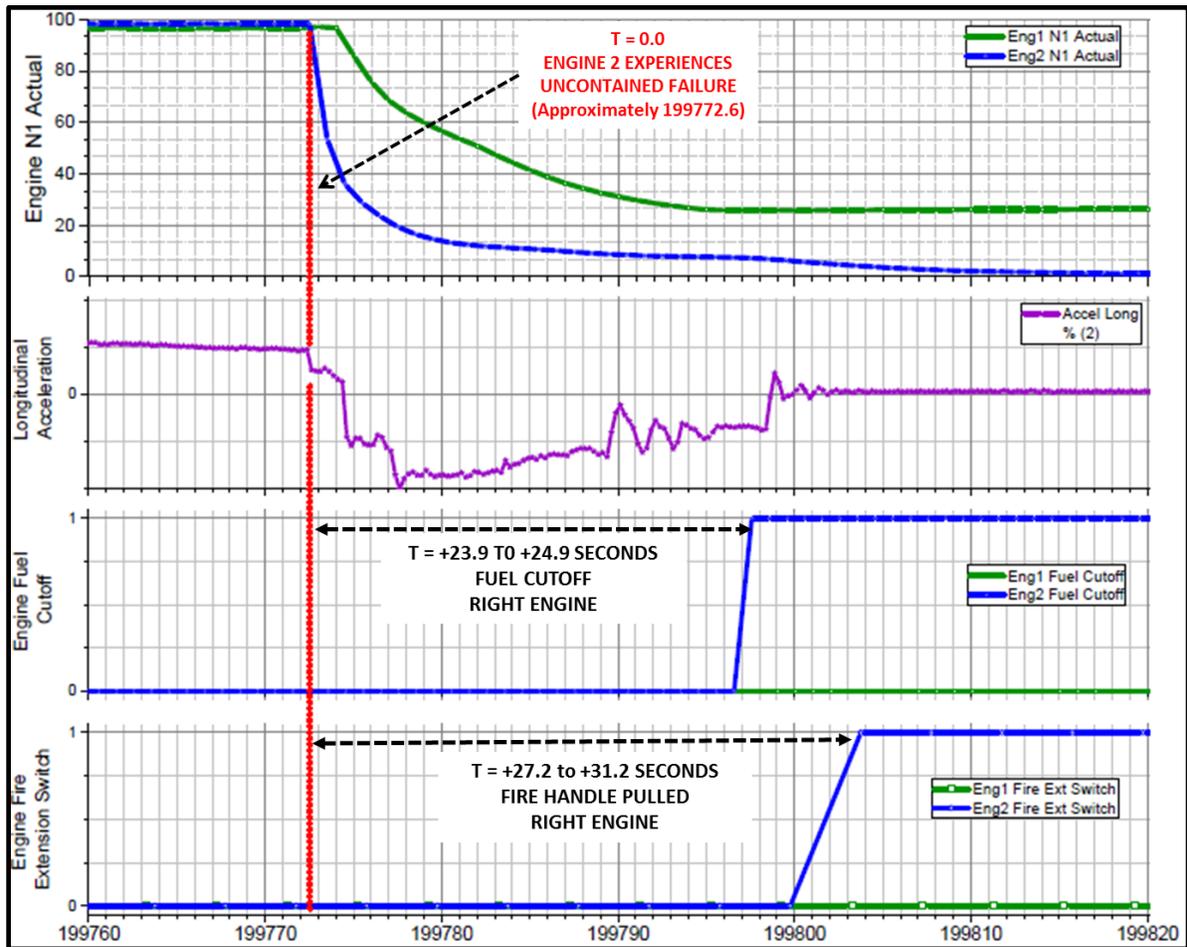
For the right engine, FDR data revealed that its engine fuel cutoff discrete transitioned from zero (ON) to 1 (OFF) approximately 25 seconds after the engine experienced an uncontained failure. Shortly thereafter, the data revealed that the engine's fire handle discrete transitioned from zero (non-activated) to 1 (activated or "pulled"). Figure 41 provides a graph showing these transitions.

Figure 41 FDR data showing engine fuel-cutoff information

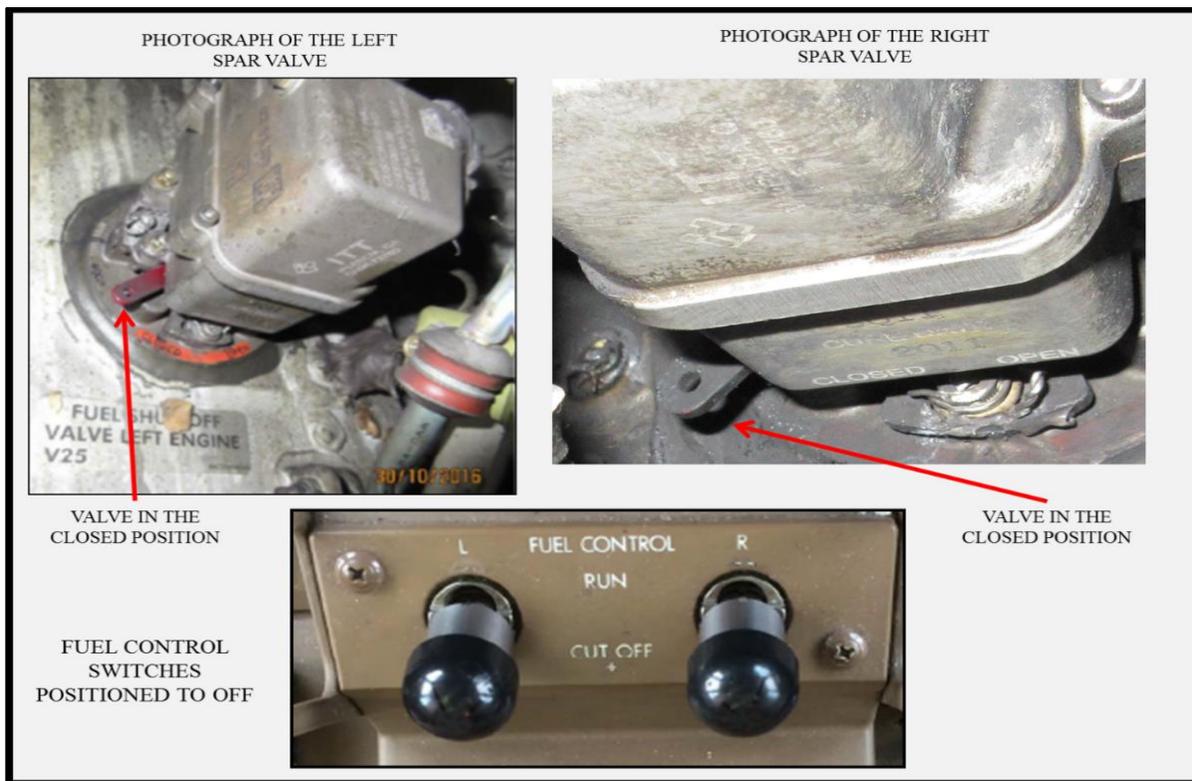
Figure 42 Spar valve positions

While the airplane was in the American Airlines hangar, each spar valve was visually confirmed to be in its CLOSED position (reference Figure 42).

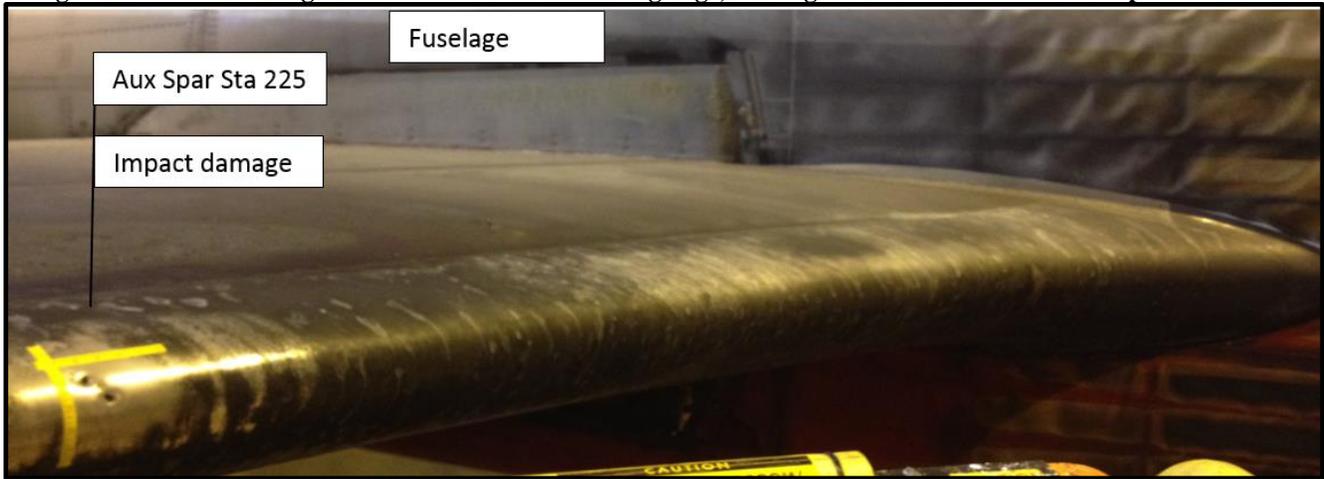
Visual examination revealed that the right horizontal stabilizer had impact damage on its leading edge surface; the stabilizer also appeared to be slightly sagging. Reference Figure 51. The stabilizer lower in-spar skin had been consumed outboard of stabilizer auxiliary spar station number 290 and the upper in-spar skin was found warped and upper stringers were found cracked and split in some areas, the ribs were found intact.

Figure 51 View of the right horizontal stabilizer leading edge, looking aft and inboard from aux spar station 230

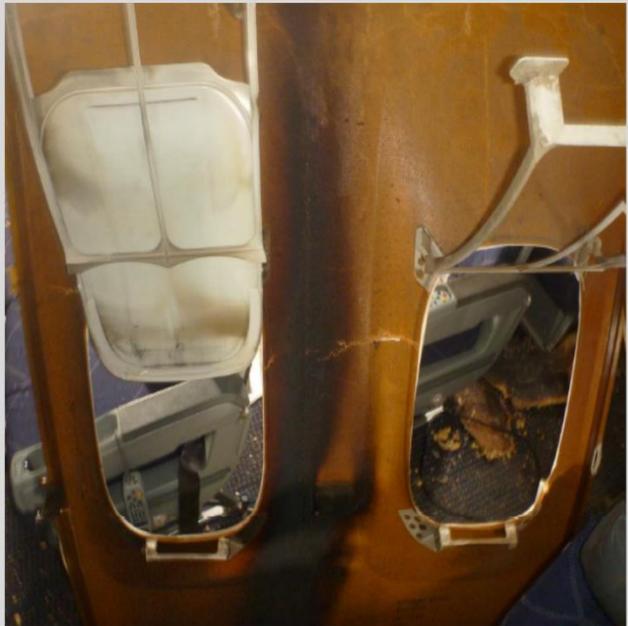
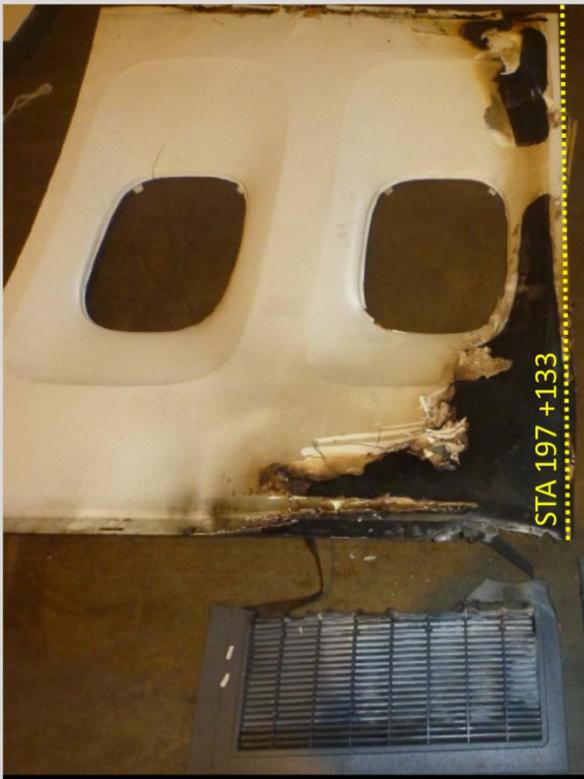
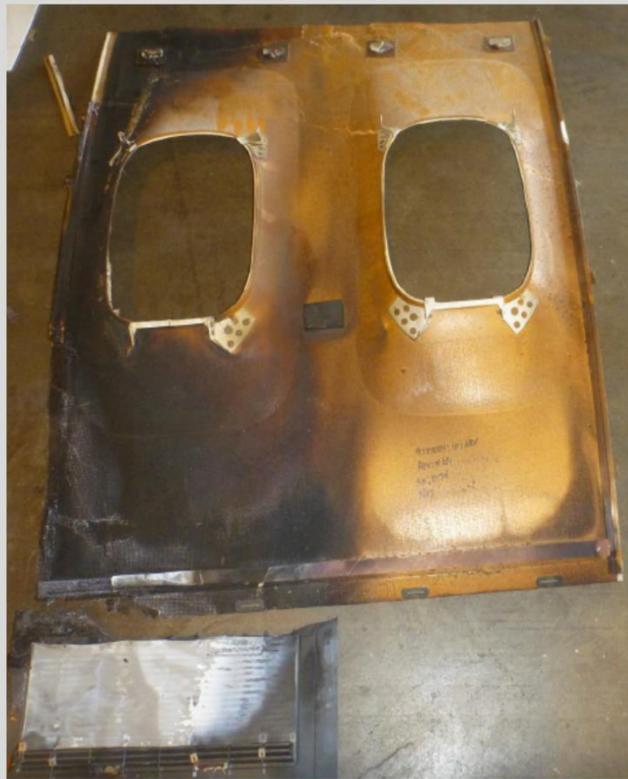
Visual inspection revealed that the most significant damage occurred at seat 33/34 (station 1197+110 to 1197+132). There was thermal damage to the interior sidewall consisting of melting of laminate and charring of the panel (inboard and outboard sides) and consumption of the majority of the resin along the aft edge of the panel. The top row of louvers on the plastic air grill (below the bottom of the panel) was charred and melted. There was a slight amount of soot on the sidewall panel above it and on the outboard surface of the seat armrest. The outboard edge of the bottom seat cushion fabric was charred, exposing the foam fire-blocking material, reference Figure 57. The insulation blanket behind the stowage bins was charred, and the cover film was gone. The char extended up into the crown. There were some wires above the stowage bins that had their insulation burned off, indicating the cover film had burned. The cover film self-extinguished at approximately stringer 6R. Reference Figure 58.

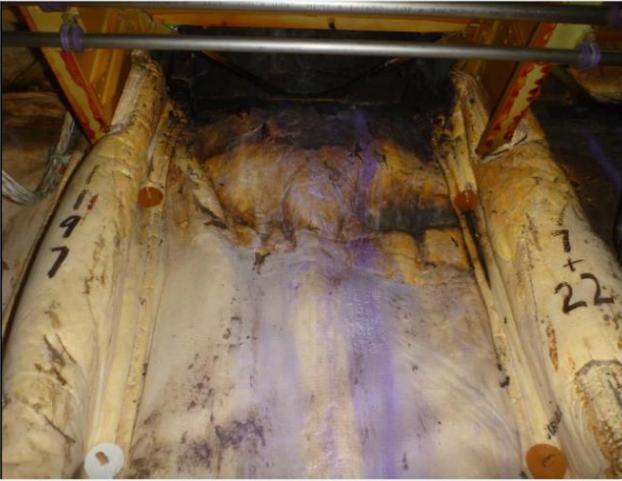
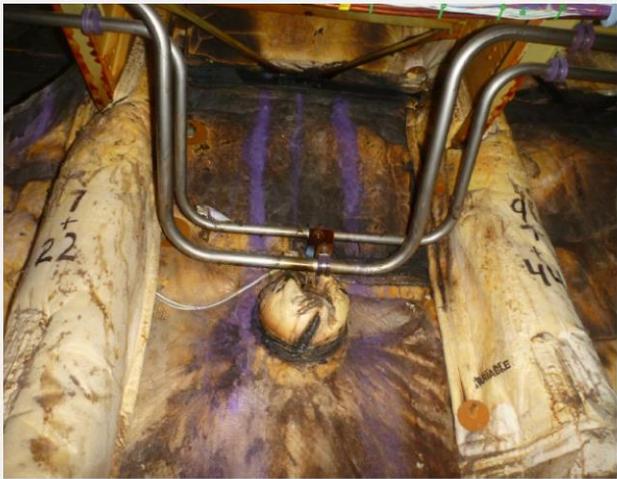
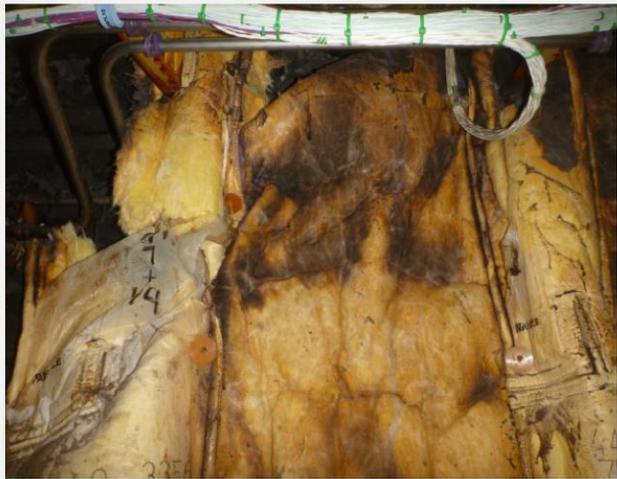
Figure 64 Insulation blanket damage

The liners on the right side were removed so that the insulation blankets could be inspected. The insulation blankets from station 1153 to 1241 had varying degrees of thermal damage with the greatest damage between station 1197+22 and 1197+132. The damage consisted of charring of the blanket and cover film. Reference Figures 65 through 67.

The blankets were pulled back to reveal the damage on the backside and on the skin. The backside of the insulation blankets, between stations 1197 and 1197+132 were all charred to varying degrees, with the heaviest damage between stations 1197+22 and 1197+132. The skin was heavily charred, there were multiple cracks through the skin and several stringers were twisted and stringer 25R was cracked at station 1197+120. The frame at station 1197+44 was twisted over a length of five stringers. The insulation blanket between stations 1197+22 and 1197+44 (at the location of the hole in the skin) was charred around the hole, but was grey/white at the hole. Reference Figures 64 through 66.

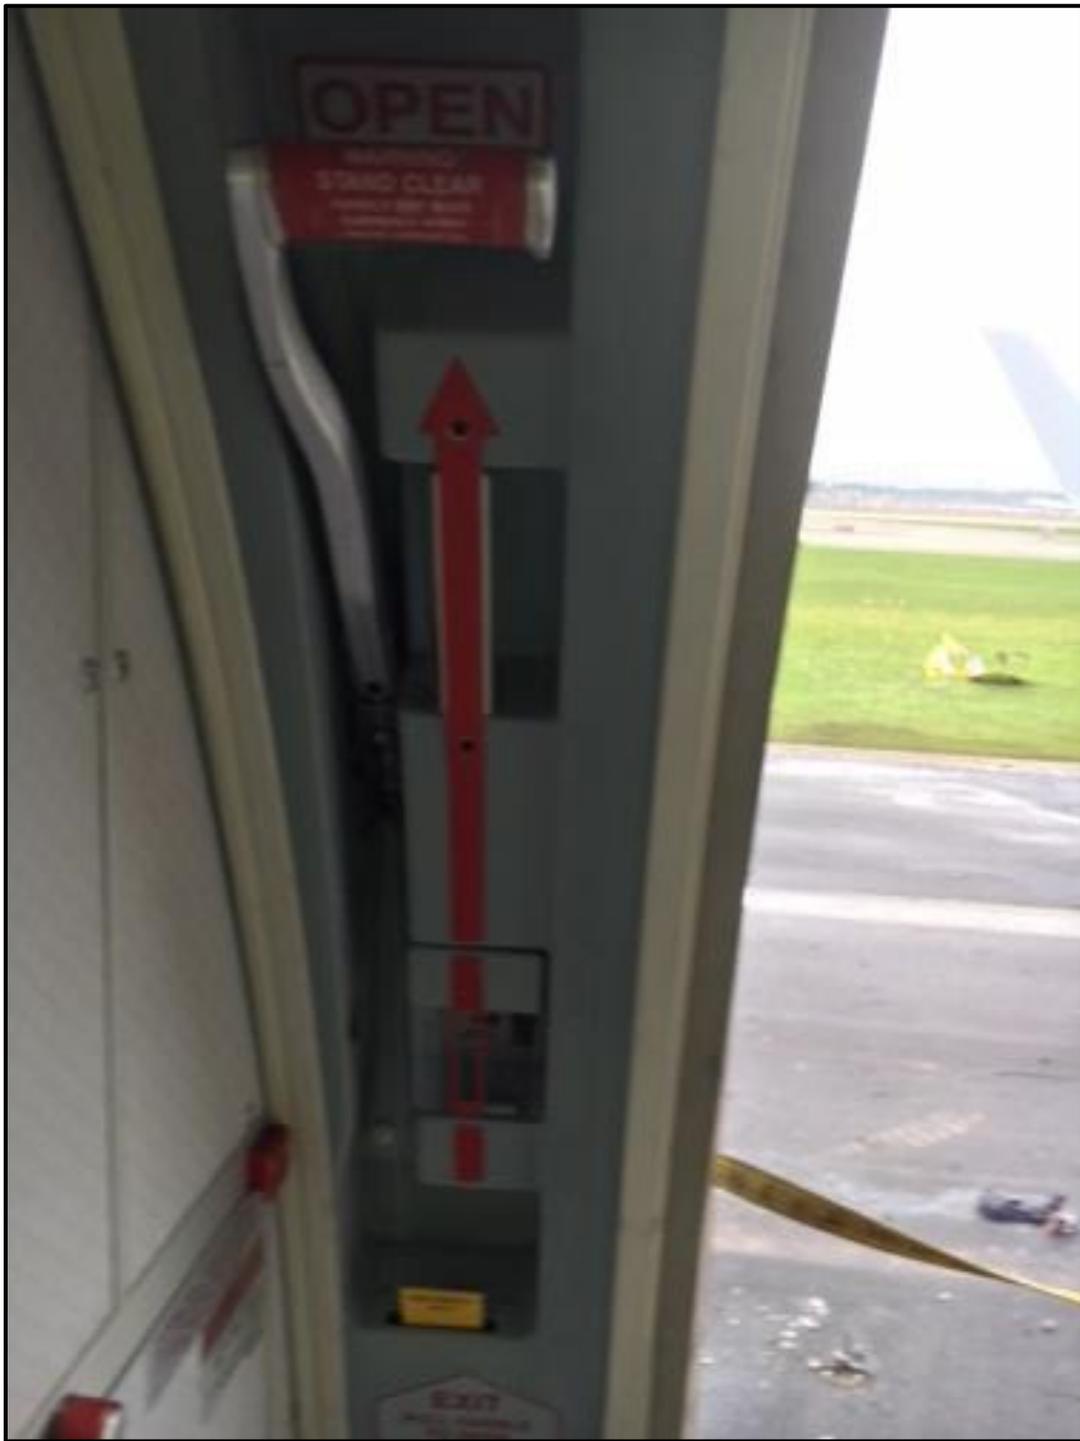
Figure 69 Door 4L

1. Door 1L was found armed and open with its ramp stand in place. Reference Figure 67.
2. Door 1R was found open and in a disarmed position. Reference Figure 68.
3. Door 4L was found open and in an armed position. Reference Figure 69.
4. Door 4R was found closed and in an armed position. Reference Figure 70.
5. Door 2L and 3L (over wing exits) were found removed and placed on the passenger seats. Reference Figure 71
6. The manual inflation handle (at door 2L and 3L) cover remained snapped closed (indicating slides deployed automatically) Reference Figure 72.
7. Over wing exits 2R and 3R were found closed. Reference Figure 73
8. A check of emergency equipment at flight attendant (FA) jump seats showed that only FA #3 at 4R door removed flashlight prior to evacuation.
9. All other emergency equipment remained in original stowage locations including megaphones.
